## TRAIL CREW NOTES

Location: Lower Dungeness (833.3), ONF

20 July 2025

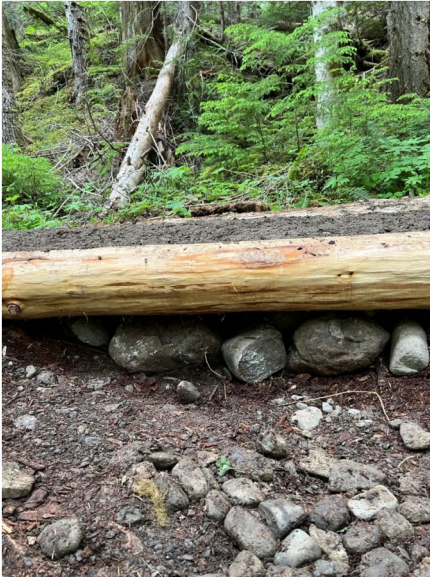
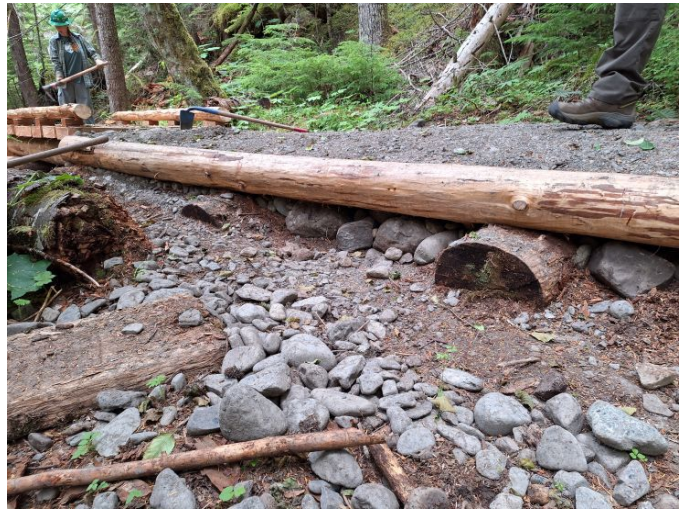
### Turnpike condition at start.

The bottom rocks not placed structurally which could allow upper layers to fall in and wash out under curb logs.

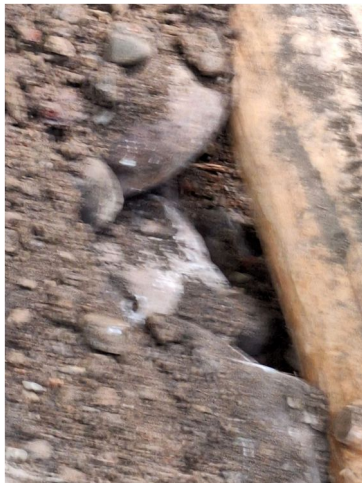
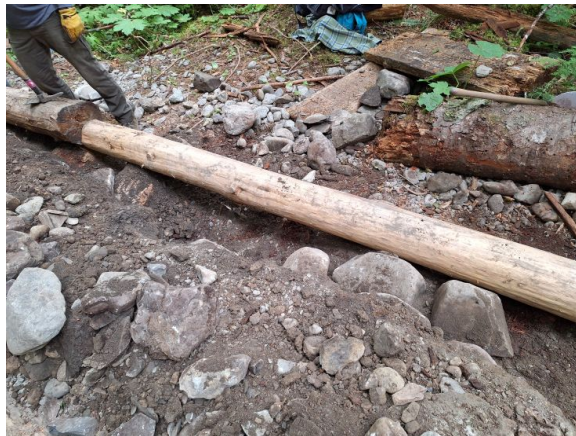
After removing top layer of turnpike soil and rock. Gaps in lower-level supporting structure.

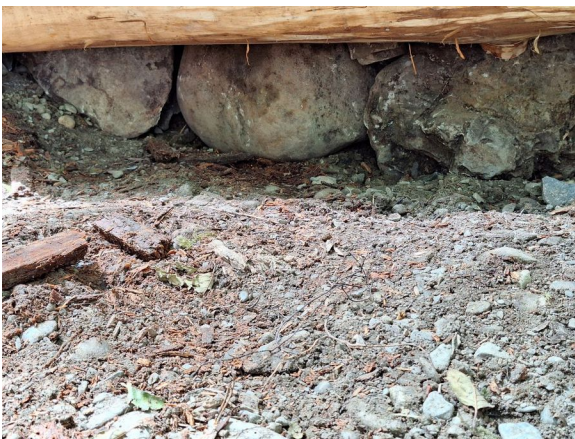
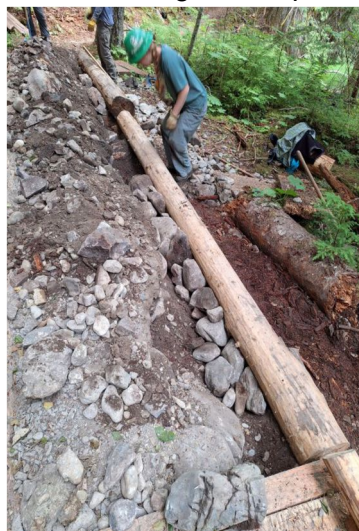
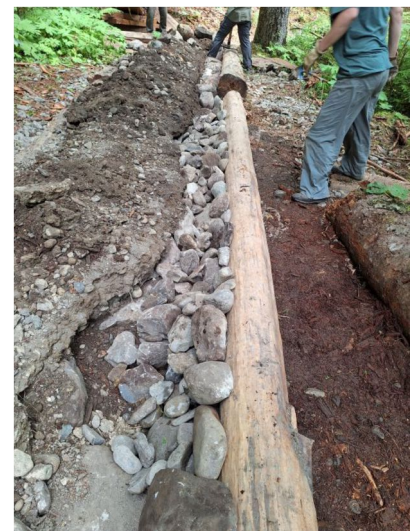
Relining the downhill edge of the turnpike. It is not necessary to have rock supporting directly under the curb log as it is not carrying downward traffic loads as would a stringer for a puncheon.

- Task(s) accomplished:
  - The turnpike remediation was fairly straightforward and was made much easier since we could re-use rocks and soil brought to the site by the NWYC. Our crew dug out the downhill edge of turnpike and relined it with rocks placed to ensure neither rock nor soil would cave in and roll (or be washed out) from under the downhill curb log. Placing the larger rocks at the bottom and moving to smaller rocks as we worked up with soil at the top layer.

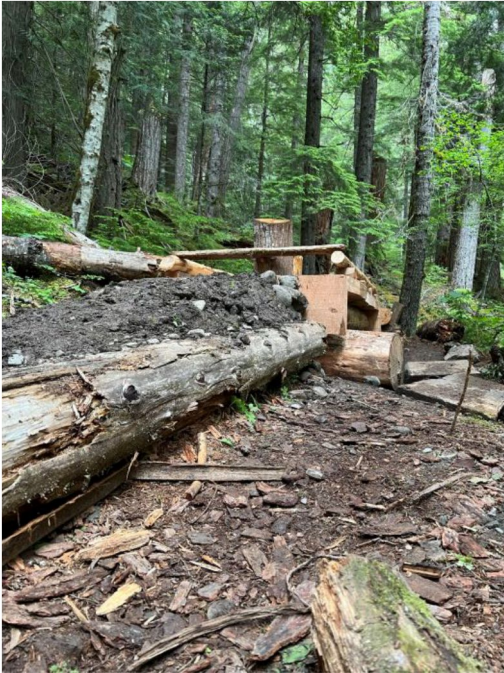
NWYC ramp (ONF directed them to dis-assemble)

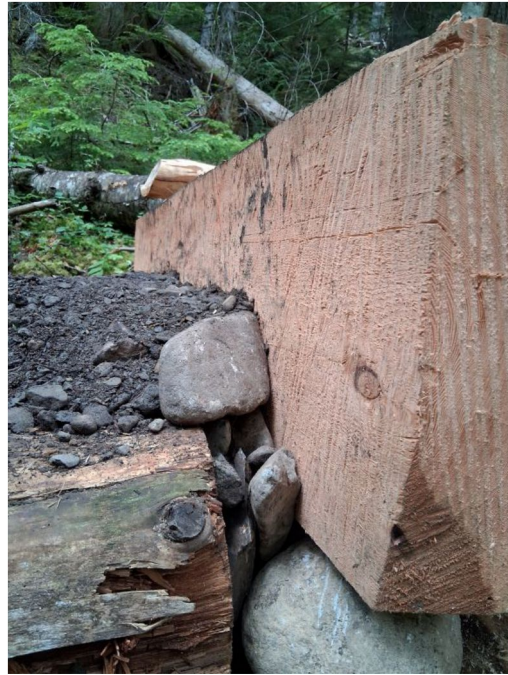
At start of our crew

- Ramps were built from the turnpikes on each end of the final downstream puncheon in this section. Because there was no NWYC-sourced rock for this structure, the crew made several trips to find rock uptrail to move it to the work site. We had brought a wheelbarrow just in case we might need it for this type of work; it helped greatly particularly with the small number of folks on the crew. Once we had the materials, prepping the underlying turnpike, building supporting side walls, and filling the center of the ramp went fairly quickly.

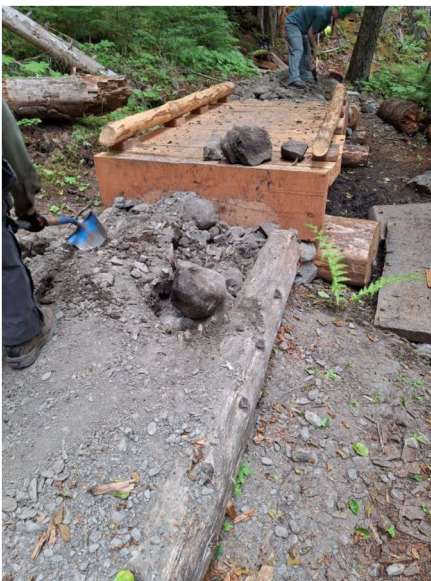
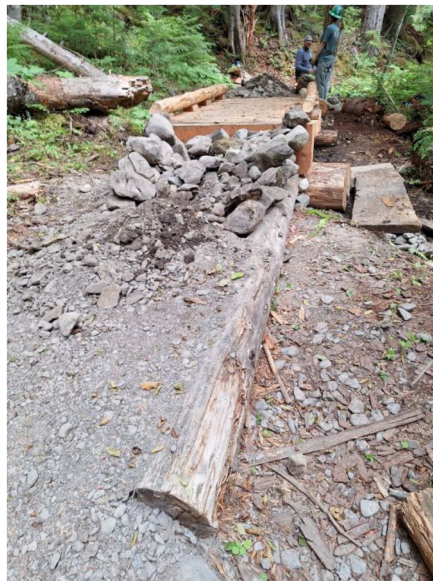
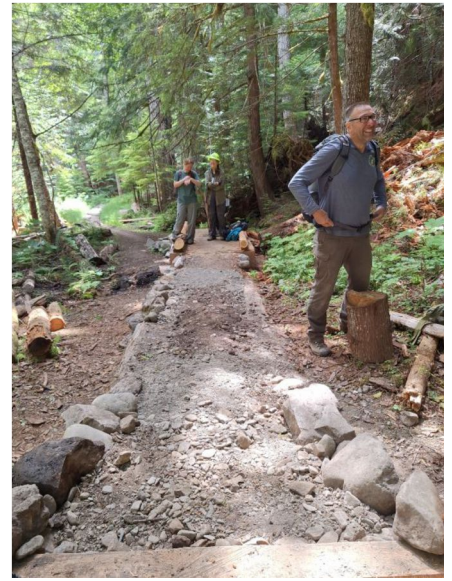
## Reconstruction and finish

The decking of the new puncheons are wider than the turnpike width because the latter used the former puncheon stringers as the outer curb logs, thus the turnpike lacks the added width given by its former puncheon decking. To prevent trail users exiting the puncheon and possibly going over the edge of the turnpike ramp, we had to build the outer rock walls to guide users toward the center of the tread. This also involved ensuring that the outer rocks were well anchored and supported.
