# Gray Wolf Trail Crew -in partnership with- BCHW, Peninsula Chapter

Heather Park Trail, Olympic National Park

14 and 16 November, 2025

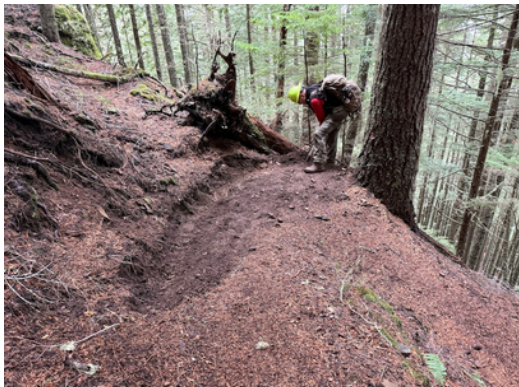
Left: this switchback was getting damaged by water seeping off the hillside. The water needed to be corralled and directed.

However, that steepness, besides taking your breath away, has another downside: erosion due to water running down the trail. There are many drainage features put in earlier by trail workers, but they all needed to be cleared out because they currently were not working and the erosion was obvious. In addition, there were long stretches where the water was flowing unchecked, so we needed to add more drainages along the side of the trail, hopefully catching those problematic areas at the top of the flow.

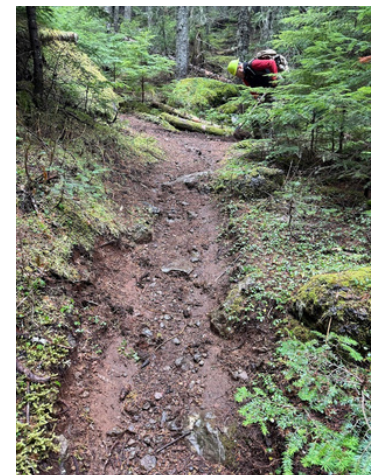
Right: You can see the erosion that is happening as a result of the water flowing unchecked down the trail. Heather Park has really nice tread - we are trying to preserve that!

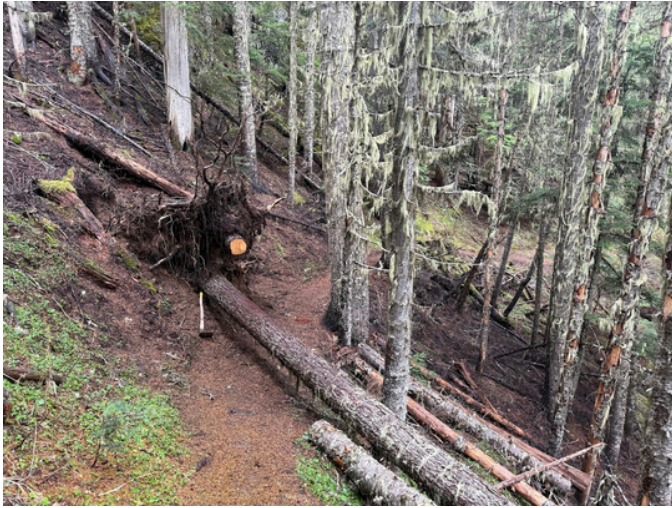
This tree was difficult to get over from the downhill side. It had been down long enough that the tread was destroyed. Martin is quite tall and yet you can see that the tree is at about shoulder height for him as he worked from the downhill side. That was because of the erosion of the tread in that spot.

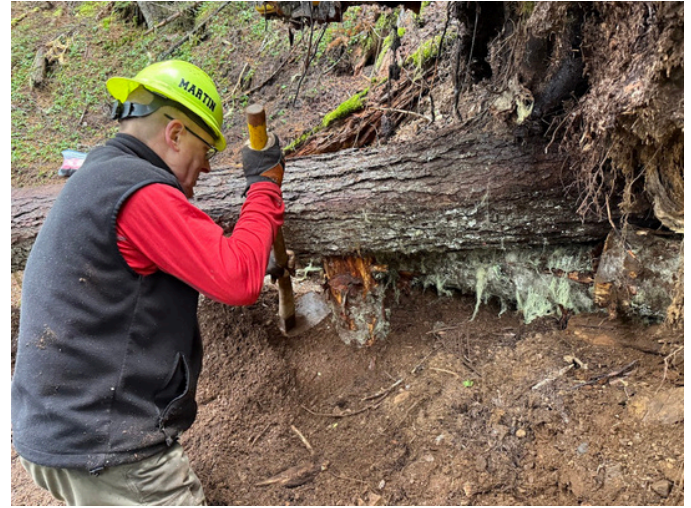
What is he doing, you might ask? This rootball was still rooted in position enough that it wasn't going to roll, however, nothing was to stop it from tipping right into the trail corridor. We decided to use another nearby downed tree as a prop to hold it up. We jammed several pieces in there to make it impossible for the rootball to tip.

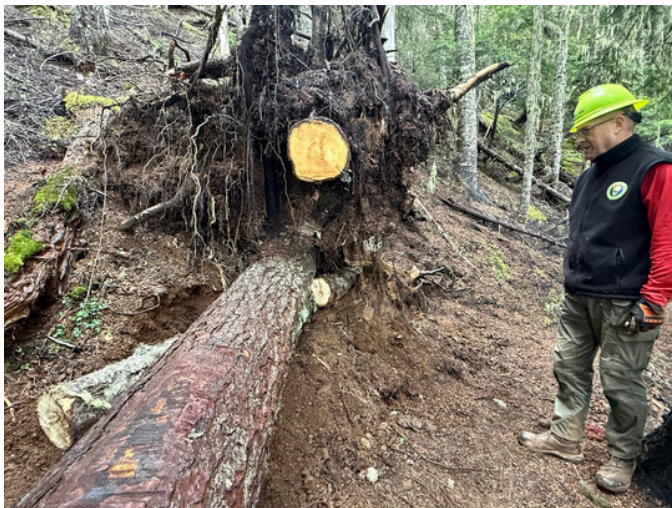
Left: the rootball is sufficiently blocked up, ready for the tree to be cut.

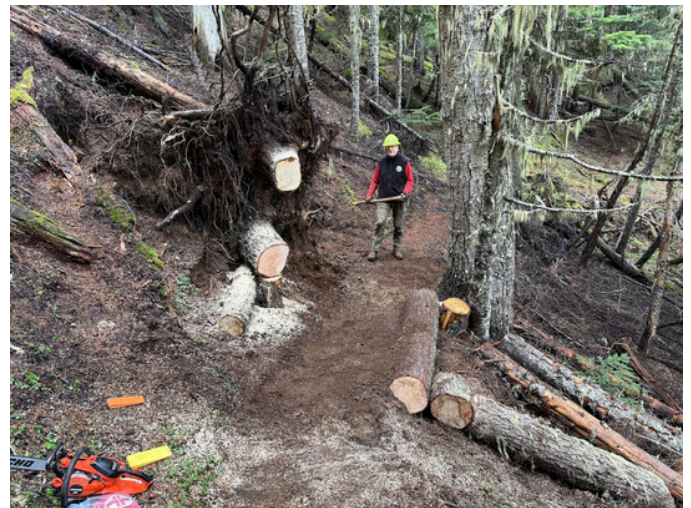
Right: After we cut the tree, we used a log from it, and others as blocks, to create a curb wall so we could repair the tread. This is the finished product.
