Gray Wolf Trail Crew - in partnership with - BCHW, Peninsula Chapter

Duckabush Trail, ONF

Stock access mitigation

Report by Rebecca Wanagel

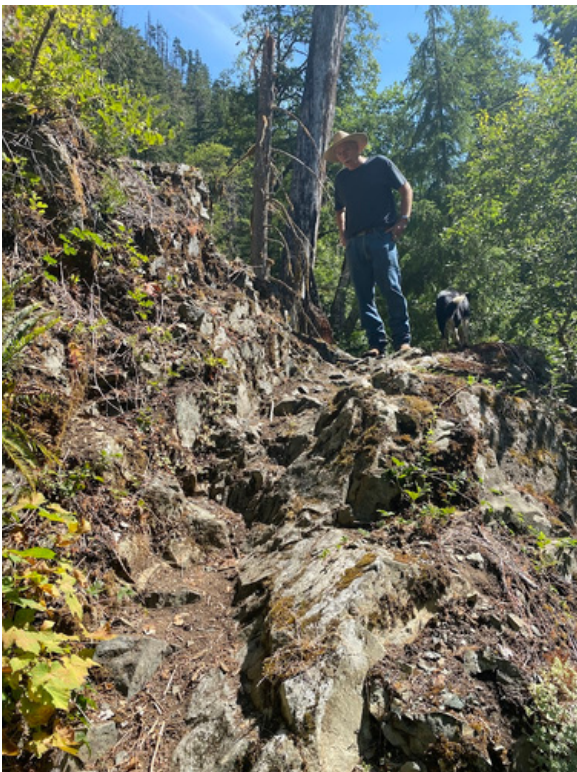
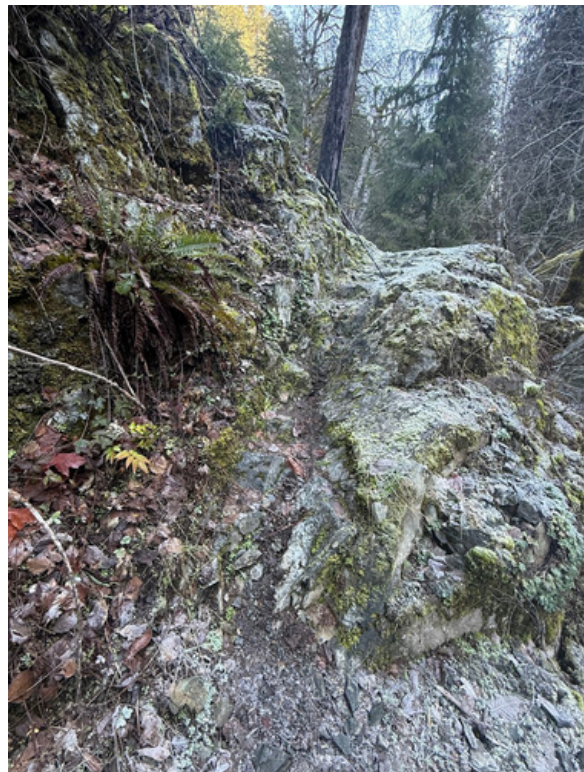
I asked Harold Wiese, one of our amazing volunteer packers, to walk over to look at Claire's rock for his opinion. He agreed that this was not a spot safe to pack through. This is looking downriver. Two "before" pictures, one has a hiking pole for reference.

5. Made it possible and safe for pack stock to get around the corner at Claire's Rock without the animals getting bumped off into the river below (**NOTE: THIS SPOT IS THE REASON NO PACKERS WOULD GO BEYOND - A FALL HERE WOULD BE CATASTROPHIC AND THE LIKELIHOOD WAS EXTREMELY HIGH**). The rock on a sharp corner, which was on a cliff above the river, was jutting way into the too-narrow trail. It was impossible for the pack boxes to not hit the rock and the river is about 30 feet below at this point.

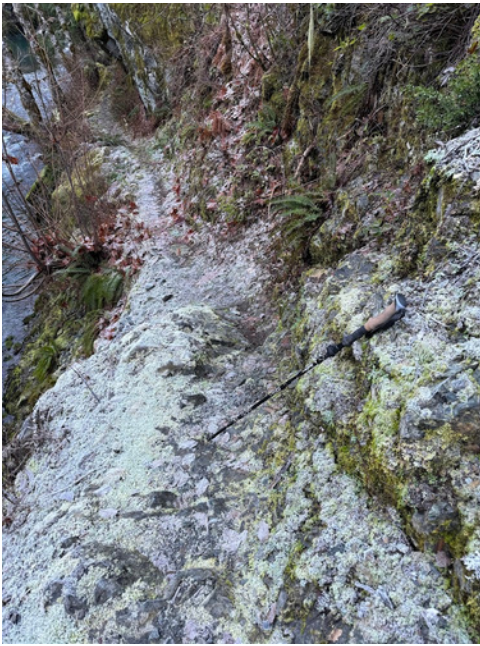
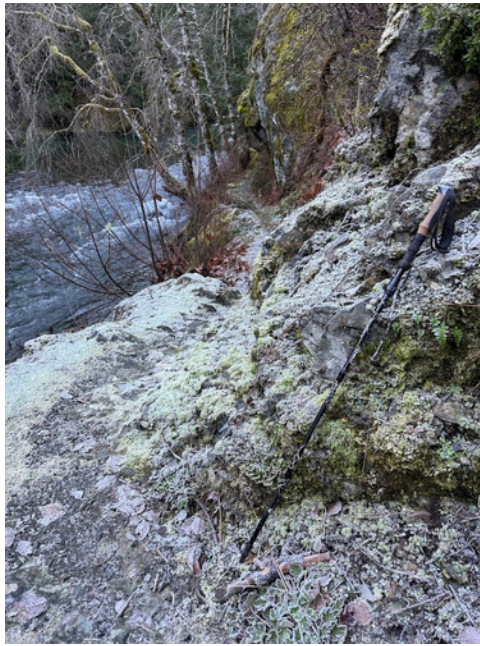
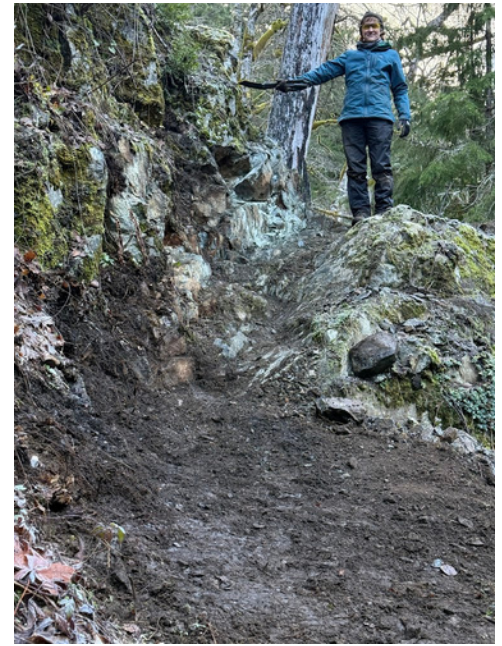
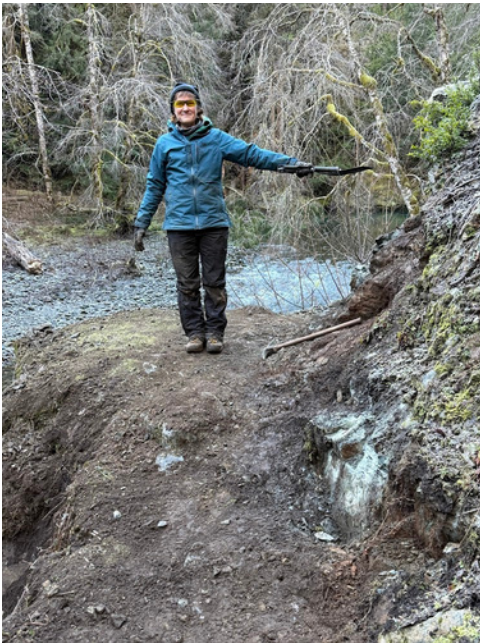
It's hard to capture tread and rock problems in pictures. You just don't get the depth and perspective. Suffice to say, this was the corner that was a no-go for anyone who packed us in for work crews. The fall to the river below is a good 30 feet and the rock jutted out so far it would be impossible for pack boxes not to hit and push the animal to the edge. The drop after the corner was just as bad, leaving no way to get down to the river level safely.

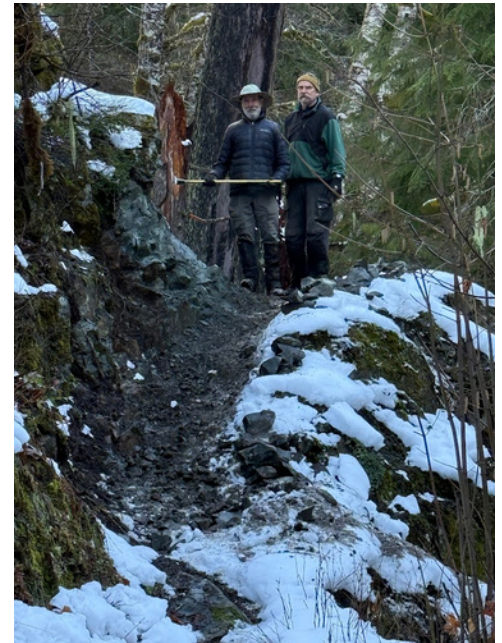
We are holding our arms out with a tool extending our reach to show how much clearance there is now. We feel like there is enough clearance for the stock to pass through safely.

This section, known as "Claire's Rock" (sadly named after a horse who took a fall here) is 5.5 miles from the trailhead. Working on this required an 11 mile round trip hike. Up and over Big Hump each way. We put more time into hiking to the jobsites than actually working!

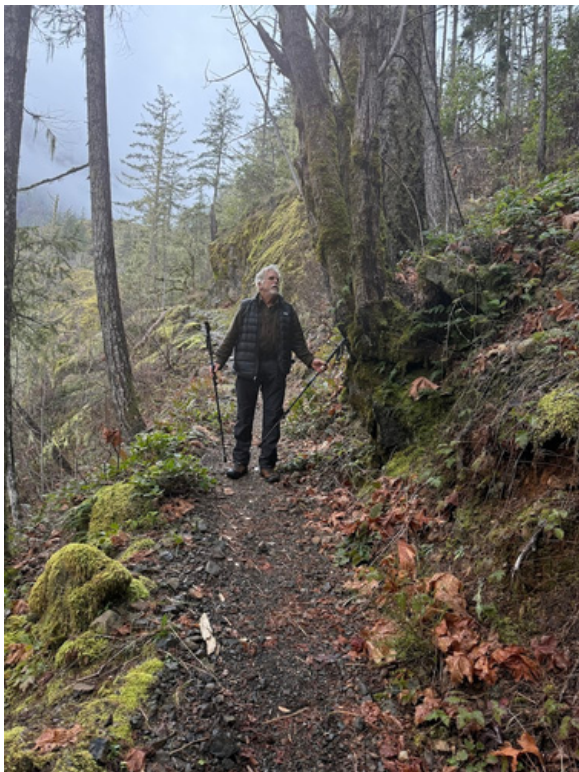
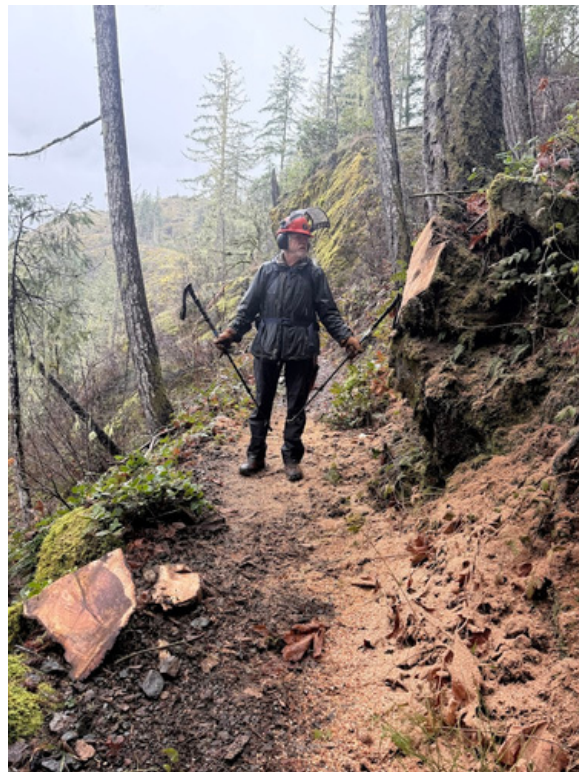
There were several maples on the uphill side of the trail on the tight switchbacks heading up to "Snack Rock." They were growing tilted outwards, which bumps pack boxes. The switchbacks are on unstable soil with soft shoulders. An easy place for an animal to take a fall.

1. Removed maples from the upside of the tight switchbacks that were pack bumpers (they were growing curved into the trail). These were bumping packs hard enough that mules were in danger of slipping off the soft shoulder of the steep and unstable switchbacks.

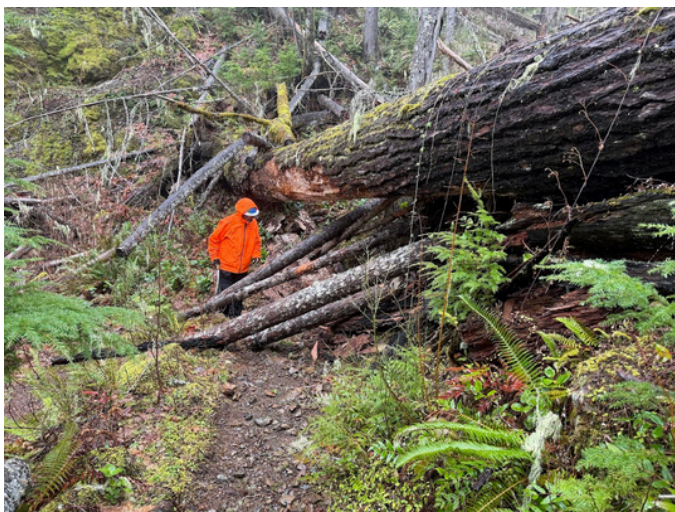
This was the large doug fir that was parallel to the trail at about shoulder / head height. The trail does a switchback right behind Martin in the orange coat. You can see where the bark has been knocked off by pack bags / boxes as packers came around the corner. The logs you see laid perpendicular were ones we placed there as skid logs. The target log was going to roll right into the trail, which is troughed. We decided to help the log help itself get off the trail down below the switchback.

4. Shortly before Five-Mile camp there was a large rotten fir that ran parallel to the trail at about shoulder height. Packs had bumped it so many times the bark was worn off. We removed that.

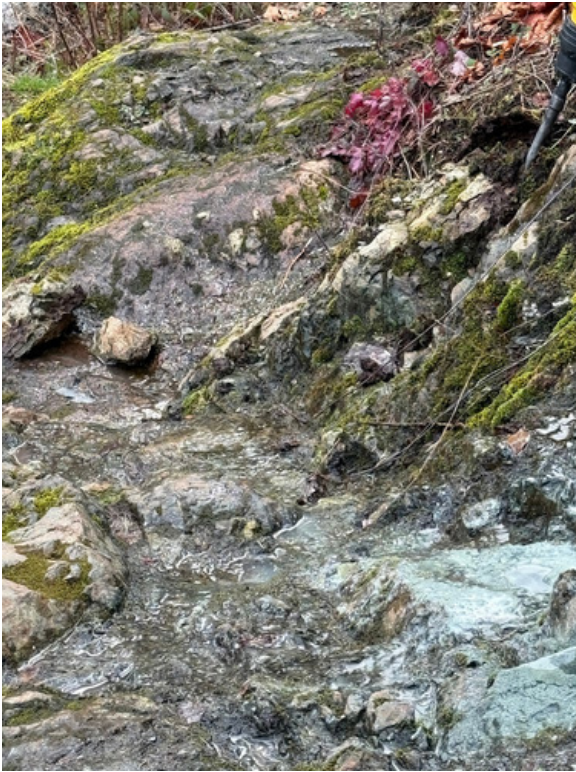
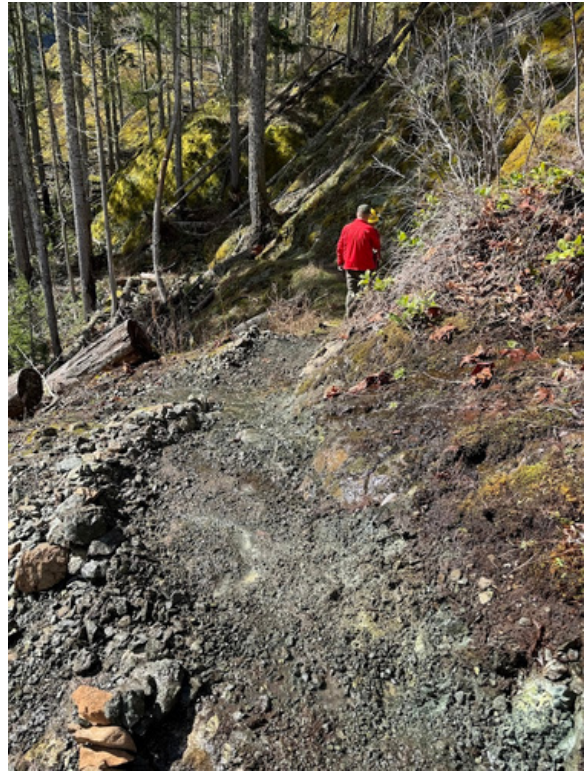
It's hard to see what's going on here but this is a section just above "Snack Rock" that is about 40-ish feet long. It is smooth bedrock that is always wet (it seeps off the hill) and is outsloped. This spot was difficult for me to watch the pack string going over, sure that someone could fall. A fall in this section was less consequential than the other areas, but highly likely. After a pack string goes over, I can see dozens of scrapes on the rocks where the animals were trying to gain purchase with their hooves. We flattened it out, made it wider and easier to ramp on or off, depending on the direction of travel.

3. Did major improvement to the slippery bedrock just above Snack Rock. This was an area that had smooth, outsloped, perpetually wet and slippery bedrock. There was no way to gain any purchase; hooves were scrabbling all over. At least one horse fell with its rider here in the past. It was nerve wracking watching a pack string go over this.

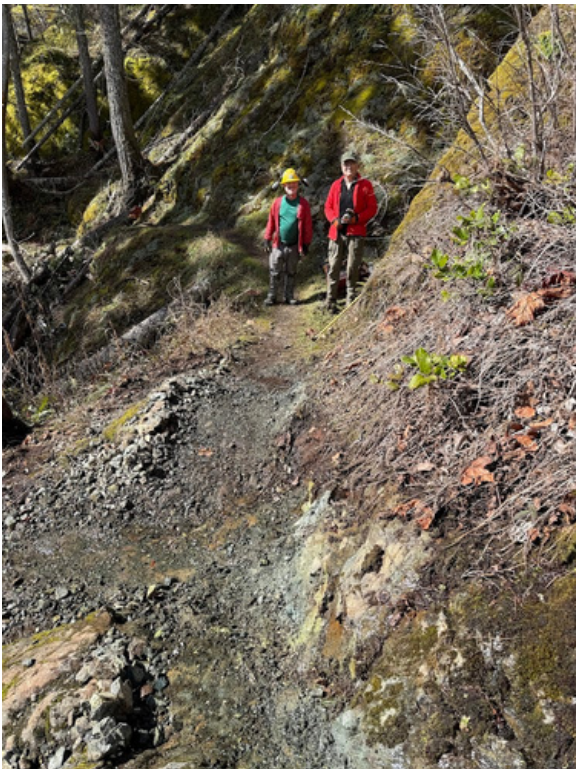
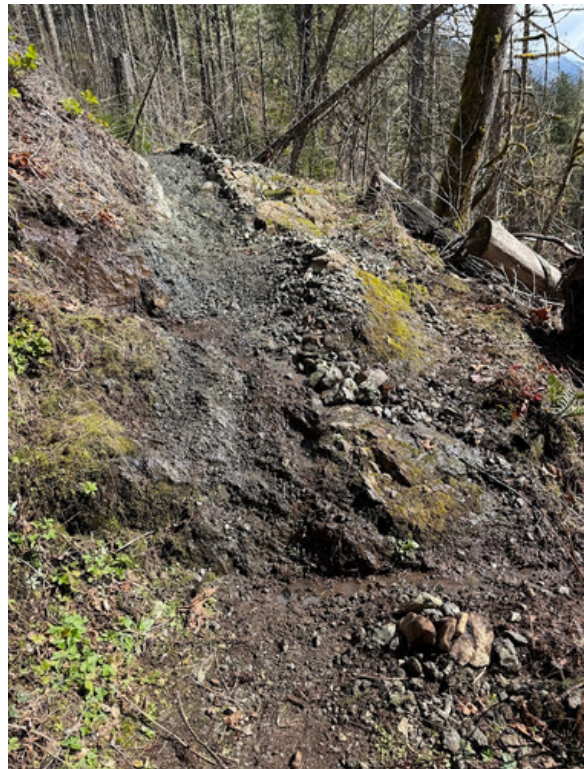
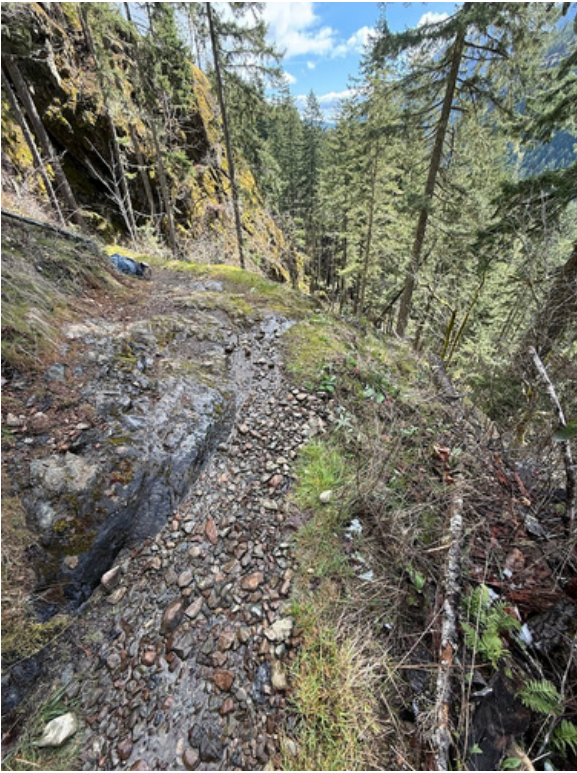
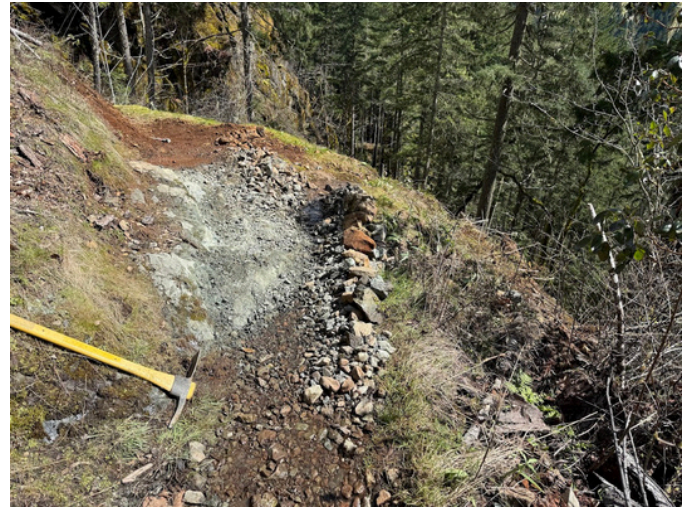
Section just below Snack Rock. Before and after, looking downriver. A fall here would be extremely high consequence. Some packers / riders have refused to come back to the Duckabush based on this spot alone.

2. Made a short slick rock section right below Snack Rock safer. A fall in this spot would likely be catastrophic. Packers mentioned this area many times.

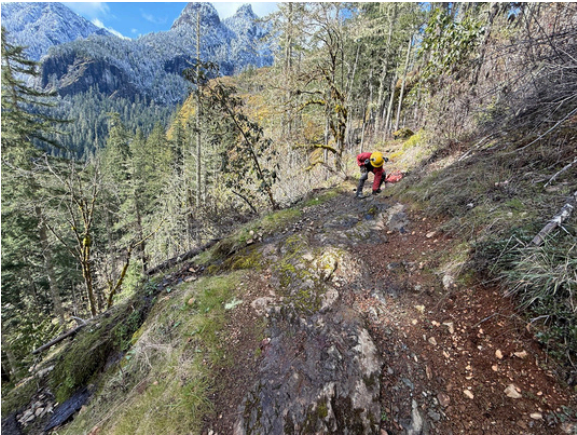
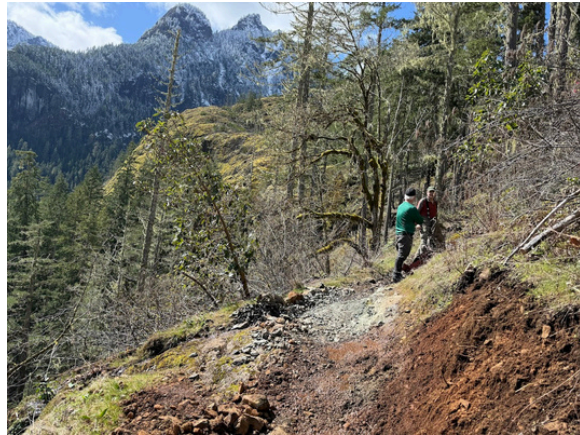
Before and after, looking upriver. On the rock projects, we finish by delineating the downhill edge of the trail with piles of rocks. This is to encourage the horses / mules to stay to the uphill side. It makes the direction of desired travel more obvious.

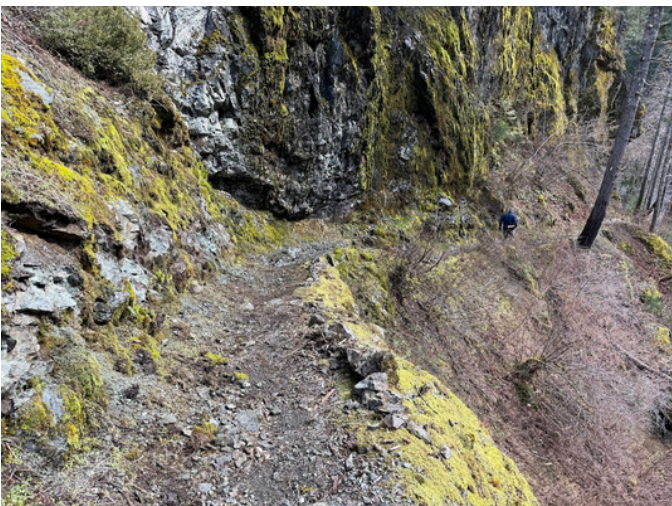
This is the traverse up above Claire's Rock. A long ways above the river, with an extremely steep hillside. This is the after picture. For 30 feet we knocked the rock back anywhere from a few inches to a foot or more. I walked this section afterwards with an outstretched arm and a tool and did not hit the rock anywhere. Before, it was much tighter and more conducive to pack bumping with a high consequence fall waiting below.

6. Just past that corner, improved footing for the animals on a short but slippery rock hill that didn't have good hoof placement.
7. On the traverse above Claire's Rock, for 30 feet we knocked the rock wall back to make more room for packs so the animals don't get bumped off.
