Two-Mile Bridge on Olympic Adventure Route

April 29 – May 5, 2022

By Donna Hollatz

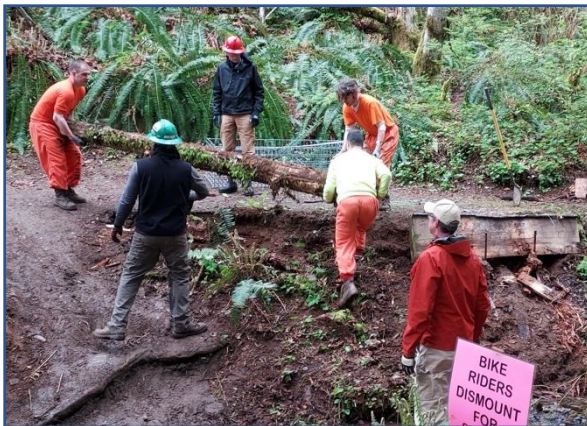
Removing the old bridge.

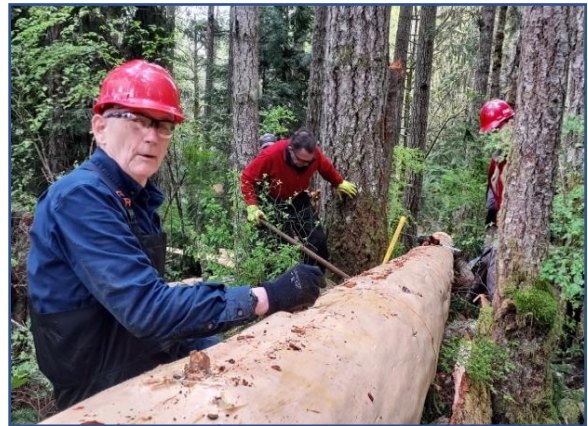
Peeling bark from the log that will become the new bridge stringers.

A log of the right size was found about 60 yards away. It was then peeled, slid into place using Griphoists, cables, and pulleys, bucked to the proper length (2 pieces), and lifted over the creek bed by a BCHW rigging crew. While that process was taking place, other volunteers removed the old bridge, dug out and leveled the abutment ends, and placed gabion baskets, filled with rock, as a foundation for the new stringers. All the tools, gravel, and large rock was moved down the trail about 2/3 mile from the trailhead (near Karpen Road) to the job site with four powered, tracked, totes.

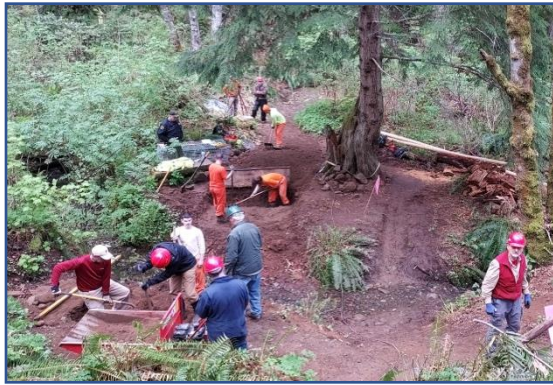
Preparing the ends for the new bridge placement.

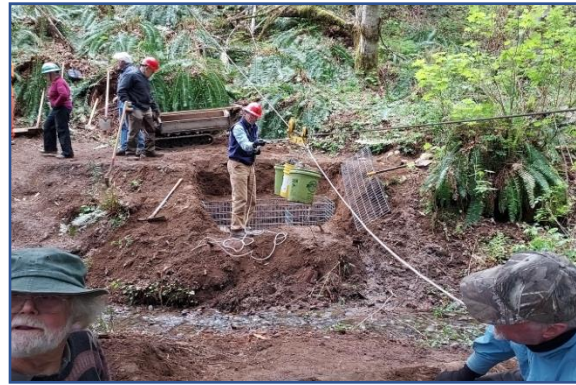
Moving rock to fill gabion baskets.

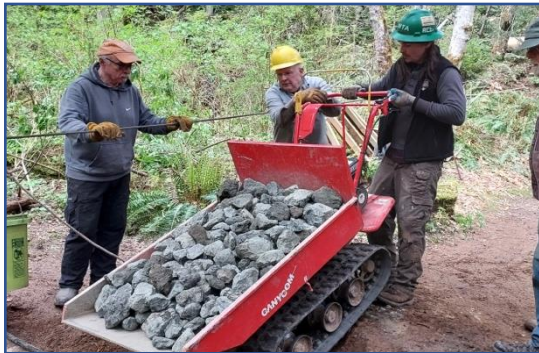
Some of the rock was moved with power totes.

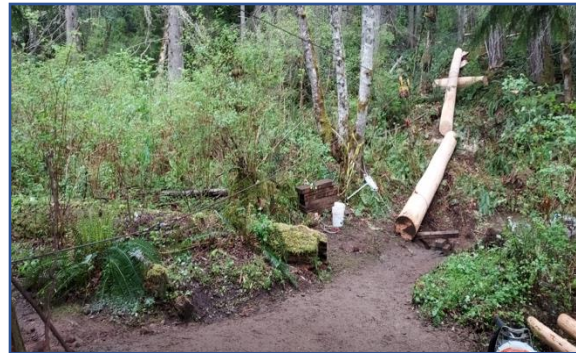
Sliding the stringer log pieces toward the bridge.

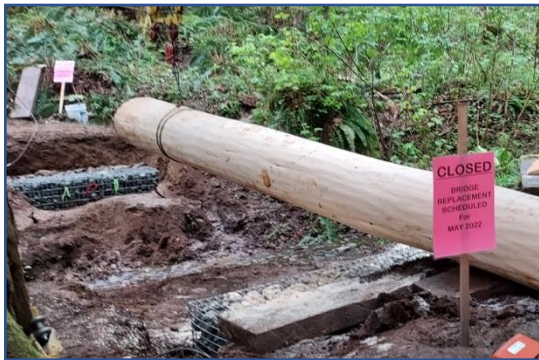
Placing the stringers on the gabion base.

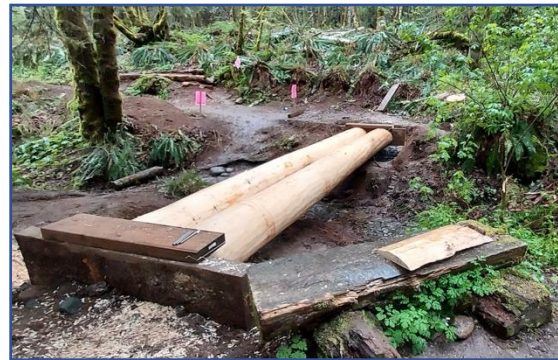
Stringers in place.

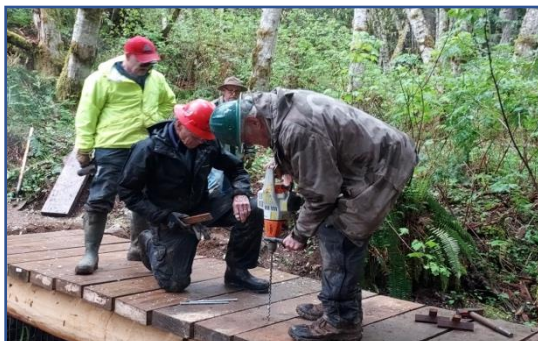
Adding bridge decking.

Some of the planks from the old bridge were sound and able to be re-used on the new bridge. A bull rail was installed down each side for safety, and the approaches to the bridge were rebuilt. This was an amazing work of coordination between several groups and resulted in a beautiful new bridge!

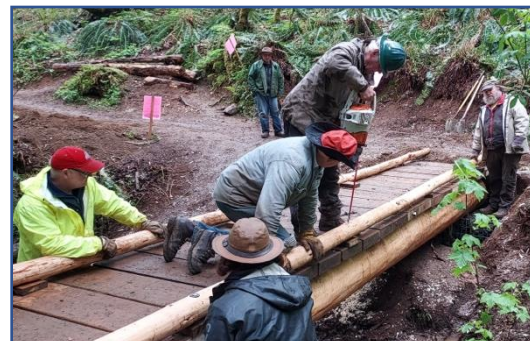
Attaching bull rail.

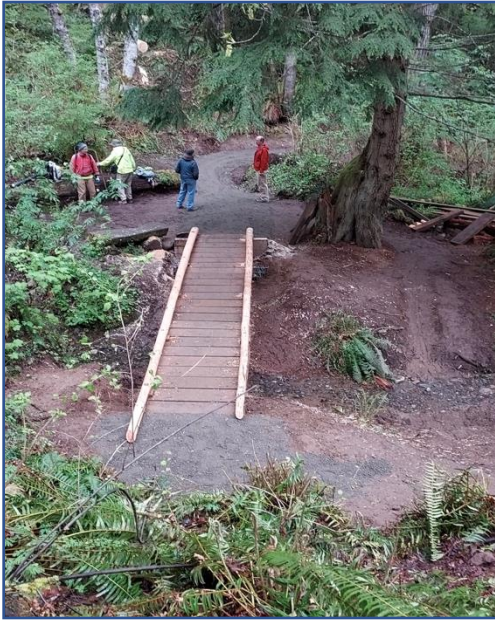
Repairing approaches.

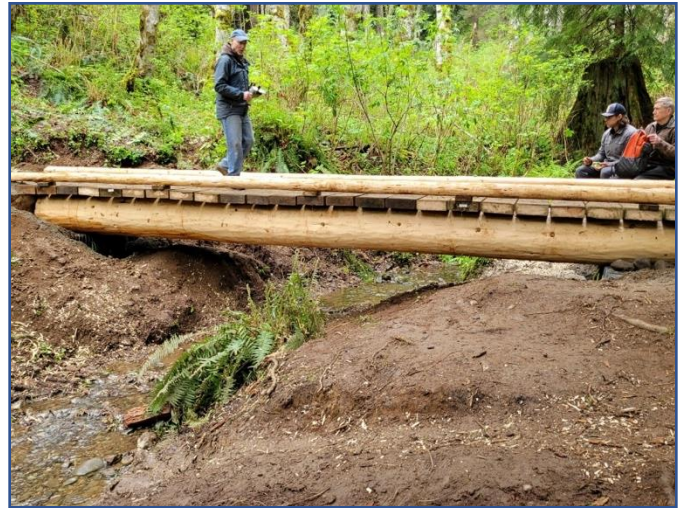
Finished structure!
