**Monthly Trail Report for the Board and Membership
Peninsula Chapter and Gray Wolf Trail Crew
Report written by Rebecca Wanagel
April 2026**

Duckabush Trail, ONF

ONF: Slab Camp and Graywolf trails

Little River Trail, ONP

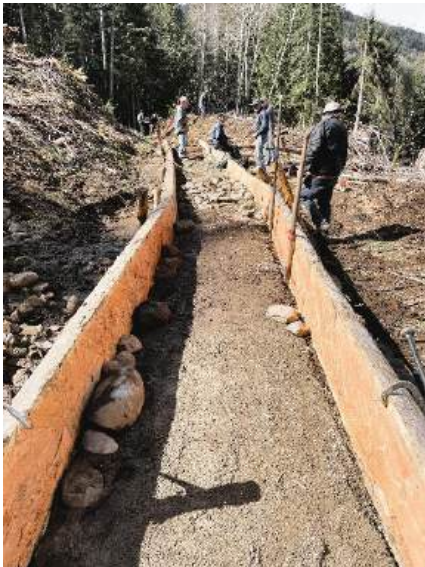
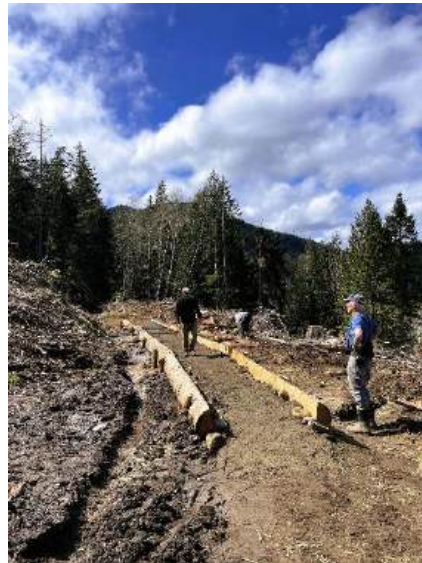
OAT MP 11; Only 9 workers signed the work sheet but the crew was about 15 workers. The work involved finishing the turnpike and addressed widening and smoothing the easterly approach to the turnpike area. So again, 15 workers; 90 work hours. Addition to this report are two photos of the finished work.

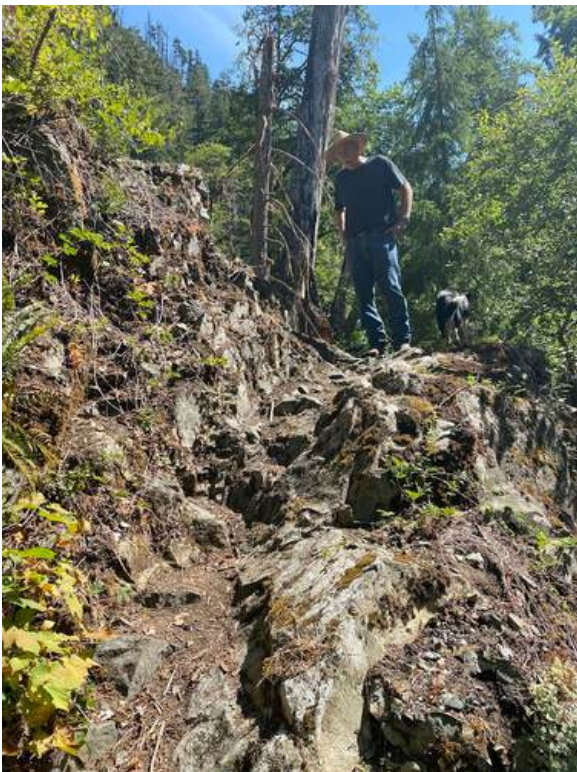
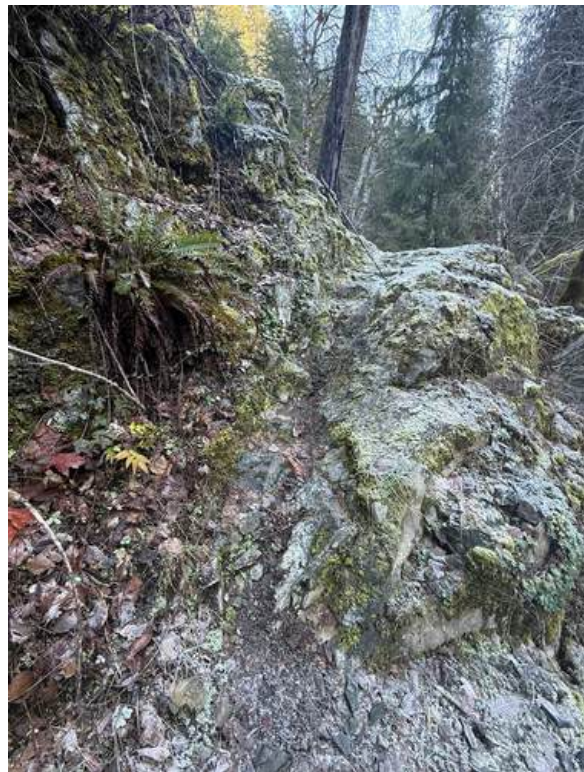
5. Made it possible and safe for pack stock to get around the corner at Claire's Rock without the animals getting bumped off into the river below (**NOTE: THIS SPOT IS THE REASON NO PACKERS WOULD GO BEYOND - A FALL HERE WOULD BE CATASTROPHIC AND THE LIKELIHOOD WAS EXTREMELY HIGH**). The rock on a sharp corner, which was on a cliff above the river, was jutting way into the too-narrow trail. It was impossible for the pack boxes to not hit the rock and the river is about 30 feet below at this point.

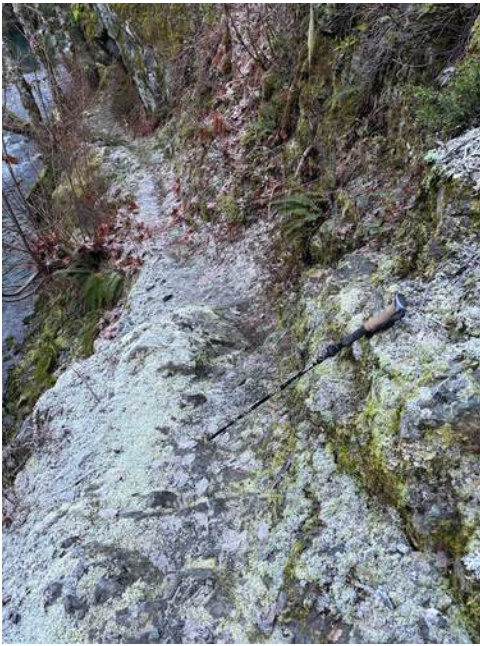
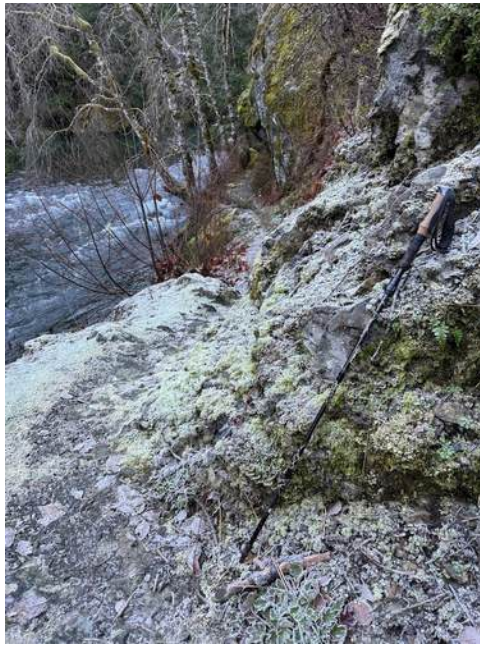
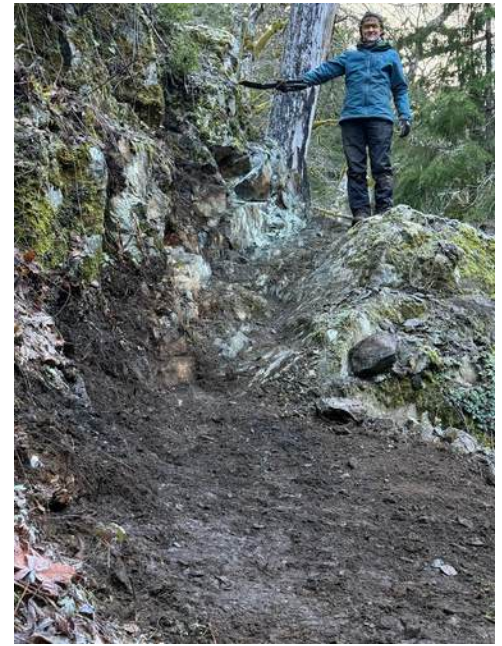
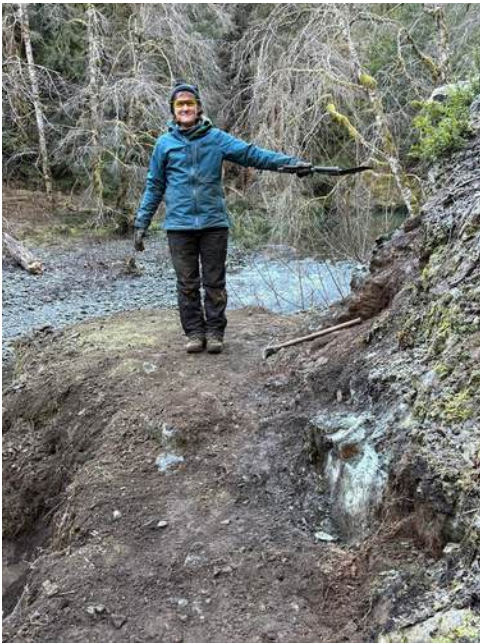
I asked Harold Wiese, one of our amazing volunteer packers, to walk over to look at Claire's rock for his opinion. He agreed that this was not a spot safe to pack through. This is looking downriver. Two "before" pictures, one has a hiking pole for reference.

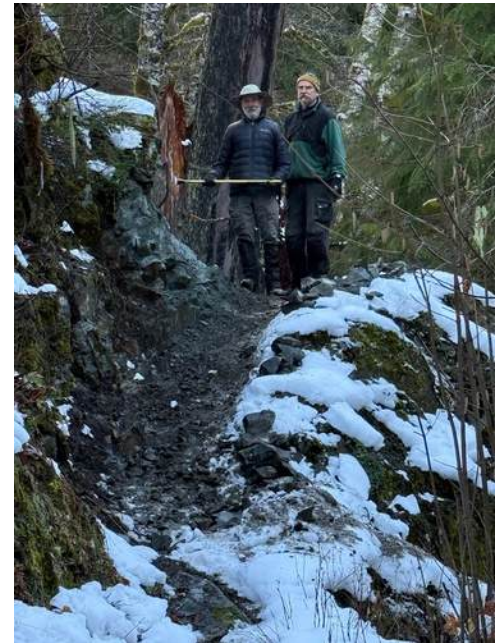
It's hard to capture tread and rock problems in pictures. You just don't get the depth and perspective. Suffice to say, this was the corner that was a no-go for anyone who packed us in for work crews. The fall to the river below is a good 30 feet and the rock jutted out so far it would be impossible for pack boxes not to hit and push the animal to the edge. The drop after the corner was just as bad, leaving no way to get down to the river level safely.

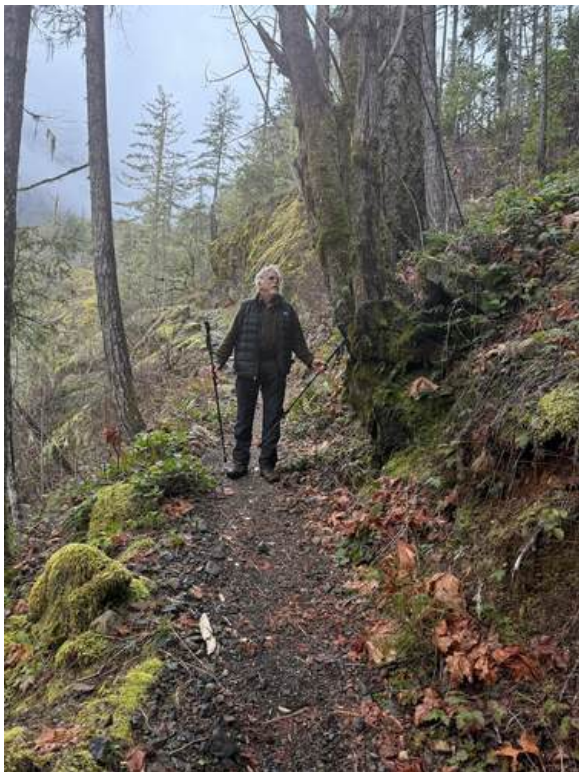
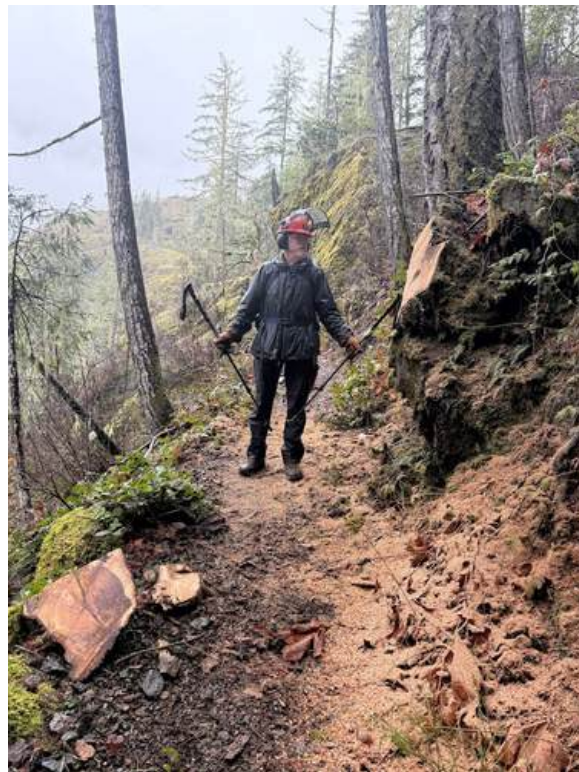
We are holding our arms out with a tool extending our reach to show how much clearance there is now. We feel like there is enough clearance for the stock to pass through safely.

This section, known as "Claire's Rock" (sadly named after a horse who took a fall here) is 5.5 miles from the trailhead. Working on this required an 11 mile round trip hike. Up and over Big Hump each way. We put more time into hiking to the jobsites than actually working!

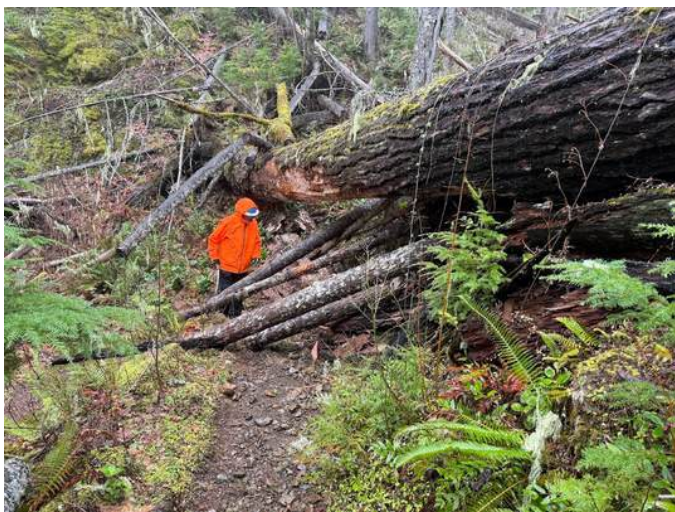
There were several maples on the uphill side of the trail on the tight switchbacks heading up to "Snack Rock." They were growing tilted outwards, which bumps pack boxes. The switchbacks are on unstable soil with soft shoulders. An easy place for an animal to take a fall.

1. Removed maples from the upside of the tight switchbacks that were pack bumpers (they were growing curved into the trail). These were bumping packs hard enough that mules were in danger of slipping off the soft shoulder of the steep and unstable switchbacks.

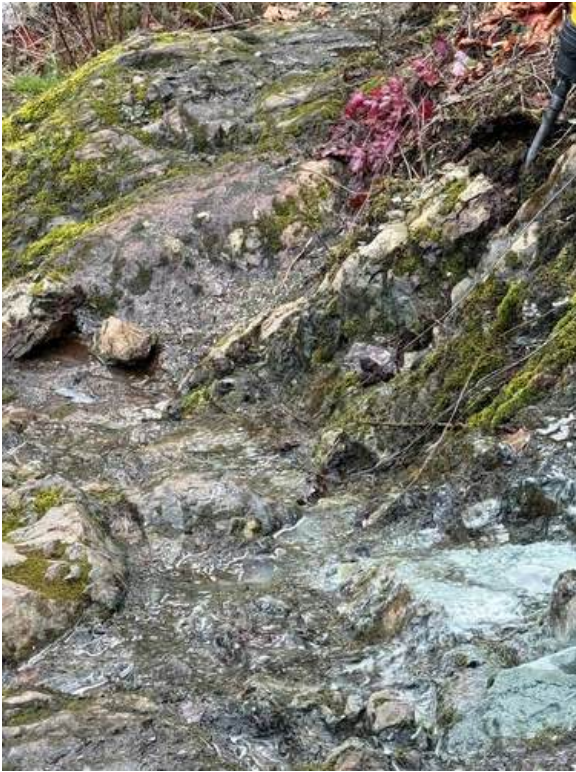
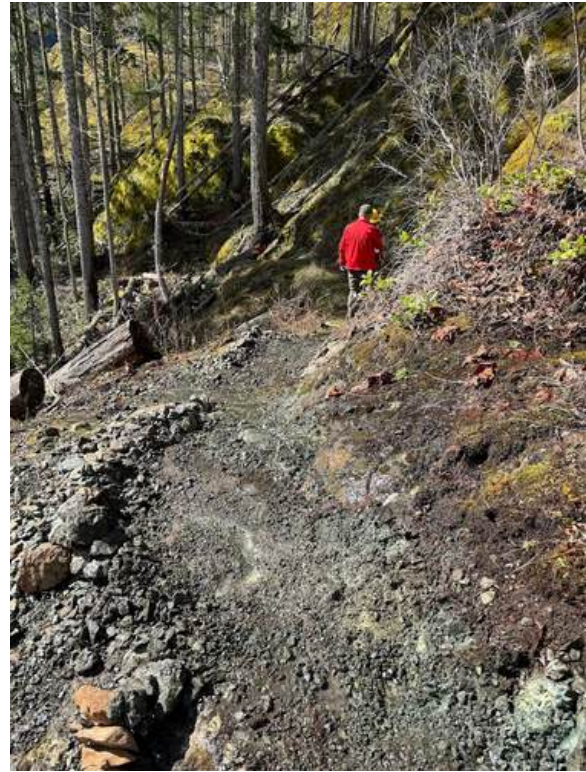
This was the large doug fir that was parallel to the trail at about shoulder / head height. The trail does a switchback right behind Martin in the orange coat. You can see where the bark has been knocked off by pack bags / boxes as packers came around the corner. The logs you see laid perpendicular were ones we placed there as skid logs. The target log was going to roll right into the trail, which is troughed. We decided to help the log help itself get off the trail down below the switchback.

4. Shortly before Five-Mile camp there was a large rotten fir that ran parallel to the trail at about shoulder height. Packs had bumped it so many times the bark was worn off. We removed that.

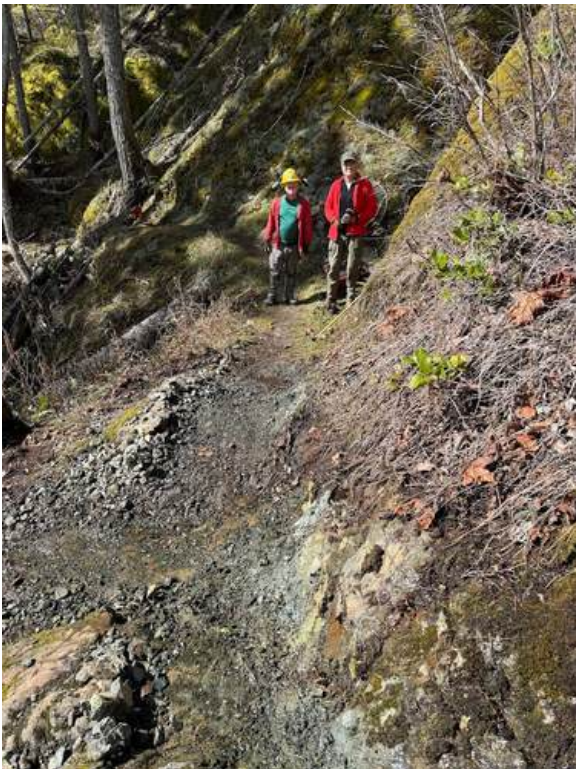
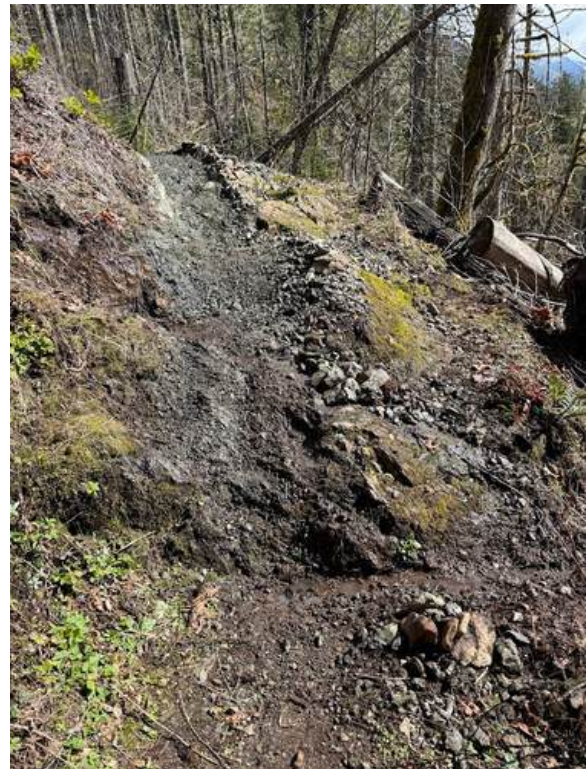
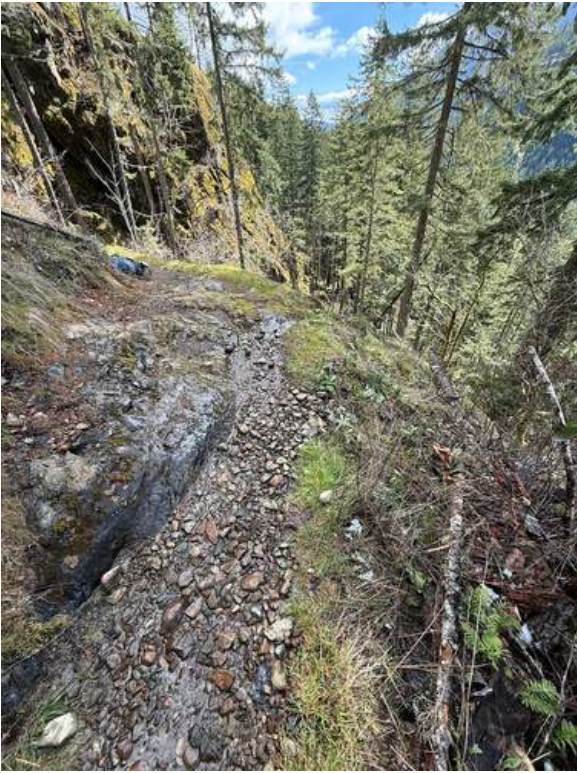
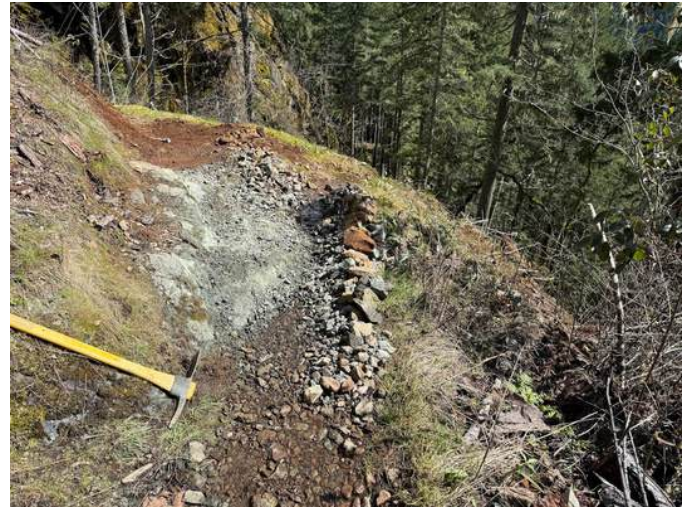
It's hard to see what's going on here but this is a section just above "Snack Rock" that is about 40-ish feet long. It is smooth bedrock that is always wet (it seeps off the hill) and is outsloped. This spot was difficult for me to watch the pack string going over, sure that someone could fall. A fall in this section was less consequential than the other areas, but highly likely. After a pack string goes over, I can see dozens of scrapes on the rocks where the animals were trying to gain purchase with their hooves. We flattened it out, made it wider and easier to ramp on or off, depending on the direction of travel.

3. Did major improvement to the slippery bedrock just above Snack Rock. This was an area that had smooth, outsloped, perpetually wet and slippery bedrock. There was no way to gain any purchase; hooves were scrabbling all over. At least one horse fell with its rider here in the past. It was nerve wracking watching a pack string go over this.

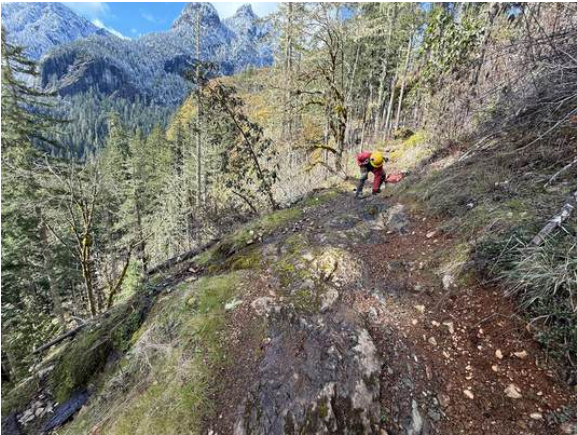
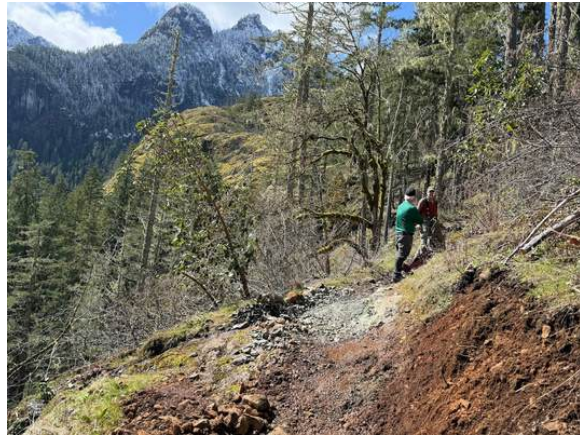
Section just below Snack Rock. Before and after, looking downriver. A fall here would be extremely high consequence. Some packers / riders have refused to come back to the Duckabush based on this spot alone.

2. Made a short slick rock section right below Snack Rock safer. A fall in this spot would likely be catastrophic. Packers mentioned this area many times.

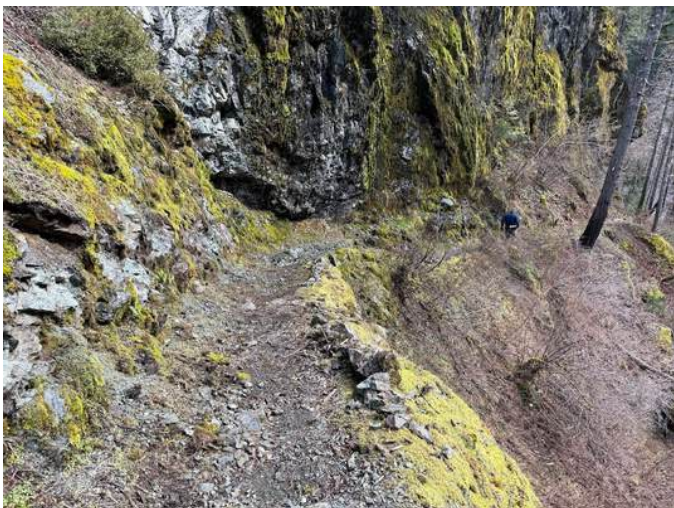
Before and after, looking upriver. On the rock projects, we finish by delineating the downhill edge of the trail with piles of rocks. This is to encourage the horses / mules to stay to the uphill side. It makes the direction of desired travel more obvious.

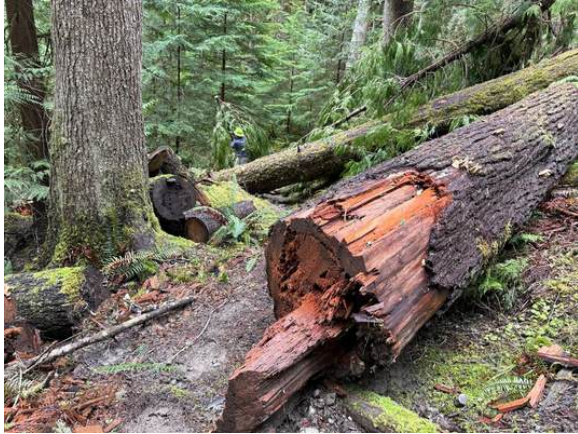
Before picture of our main project on Graywolf trail.

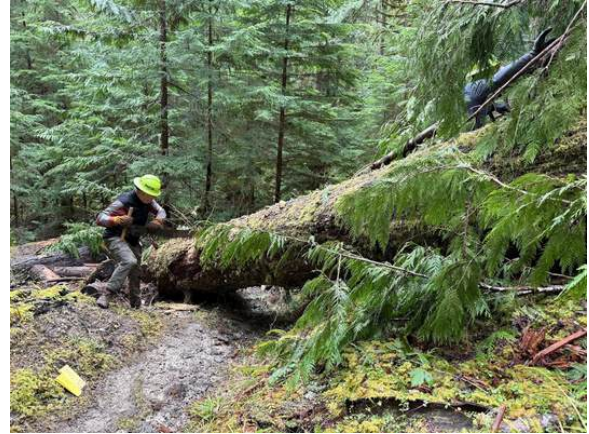
Getting started by single bucking with the smaller of the saws that we brought. (the guys with the bigger saw were finishing up an earlier project)

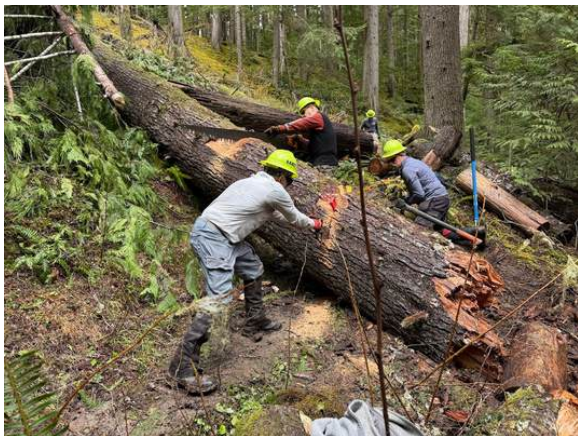
Working on two cuts at once, something you can do with crosscut saws because the cuts take a while on a tree of this size.

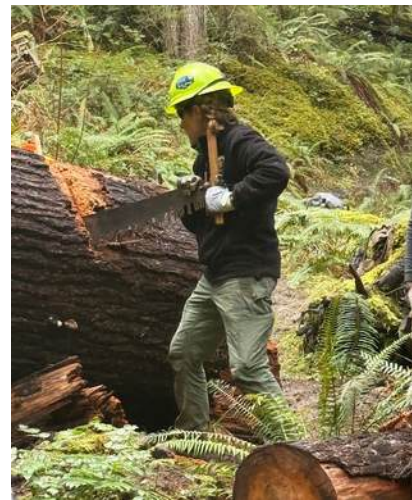
Starting on the second log.

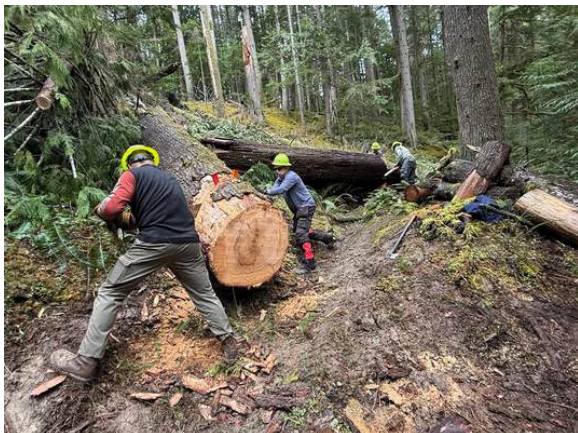
A team working on each tree.

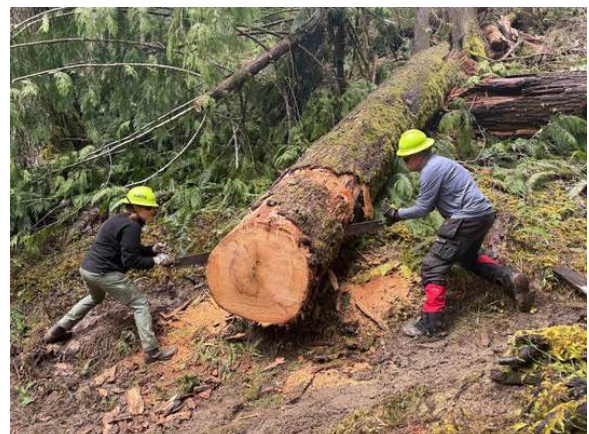
We really didn't have any unexpected difficulties to this project, other than the hillside (and the trail) in this area is wet clay. Extremely slippery. This made safe footing a challenge.

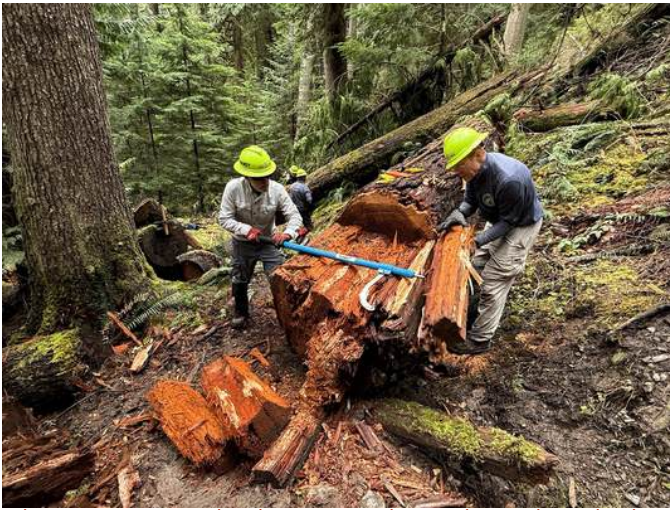
This one was completely rotten and waterlogged. We had to do a combination of sawing and breaking it apart.

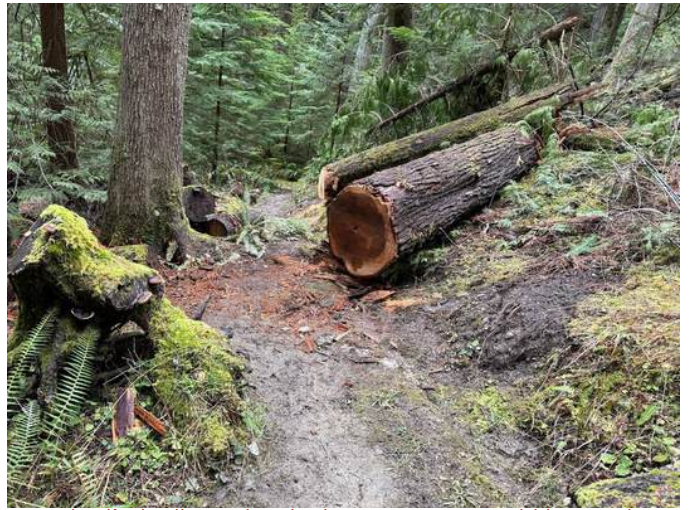
Finished! Ideally, and with chainsaws, we would have taken off a few more chunks on the foreground tree. The reason we left it like that is it is passable, and if we took off another chunk, the whole thing would have rolled into the trail. Sometime we will get rid of the rest of it, but today it was hugely better and we had miles to cover.

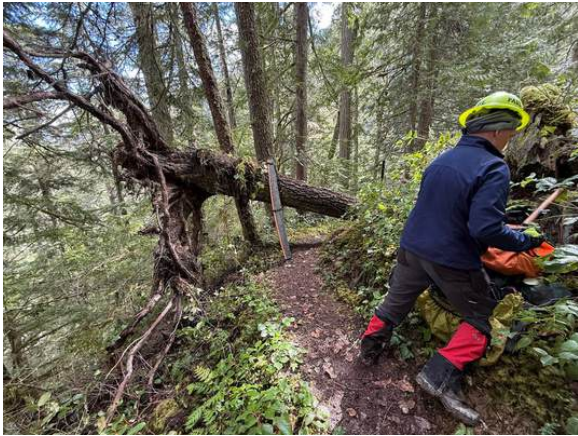
This tree had severe bottom bind due to the weight of that suspended rootball. It was also suspended down below to the right after it went off the trail.

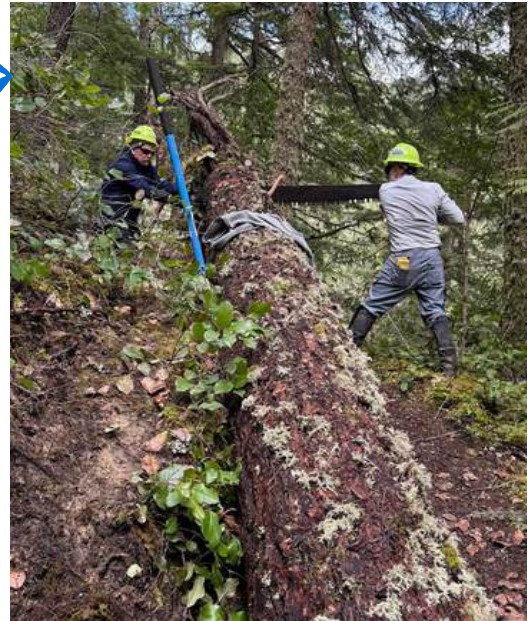
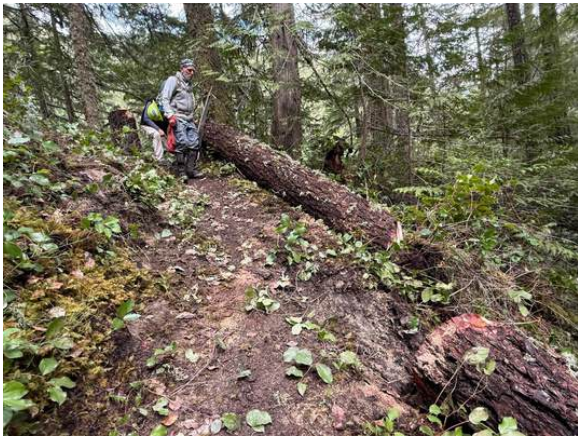
This one wasn't large, but it was fully suspended down below to the left off the trail. It started cracking and popping almost right away because of the weight of the tree down below. Once released, the piece to the left sprang up and AWAY from the sawyer (predicted, that's why I'm cutting from where I am and angling it to let the piece go in that direction) and then slid way down off the trail in a split second.

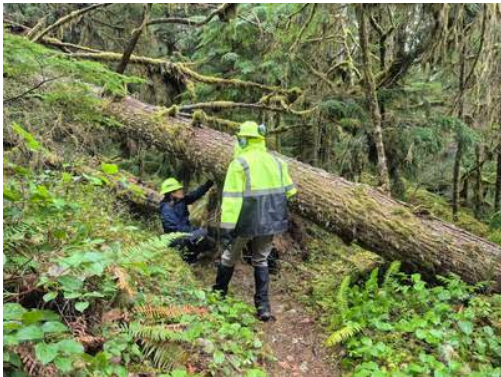
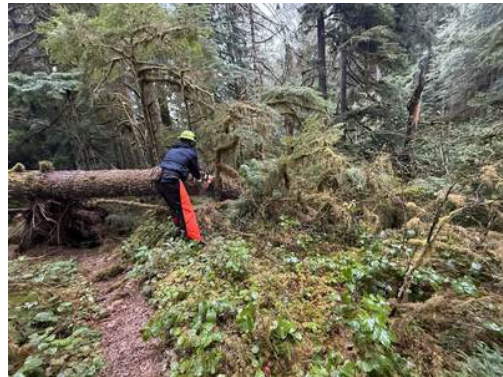
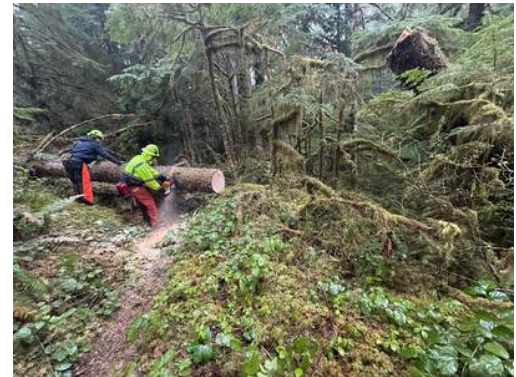
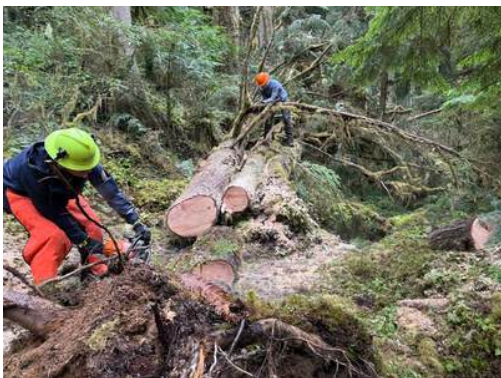
This was a set of two logs, both had fallen to the uphill side. The larger of the two had its rootball halfway down to the river. We knew this one was going to stand up after cutting and the bottom bind was severe. Paul got to do the release cut and it started snapping and pulling apart about when he put the saw to the wood. However, he handled it expertly and the log was released cleanly. Up it went!

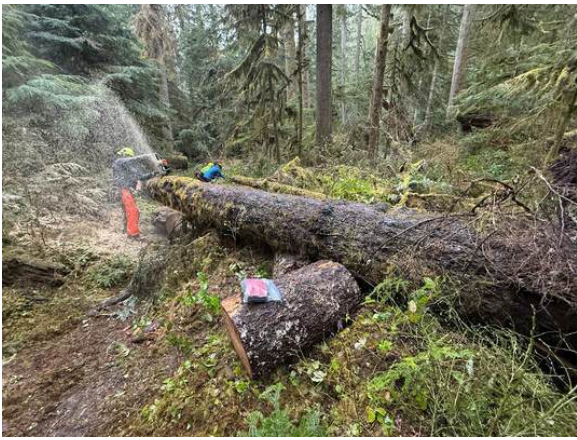
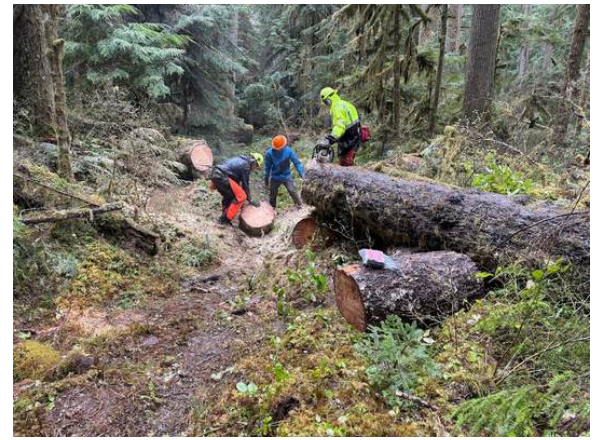
Some of the logs were non-complex like this one. However, logs at this height and size tend to be difficult for hikers to get over without getting soaking wet.

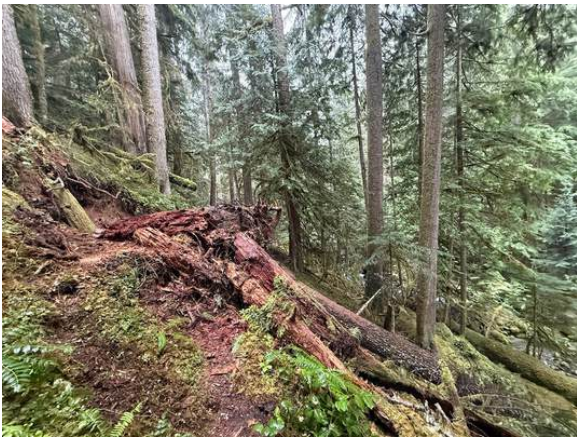
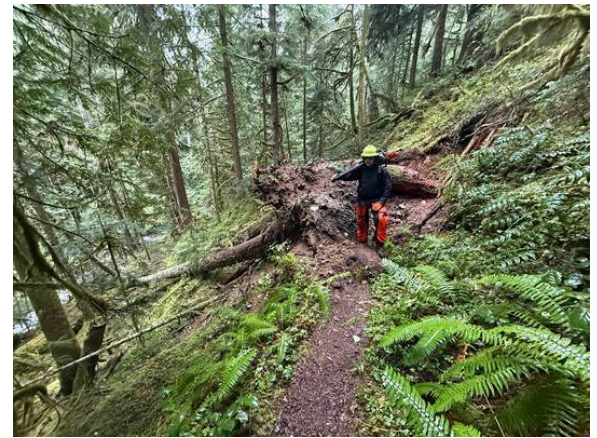
An overturned tree took out the trail for a short section. We quickly cut out one small rotten blocking log, but otherwise, this area needs a tread crew on a different day. Hikers are getting around this easily and have already beat in a path, so this project is not urgent.

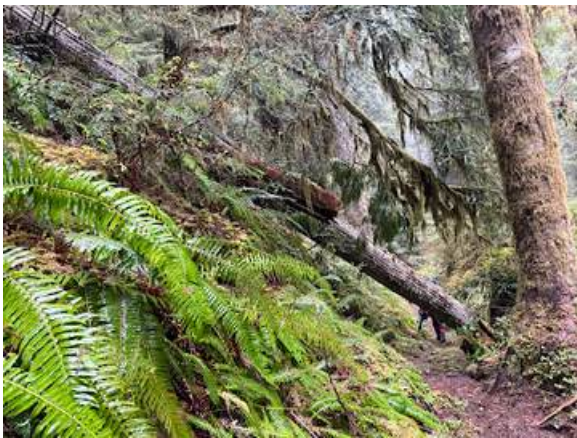
This is the cedar we decided as a team to leave for another day, which will be soon. The picture does not convey it well. The cedar is larger than it looks, very long, and completely detached from its rootball way up that very steep hillside. The chances of this thing sliding are 100%. That is not a problem for us, but does mean that we will have to cut it multiple times as it continues to slide down the hill (my joking term for that is a conveyor belt tree). It could take several hours and we had other big projects waiting up ahead. We decided to save this one for a better weather day when it can be the sole focus.

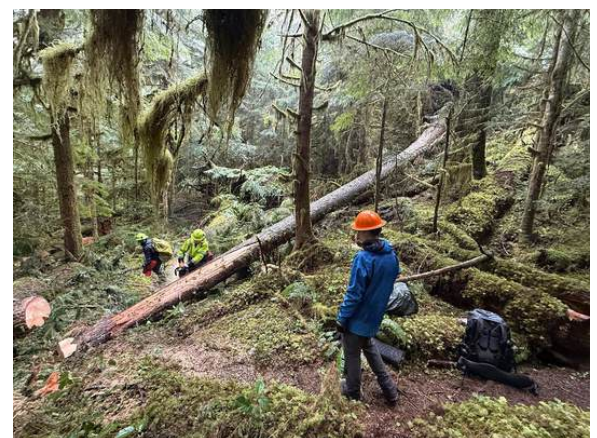
For as dramatic as this fir looks with its rootball way up there, and clearly snapped from the force of the fall, it was not difficult to cut. Bernt handled it with ease. And then we took lunch sheltered as best we could from the rain.

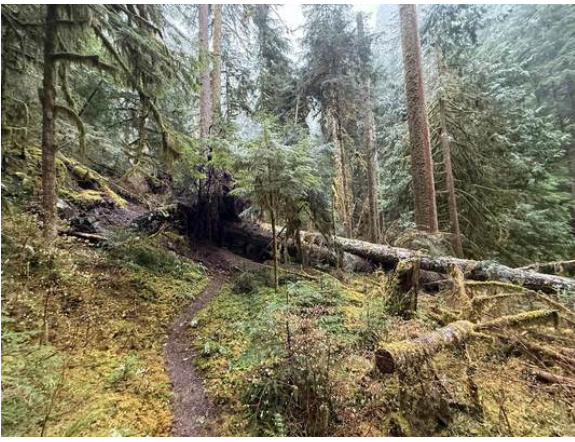
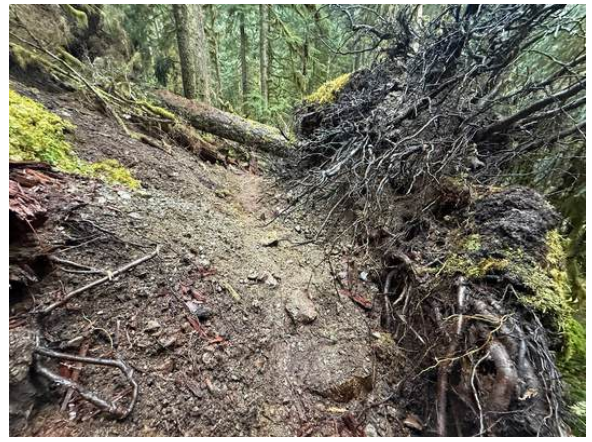
The second area where the trail was taken by a downed tree. You can see the trail goes right underneath the rootball. Hikers had clambered up around the back side, which you can see in the right picture. There being no way to retrieve the original trail line, we decided to cut out the top tree above the large rootball, and realign the trail to meet up with the original on the other side of this mess.

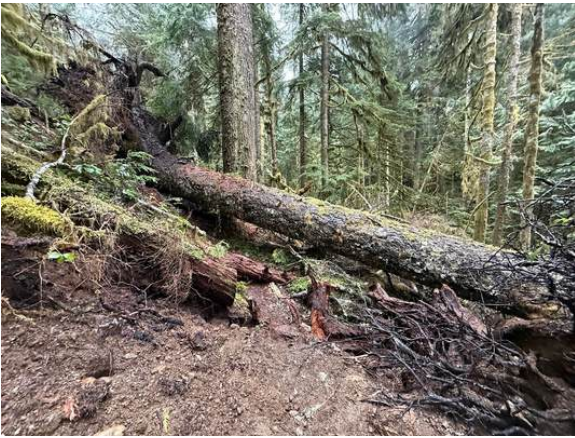
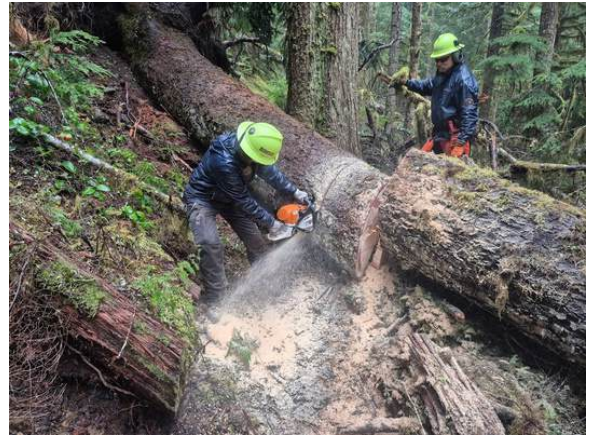
We chose the route to be above the standing tree because on the lower side the ground drops off sharply. The tree we're cutting is larger than the picture says it is - it was about 36" and the bark was full of dirt that had splashed onto it from its rootball. The dirt we had to clear away from underneath was full of rocks.

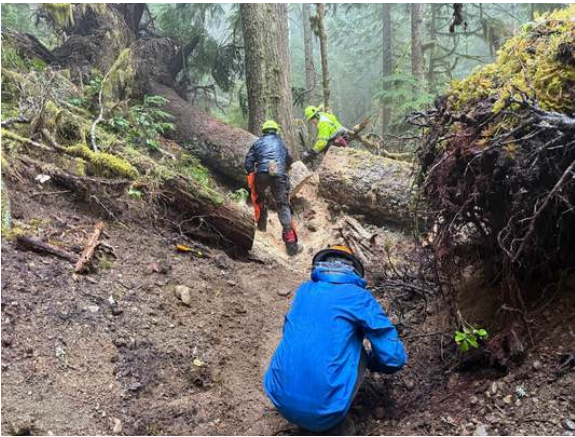
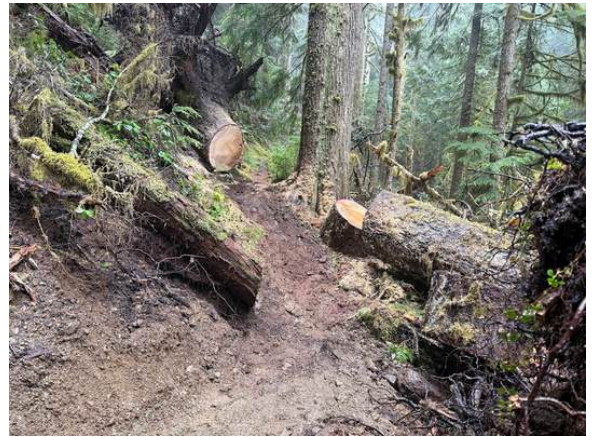
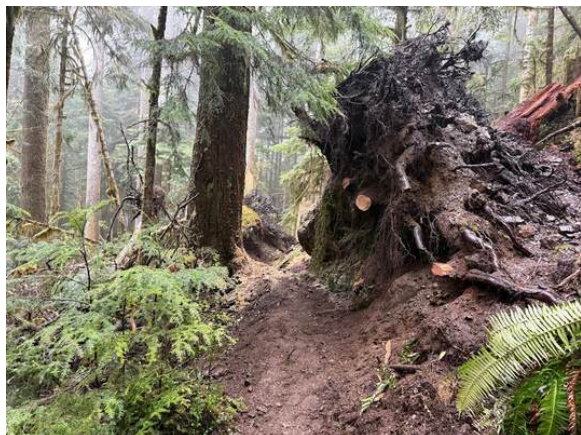
We cut away roots, smoothed out a tread and opened up a path. This is just fine for hikers. Is it to stock standards? No. You can see that the opening is not to typical stock standards although a horse there for recreation rather than tool packing could get through. For more on this see my note at the end of this report.
