**Monthly Trail Report for the Board and Membership**  
**Peninsula Chapter and Gray Wolf Trail Crew**  
**Report written by Rebecca Wanagel**  
**July 2026**

Lower Big Quilcene, ONF  
6/11, 6/12 and 6/13/26  
Report by Rebecca Wanagel

Duckabush (upper), ONP, June 20-24, 2026

Lower Gray Wolf Trail (#834), Olympic National Forest

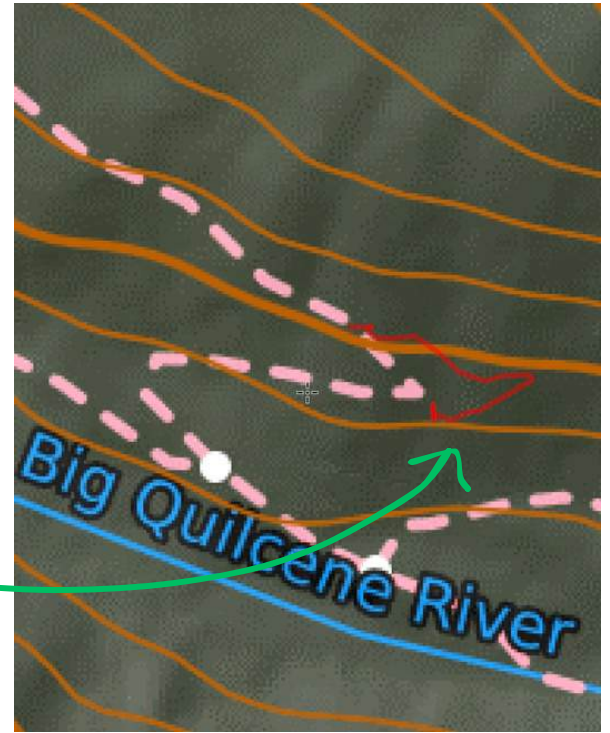
Job site.  
100 feet of too steep tread.

Realignment (thin red line)  
300 feet of sustainably  
graded tread.

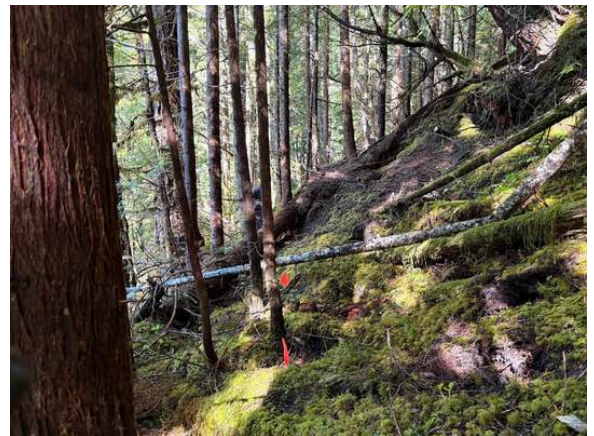
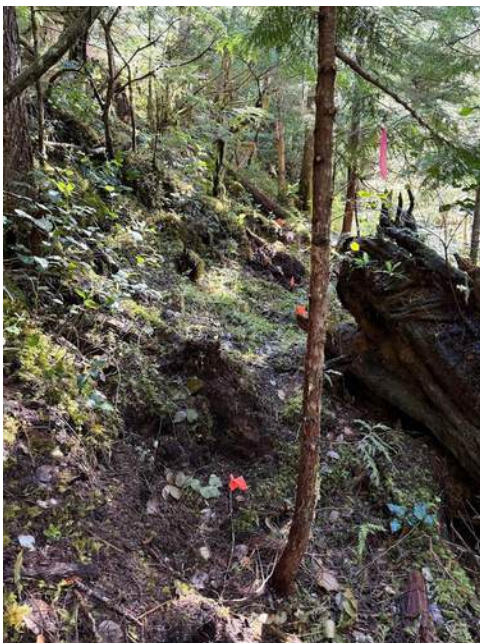
*This is what it looked like in the beginning when we were laying the flag line..*

*Looks like a trail, eh? It does to our eyes ... are you wondering how we decide where to lay the trail in this forest?*

*There are a lot of factors. The steepness has to be sustainable. There has to be room to put in a climbing turn if necessary. We need to place it where we can cut the tread entirely into the hillside and not rely on structures. Trees, rocks and other features also help define the line. The final product needs to look natural, flowing organically through the woods. Nature doesn't do straight lines, so we don't either. We strive to make it look like it's resting on the terrain rather than plowing through it.*

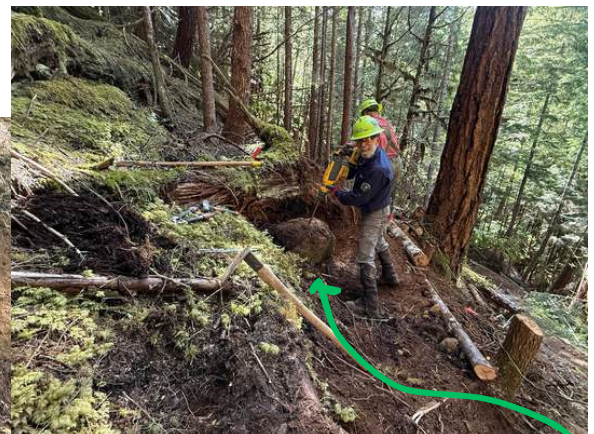
*Hammering rock to bits*

*(remember this picture and the  
size of that rock ...)*

*Look back at the picture of the rock I told you to remember. Randy is pointing to where it was!*

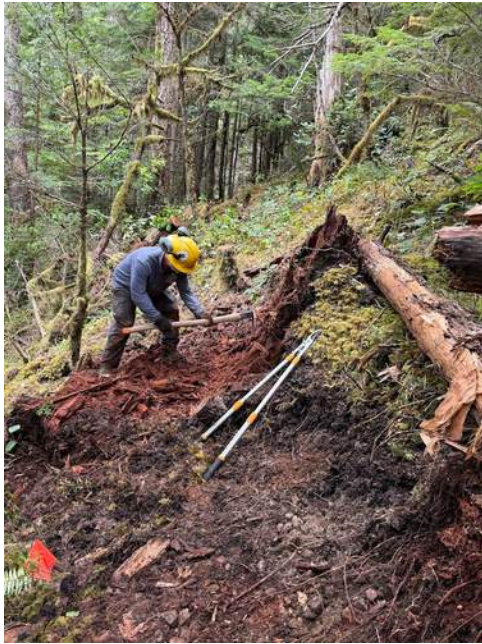
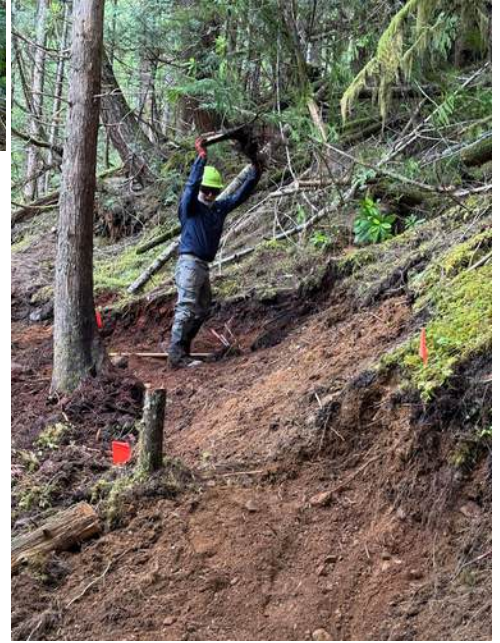
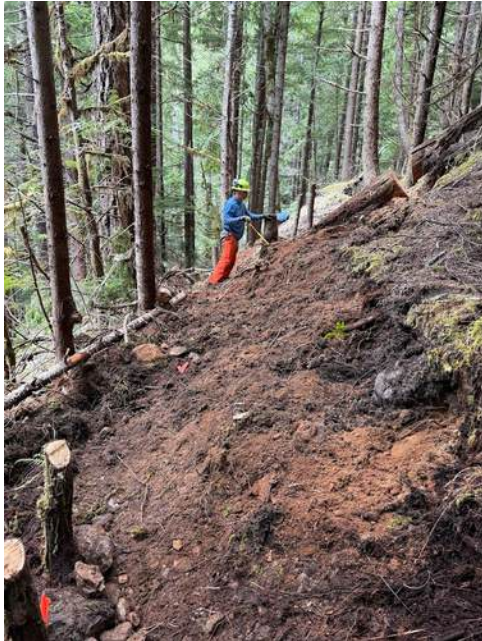
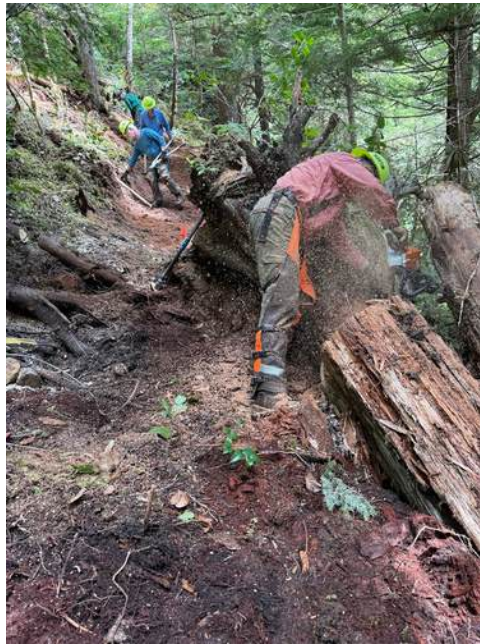
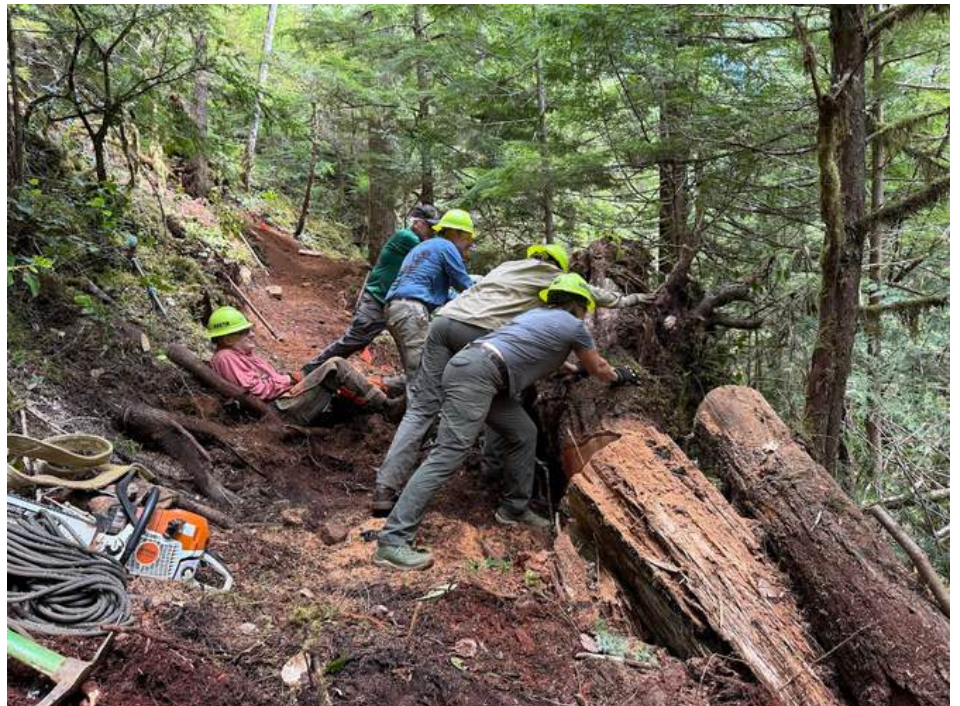
*Digging in the new tread. Getting rid of all duff, roots, rotten embedded logs and stumps. Moving a rootball off the trail.*

*This is what it looks like to fine tune the product. We are checking for stock and bike suitability, double checking for pockets of duff, making sure the tread is solid and cutting back branches to stock standards.*

*This hillside had a LOT of rock in the dirt. This was excellent. Rock is gold to trail builders. When we dig out rotten trees or stumps, we end up with holes. Those have to be filled with rock before dirt. When we lay a log to better hold the edge, it has to be lined and filled with rocks. Any low spot needs to be brought up with rocks. Rocks drain the water and hold the trail solid rather than letting it sink. It stands up to hooves and tires.*

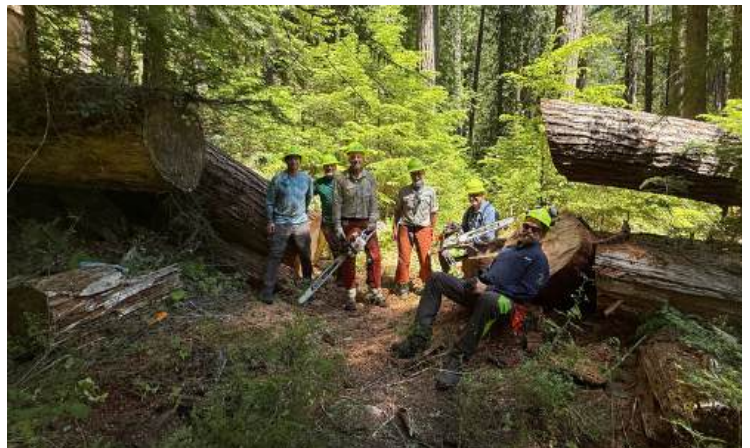
Before. Ok for hikers, not for stock.

It was resting on a boulder with a long cantilevered piece that had ripped off from the rootball.

We decided to get rid of that piece first.

Now that long extended piece is out of the equation.

Good angles on the other cut so the main portion could drop.

That gave us this. Just need to chunk it up now.

We all took turns chunking it up.

Finished!

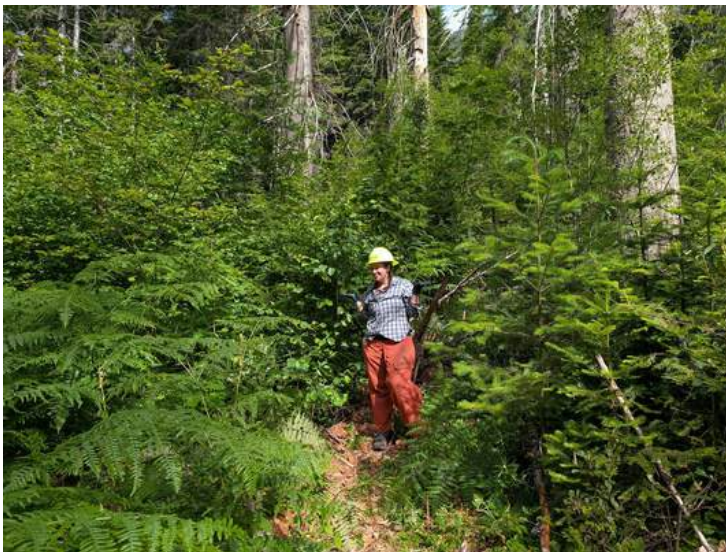
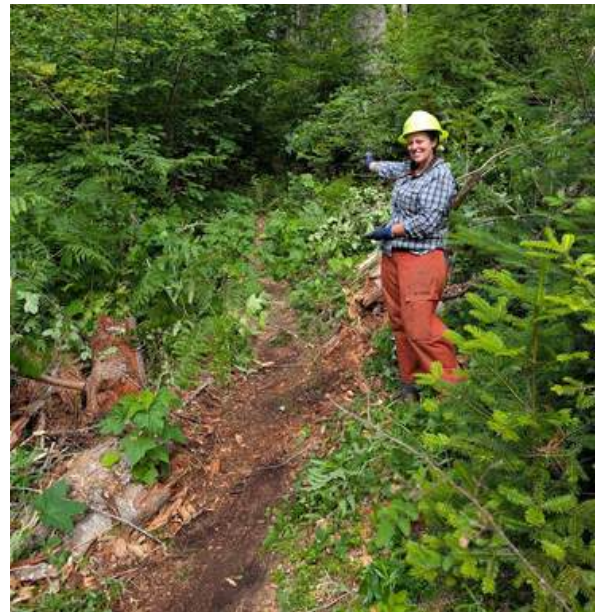
An example of a place where we couldn't see the trail at all, and then after some hand clearing. The trail is at least visible!

Days 1, 2 and 3 had more than sawing going on. The brush on this trail was (is) the stuff of nightmares. I had decided ahead of time that our crew would be logging it out and doing only handbrushing where critically needed – to make it so the ONP crews can get packed in later with power brushers, rigging, etc to really dig in deep to some problems on this trail.

We cut things back that met the following criteria:

- > Vine maples or branches that were at packer eye level.
- > Brush approaching creeks that packers and hikers need to see.
- > Conifers that were growing thickly on each side of the trail, completely obscuring the trail so you wonder where to go.

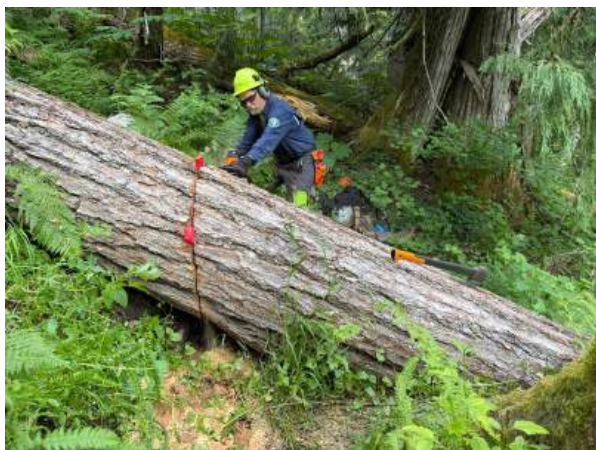
Before / during

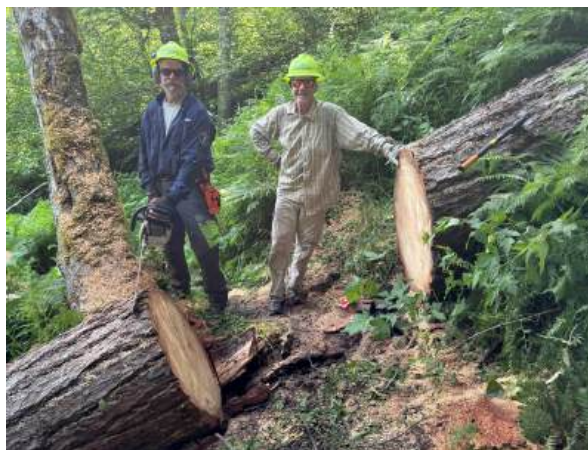
After. This was the problem log on Lacrosse Pass trail, that's why it isn't cut to stock standards like the rest.

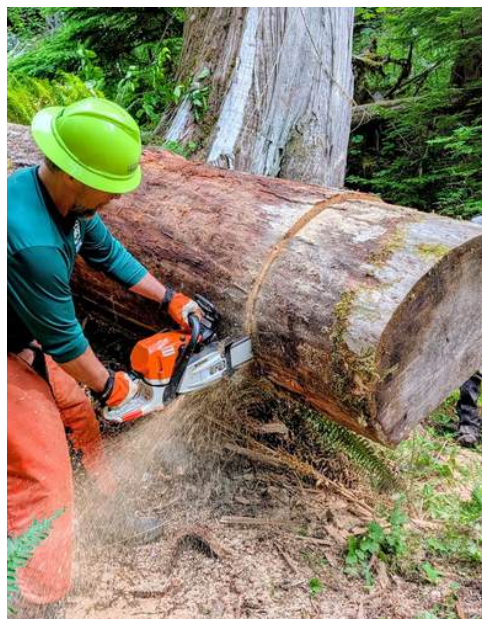
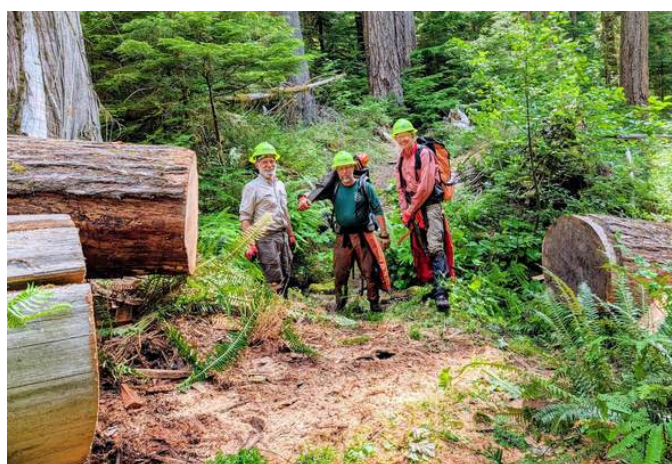
Widening long-ago cut logs to make more room for pack animals.

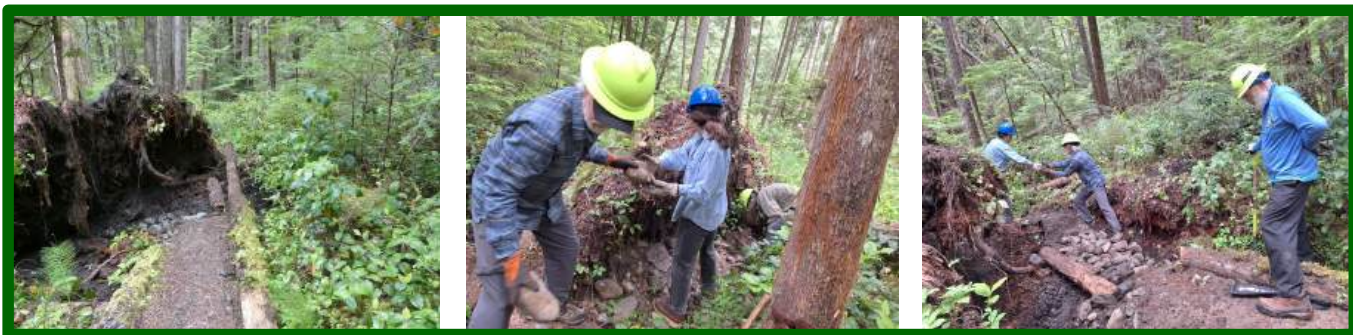
Sometime this winter, a cedar next to the trail fell over and its rootball went from being under the trail to being next to a large hole in trail. We came across the problem during a March scouting hike.

The rootball not only pulled out some dirt and rock but parts of a turnpike that was built over it including a section of geotextile fabric. The crew pulled and relocated the rocks and the fabric; the latter had to be cut from the cloth that was still under the intact section of trail. The burrito wrap construction (fabric/rock/fabric) will help keep the rocks from sinking into the wet clay underneath. This was covered by a mix of dirt/clay and smaller rocks.
