**Monthly Trail Report for the Board and Membership**  
**Peninsula Chapter and Gray Wolf Trail Crew**  
**Report written by Rebecca Wanagel**  
**September 2026**

# Gray Wolf Trail Crew -in partnership with- BCHW, Peninsula Chapter

Kloshe Nanitch and Snider Ridge Trails, ONF

West Elwha Trail, ONP  
Puncheon removal project  
September 12, 2026  
Report by Rebecca Wanagel

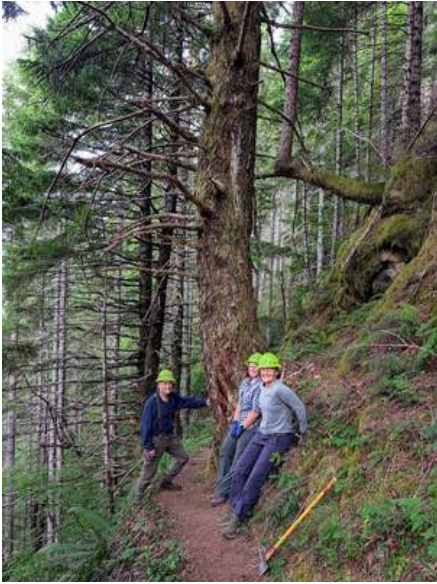
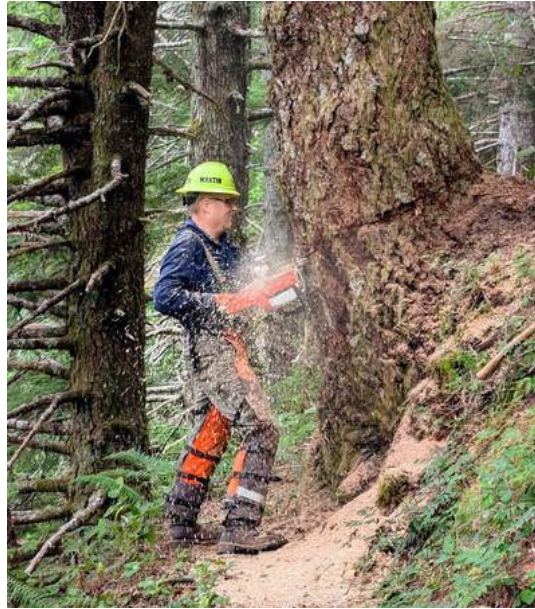
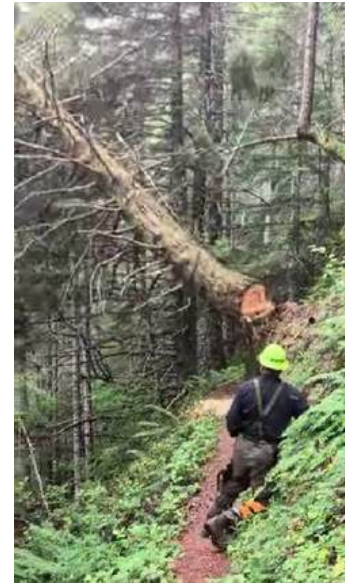
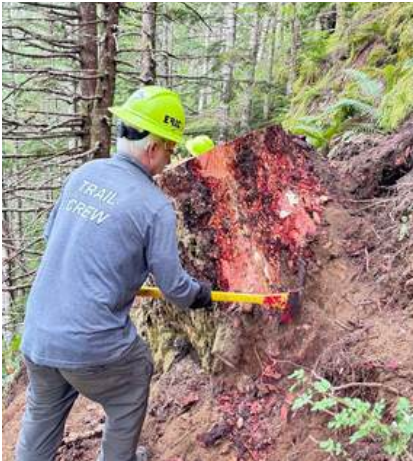
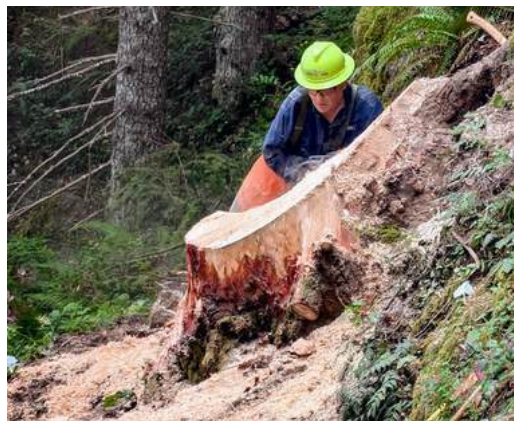
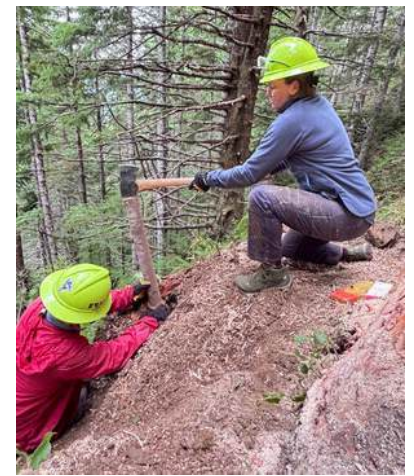
**Kloshe Nanitch: narrow tread mitigation**  
**Kristie, Elizabeth, Eric, Martin**

Horses were stepping down off the trail onto that extremely steep slope. Martin expertly felled the tree (approval granted by ONF) and the plan was to remove the stump. That proved impossible. They went to Plan B: cut the stump way down and back, then put in a curb log and fill with rock and mineral soil to widen / reinforce the tread which had gotten damaged when the butt of the falling tree hit it.

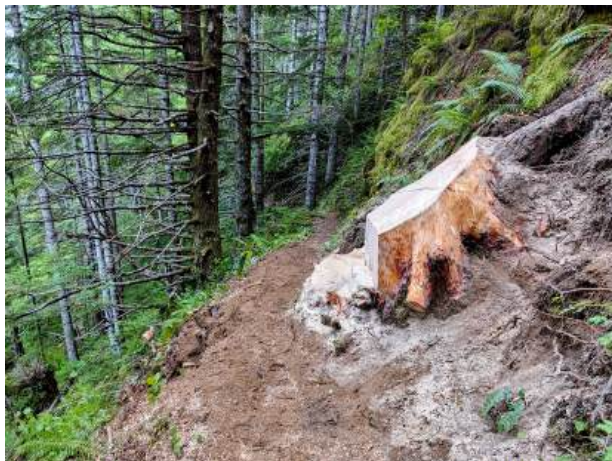
Here is the final product! It's now safe for horse riders. The stump has been cut down and back to the point that there is enough room. We might go back in next season and take a little more off. There was gravel, oddly, **inside** the stump which ruined 4 chains.

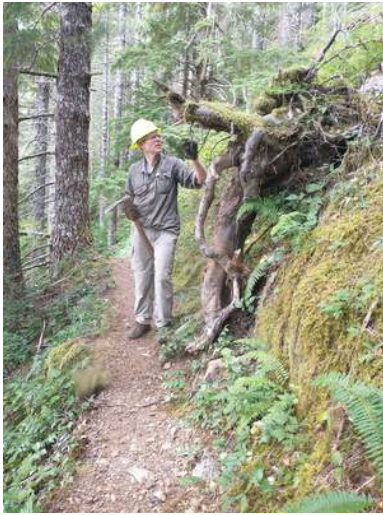
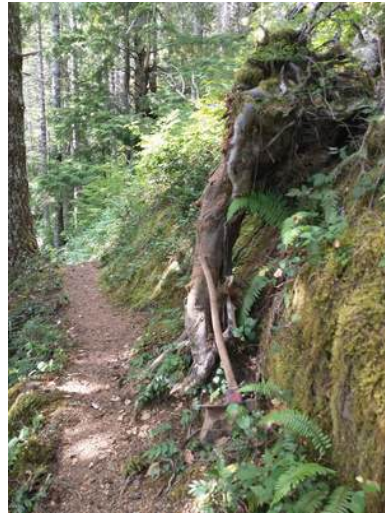
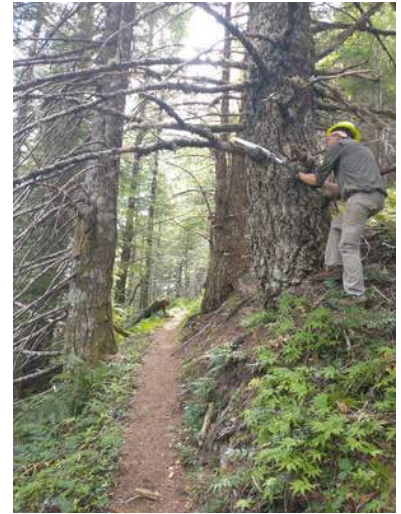
**Kloshe Nanitch: logout, stock corridor, tread maintenance**  
**David and Joanne tackled this trail on Friday, Aug 21.**

It's important to pay attention to detail on trails. Old cuts and branches sticking into the trail like this aren't often noticed by hikers, but definitely noticeable by horse riders.

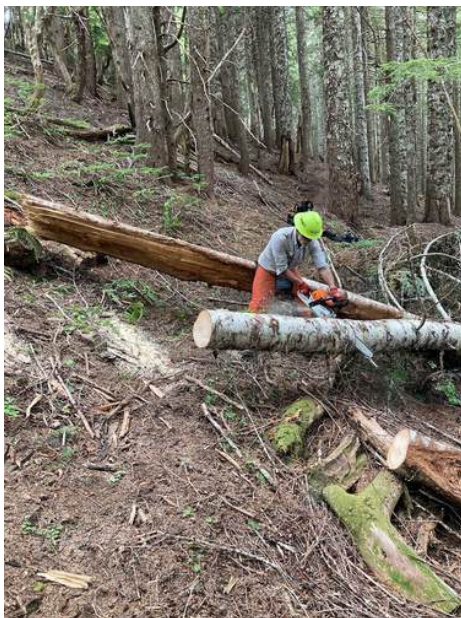
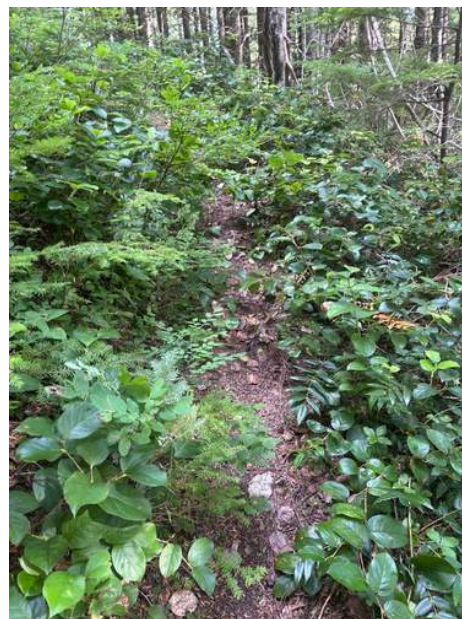
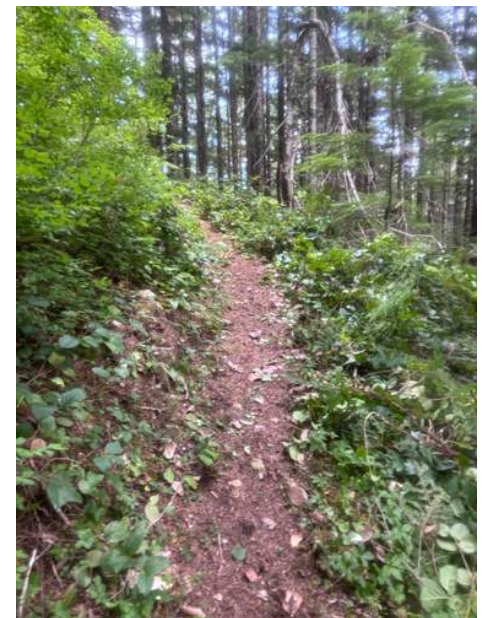
**Snider Ridge: logout, tread repair, fir tree encroachment mitigation.**  
**Deni, Mark, Randy**

About 16 logs were cleared along the 3 mile ridge trail.

A great before and after shot of what the encroaching fir trees do to the trail. If we get them when they are young, most can simply be pulled (but there are a LOT of them!). Along the route many branches were cut back as well.

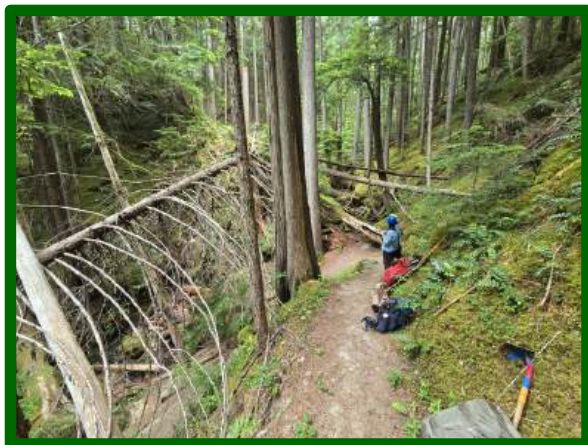
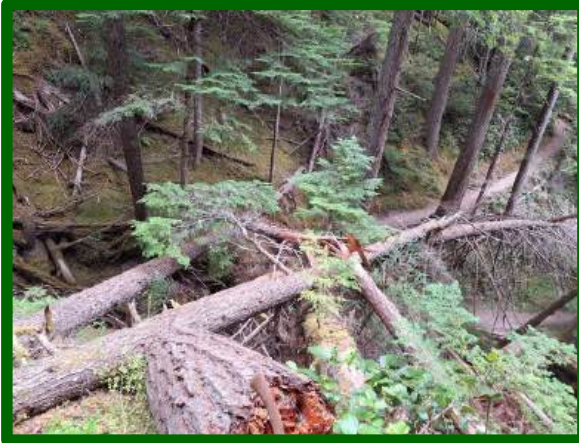
The tree had been left alone because its trunk was pivoted high up on the steep opposite side of Slab creek. Several other trees had also fallen just under or on top of the cedar so there were numerous complicating factors. In the left photo, you can barely see the top of the cedar's trunk. In the right photo, the cedar is completely hidden.

After climbing over and above the mess (which again, was at the midpoint of the cedar's length), the crew decided on a plan to remove 1) the complicating factors, and 2) the cedar itself.

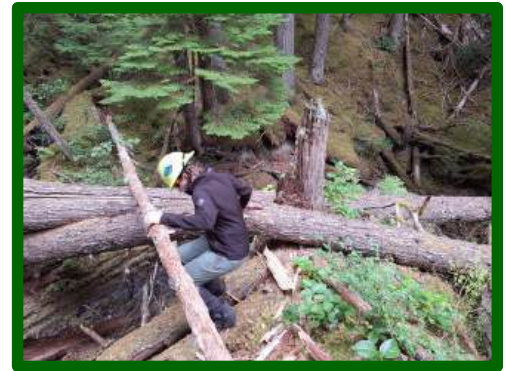
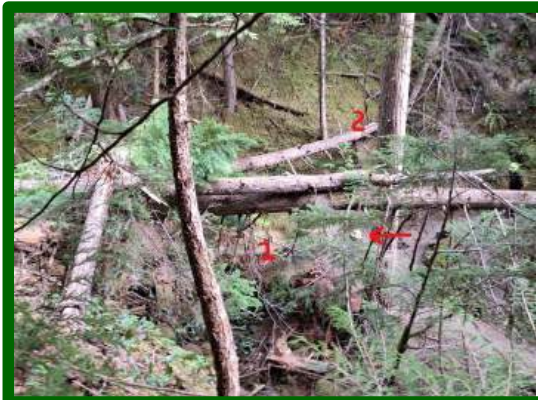
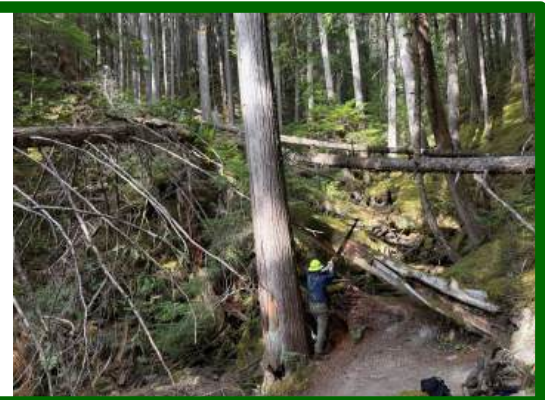
First, from the trail, we cut the tree lying under the cedar so that when we cut the cedar, it would fall far enough to be removable. Next, we cut the log just

uphill of the first log; this log was resting on the cedar. It pivoted clear.

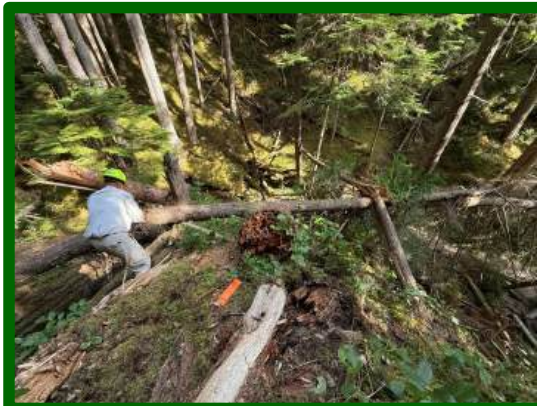
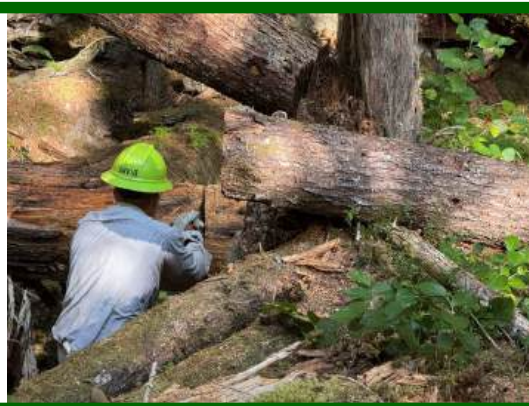
Finally, we cut away the blocking wood up top and then the cedar itself which, as expected,

quickly split and dropped the top to the ground.

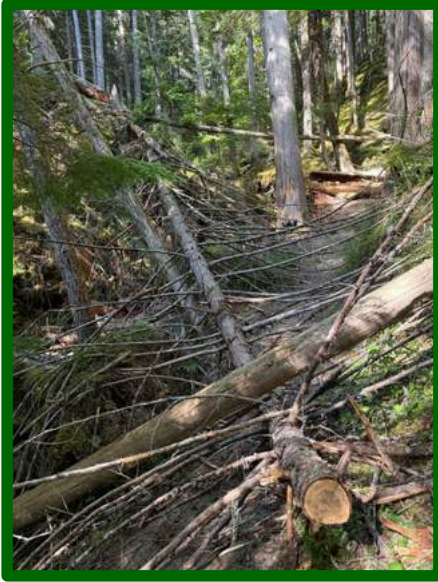
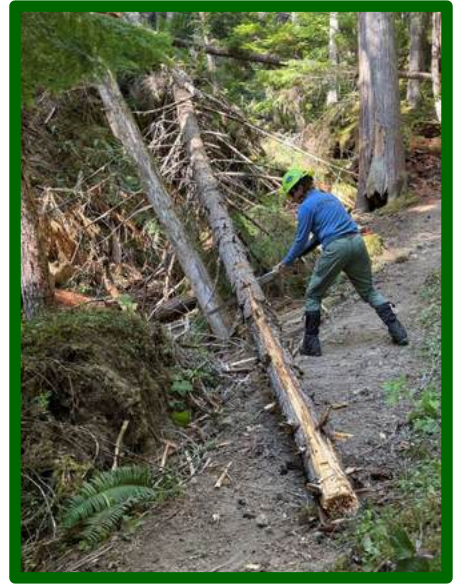
The final tasks were just to cut off all the branches intruding into the trail and to remove the top portion of the trunk that was in the trail corridor.

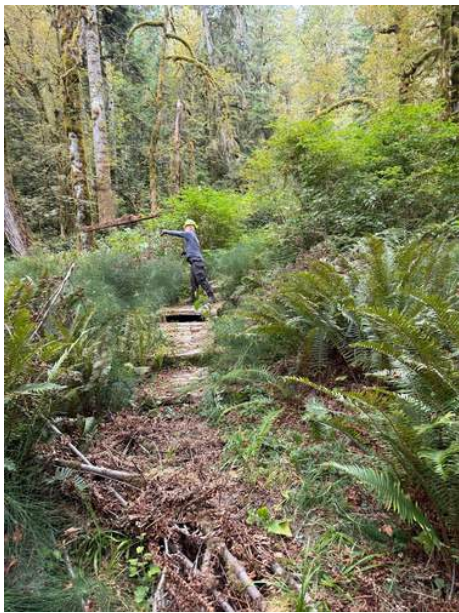
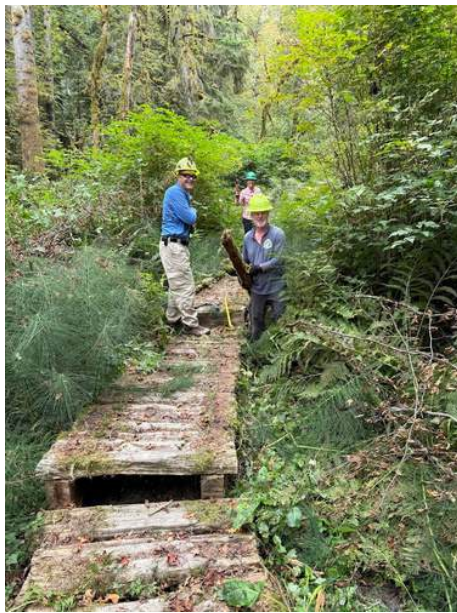
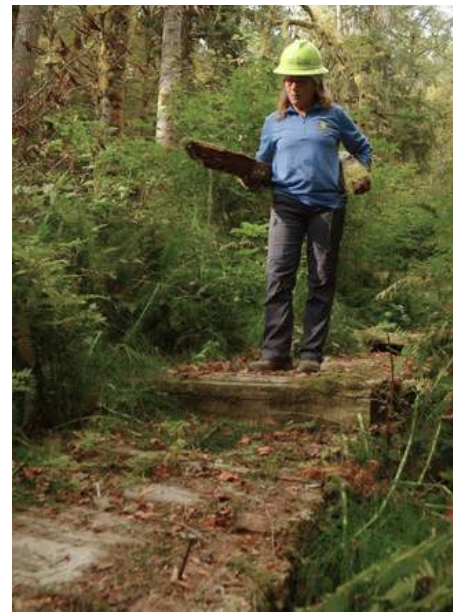
We start by putting aside the brush we had thrown over it back in May so people would start using the new reroute. Then remove the bullrails and start the process of carrying everything with fasteners still attached over to the fastener removal department.

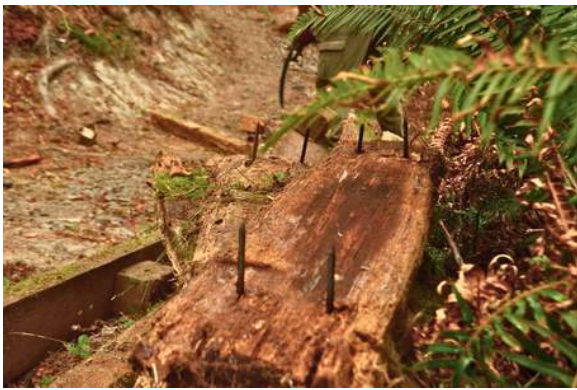
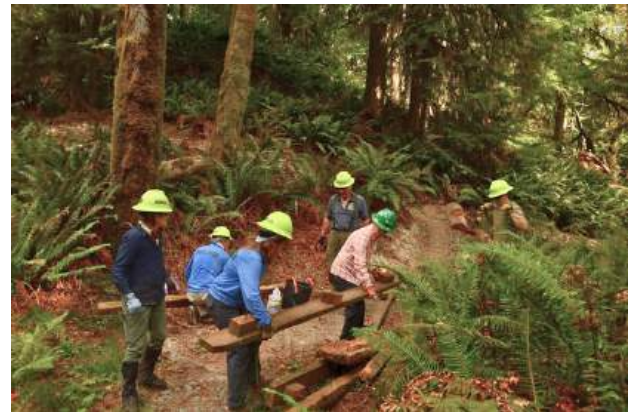
Why remove the fasteners? Because we would be tossing all the old wood to disperse it back to nature in the surrounding fern and salmonberry forest. There is no way we would leave these dangerous spikes sticking out for some poor unsuspecting chipmunk or other critter to injure themselves. None of the old wood was pressure treated - it will all decompose.

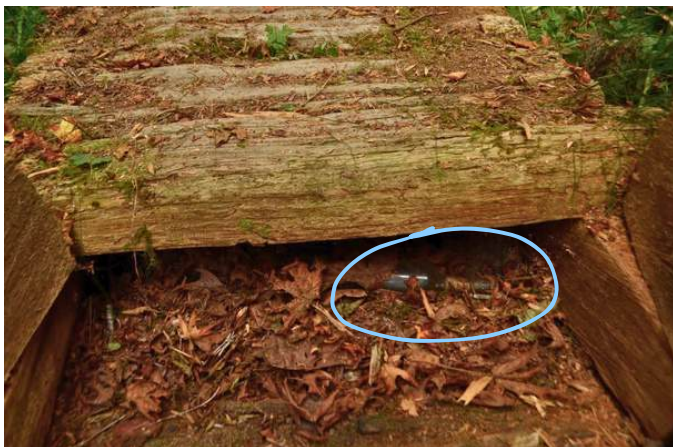
We were joking about what we might find under those planks that have been there for many decades. Money? Treasure? All we found was two old beer bottles, which we packed out.

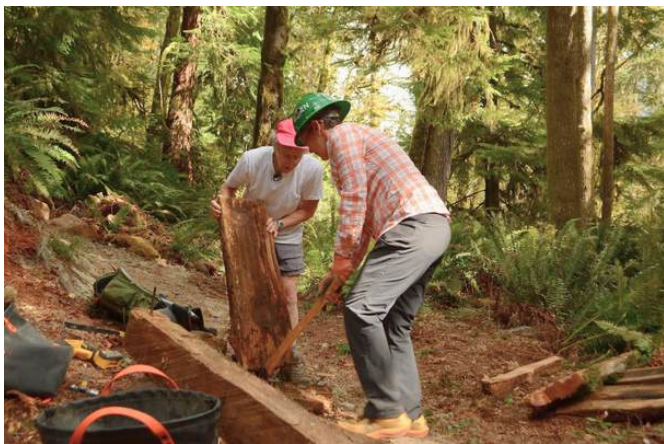
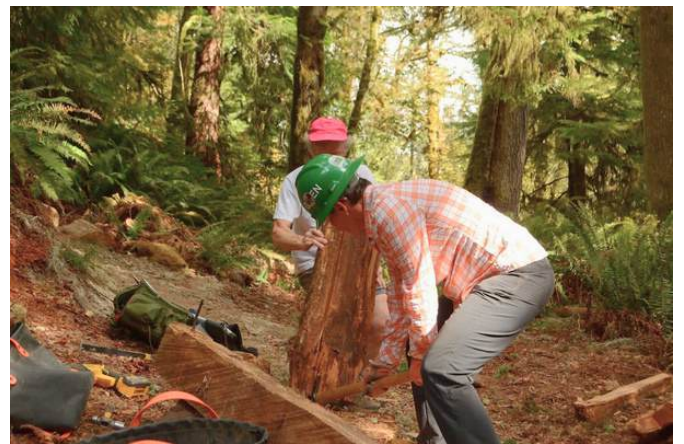
Bobbie took the time to teach Gwen how to set the axe at the edge in line with the spike, then turn the wood over, lift the plank and bring it down on the axe - it drives up and splits the old cedar to release the spike. That helped speed up the process!

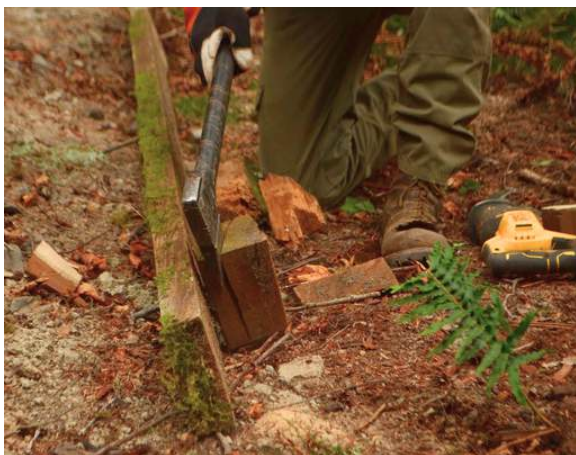
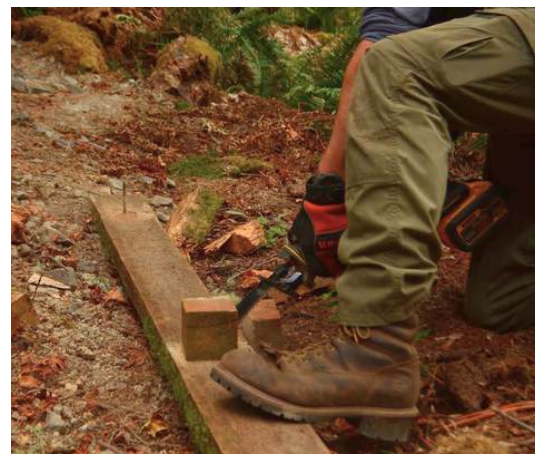
We utilized many methods of getting the spikes out - depending on the size of the wood it was buried in. Axe. Sawzall. Splitting. Punching through ...

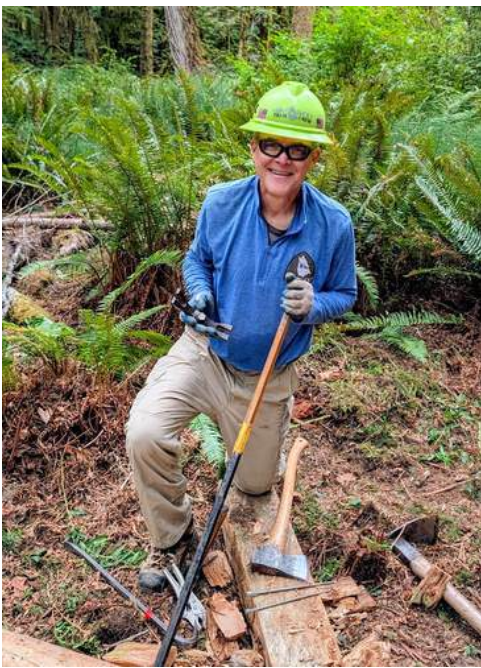
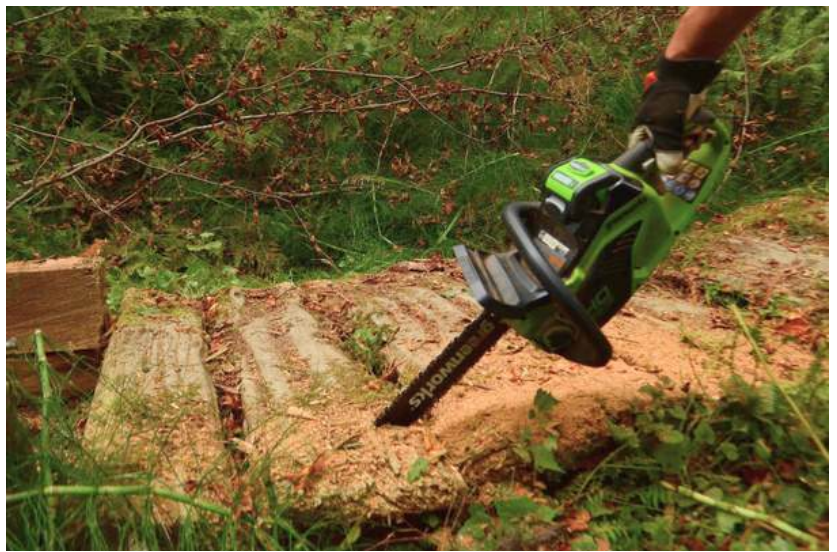
Our crew does not realize its own strength. We managed to break the head off the demo bar! So that made us switch to Plan B - made up on the spot. We would now cut one side of the planks with the battery chainsaw we had brought, and then wrench the plank off the other stringer. We could only do that because they were so rotten. Turns out this method was faster! Who knew?

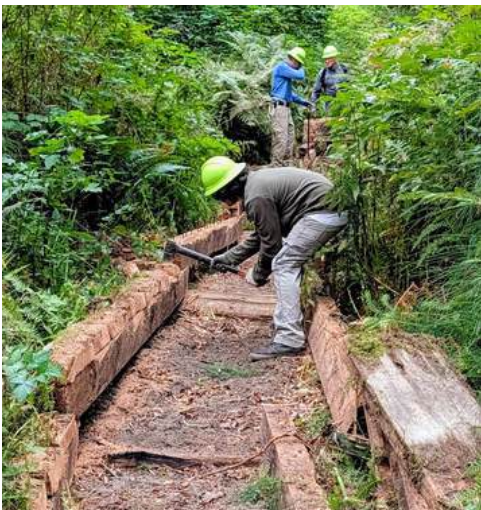
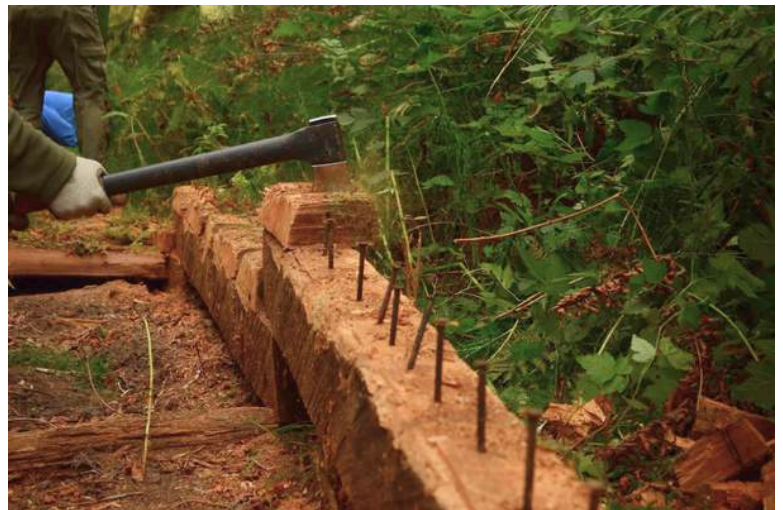
That left blocks on top of the stringers on one side, which we were able to knock off with an axe and then pull out the spikes.

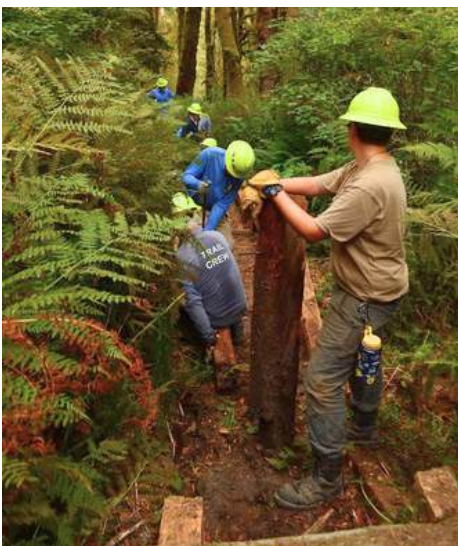
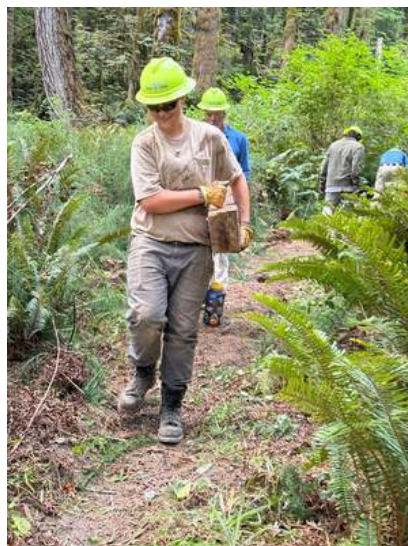
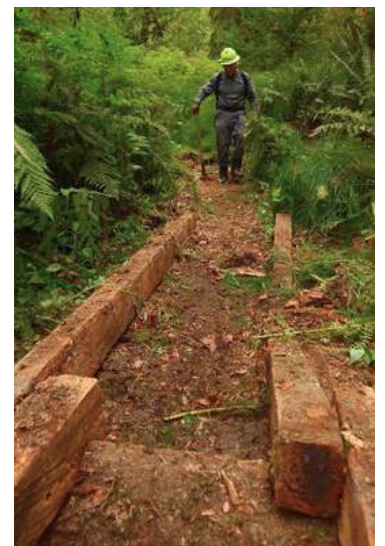
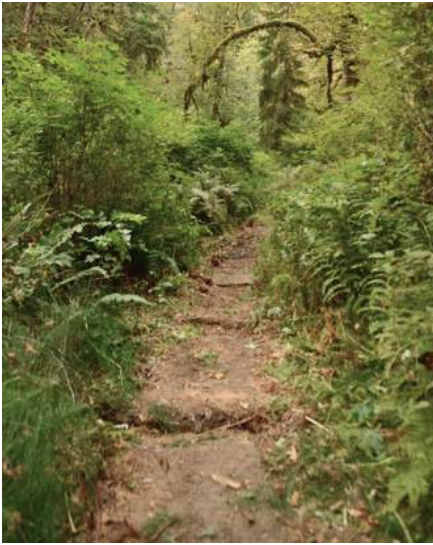
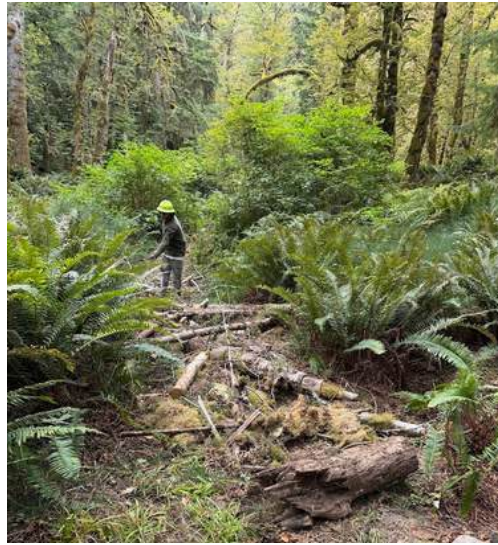
Once the puncheon was gone, we “decommissioned” the pathway it left behind. Meaning we threw a whole bunch of natural debris into the pathway. Ideally what it needs is for a few dozen ferns to be transplanted into the path. This was not the day for that, maybe over the winter.

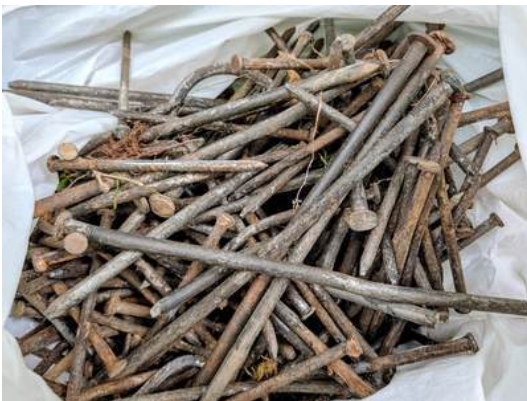
What to do with these old spikes? Well, there was probably 50-60 pounds of them, so we didn't want to carry them out. I got a hold of the ONP packer, Heidi Brill, and she readily agreed to come in with a mule later this week to get them. I'm sure they will be recycled. For now we hid them behind a tree.
