TRAIL CREW NOTES

22 February 2024

Location: Lower Big Quilcene (833), ONF

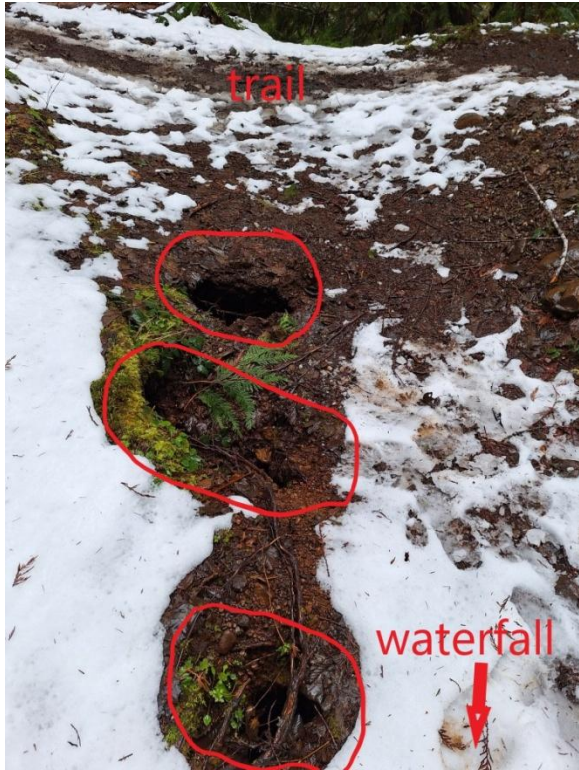
19 Jan 2024: Sinkholes over culvert

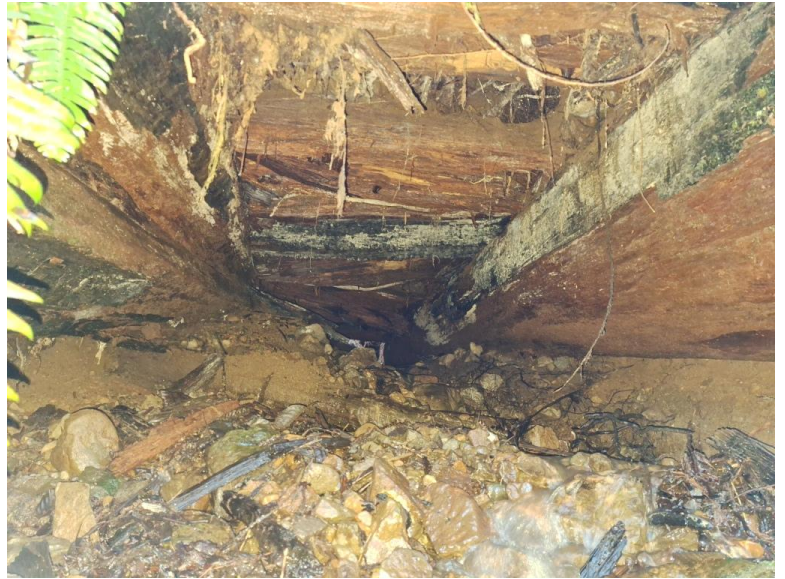
22 Jan: Inside culvert as seen from exit.
Light through failed area visible at far end.

- Objective(s) for the day:
 - Diagnose cause of sinkholes over culvert and repair area to prevent hikers falling into culvert
- Task(s) accomplished:
 - Photographed inside of wood culvert showing status of wood structure.
 - Failure mechanism identified: wooden culvert cover boards are failing and falling into culvert beneath. Dirt above failed boards also collapsing down into culvert, causing sink holes above each failed board.
 - Remove dirt around sinkholes to expose failed culvert portions and remove unsupported dirt that could cave-in if stepped on.
 - Construct barrier to cordon off sinkholes.
 - Cleared debris from 50' of drainage ditch.
 - Removed hiker-placed debris and rocks from two stream crossings to get stream back into channel rather than flowing onto trail.
- Task(s) remaining:
 - Remove or replace failing culvert

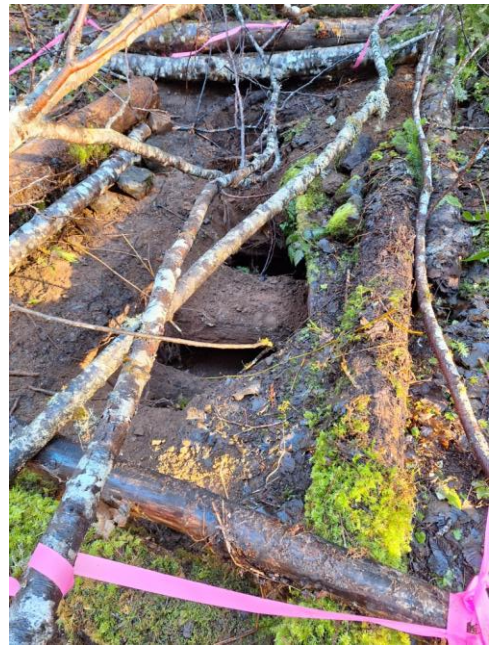
Cordoned off area

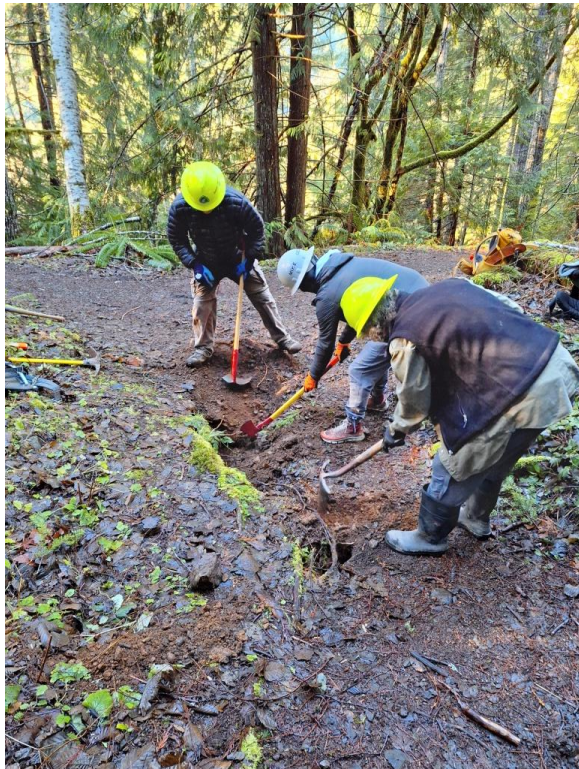
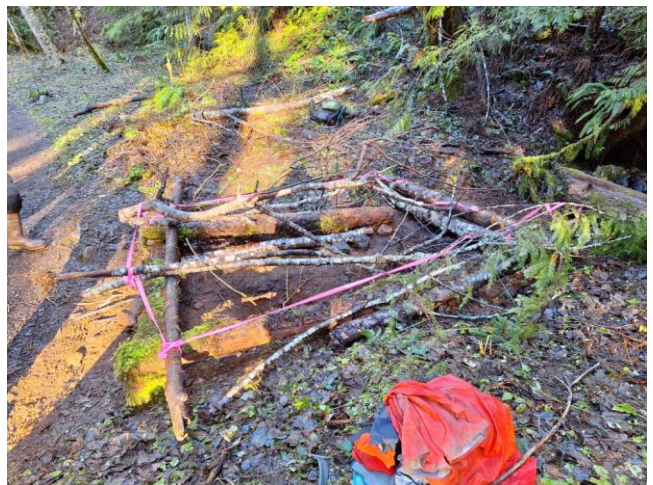
Working to open sinkholes
