Gray Wolf Trail Crew - in partnership with - BCHW, Peninsula Chapter

West Elwha Trail, ONP

January 3, 2026

Report by Rebecca Wanagel

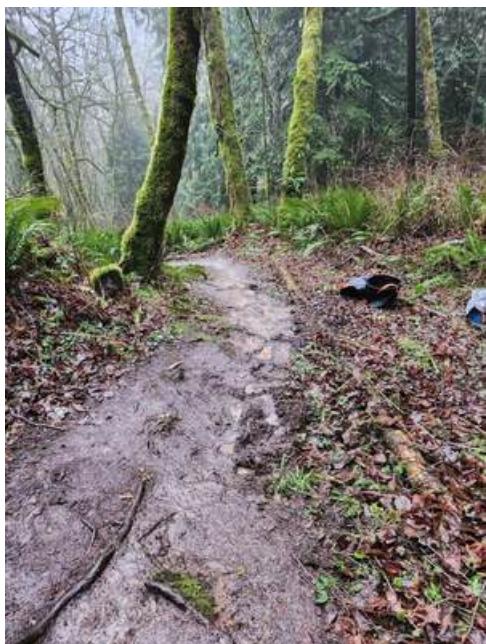
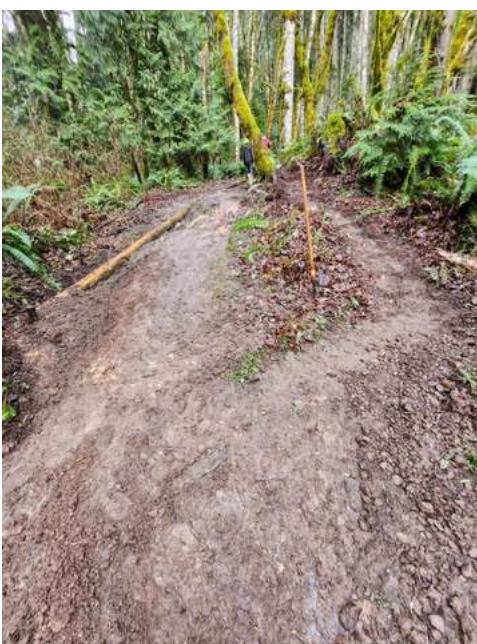
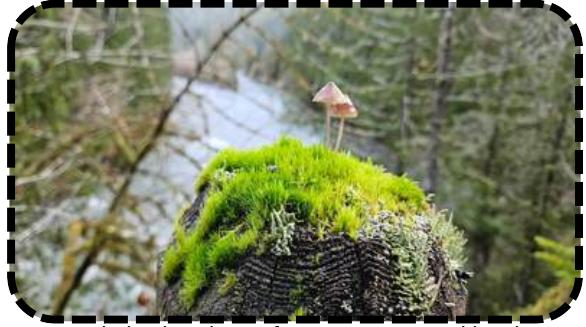
This wet, slippery corner, $\frac{3}{8}$ mile from trailhead, has been a problem for a while. It's been dealt with before but never completely fixed. It is pure clay and the water collects here.

Left picture: before, looking south

Bottom left: after, from the same viewpoint

Bottom center: after, looking north. Note the bypass. What doesn't show in the picture is the steps cut into the clay and the strategic placement of gravel on each step.

The team - Bill, LaVonne, Jonathan, Lisa, Neil and Marti - assessed the problem and decided the best scenario would be a short bypass. Bill and LaVonne have looked at this problem with their highly-experienced eyes many times before, so they knew what had been tried and where to go from here.

They found a source of gravel about 100 feet up trail (that's GOOD - it means you carry empty bags uphill and heavy full bags downhill). They put in a short bypass and made steps out of the clay. Crucially, they lined each step with gravel for traction.

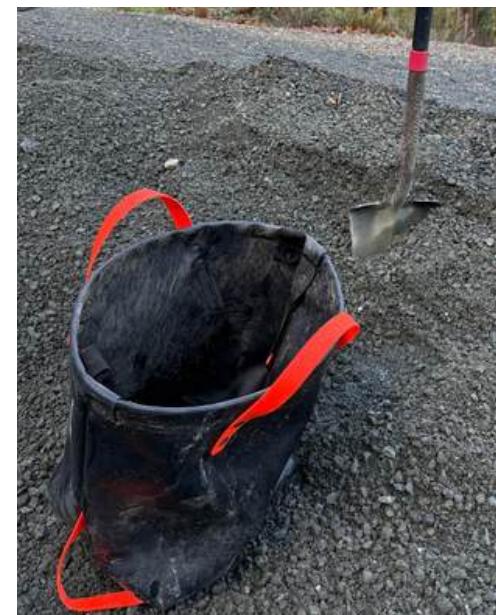
In this picture, Martin - who was on the second-pass-through team, takes a pause for Eric to snap a picture. What I don't have a picture of is the before and after of how thickly lined the trail was and how clean it is afterward. Sorry - it's just that we were working in pouring rain so folks were having a hard time pulling their phones out in that persistent wet to snap pictures.

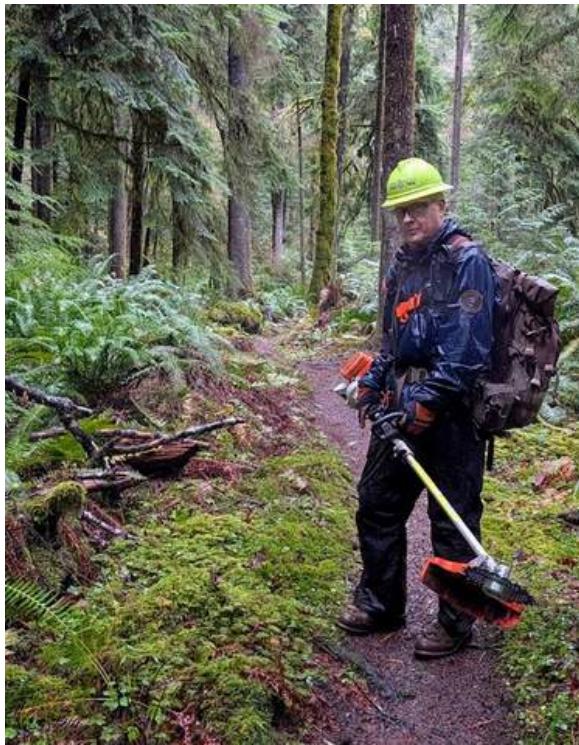
Right picture: You can barely see but there is a thick layer of ferns behind me as I walk up the trail towards Bernt, who was taking a hard-earned lunch break. You can also see Tim's brusher on the side of the trail. Note the mud coating on Bernt's pants and boots and the sorry, wet, muddy state of my condition as I walk towards him. That is the segue to my next topic, rebenching.

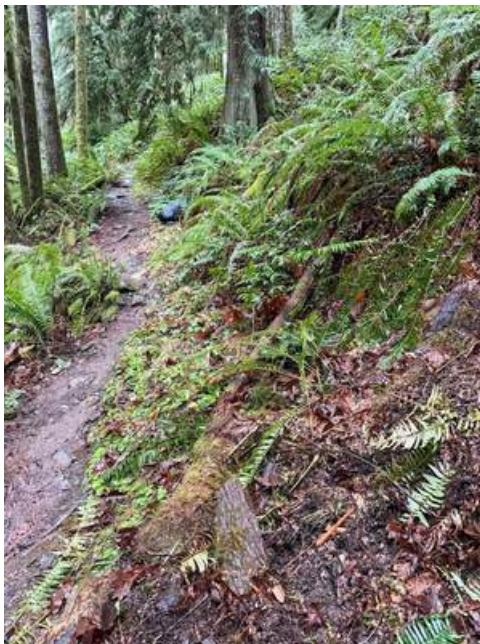
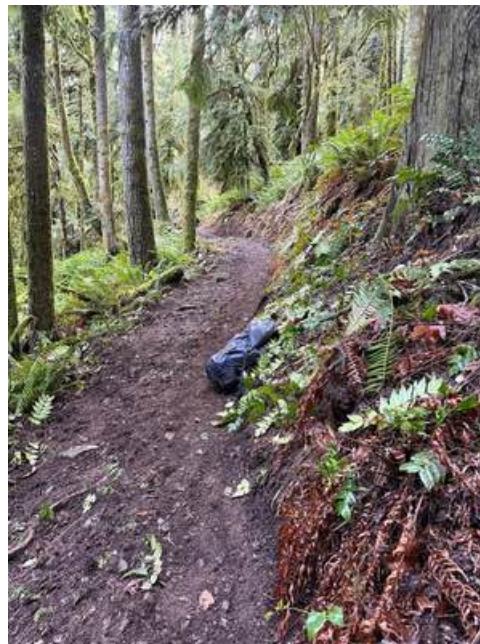
This is a before and after taken from the same vantage point with my pack for reference. The trail had moved downhill so badly that we had to move it back up 2 or more feet. It was slippery, off-balance, and hard to keep your footing. This is also a very wet location.

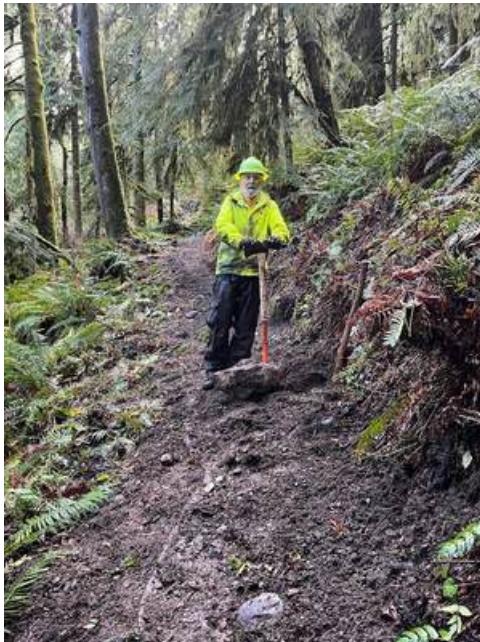
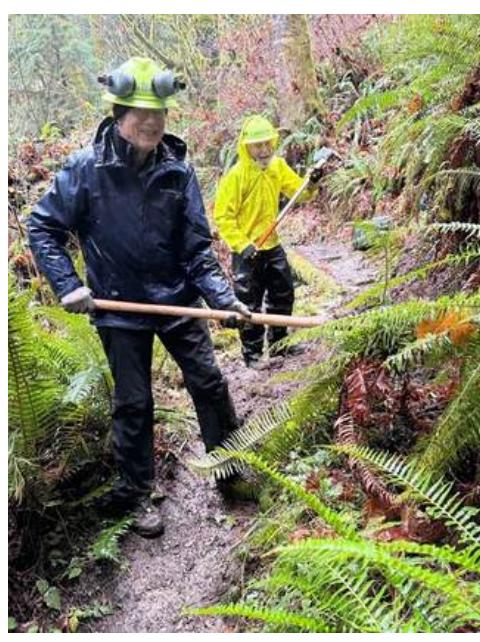
Rebenching Tread

1. A lot of it was very rocky.
2. Wet, wet, wet made worse by the fact that it was raining all day. Our boots, raingear and gloves were coated with mud. I actually felt like my feet were encased in concrete they were so heavy from mud.

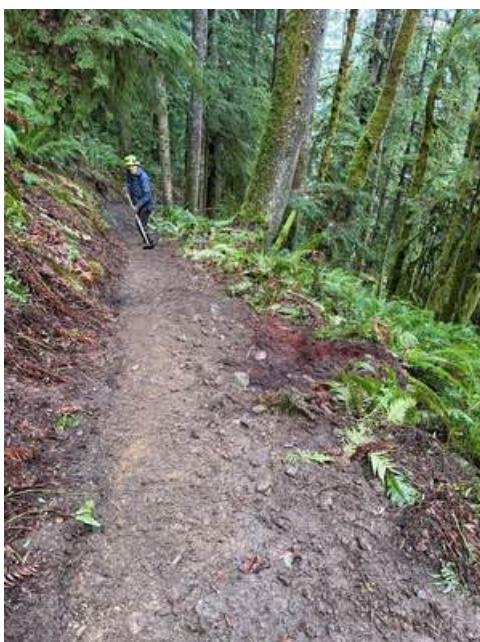
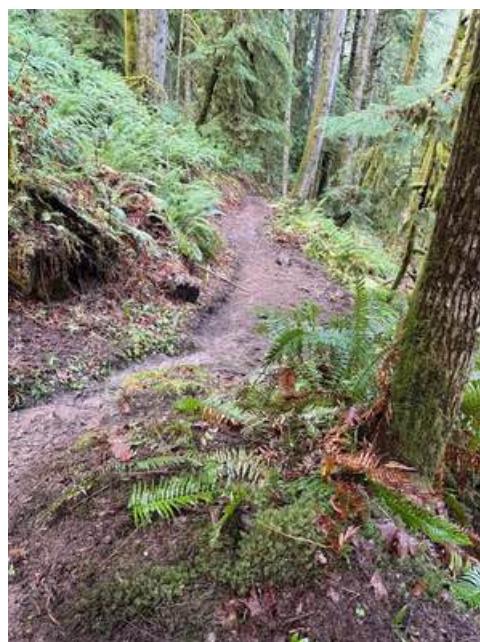
A couple more after shots. Bernt doing some final raking. You can see here that this whole section is now moved up, wider, smooth and back to regular trail specs.
