# Gray Wolf Trail Crew - in partnership with - BCHW, Peninsula Chapter

West Elwha Trail, ONP

January 24, 2026

Report by Rebecca Wanagel

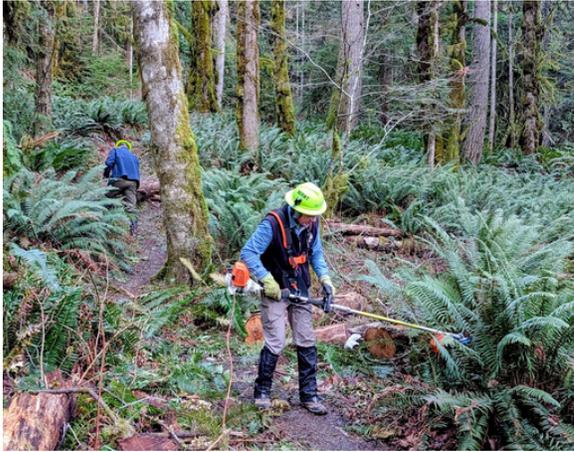
This day our brushers were Bernt, Eric, Rodney and Tim. The progress they made was remarkable, zooming their way through the last ¾ mile of trail full of ferns, salmonberry and other vegetation on both sides of the trail.

But, wow, did they ever leave a mess behind them! ;-)

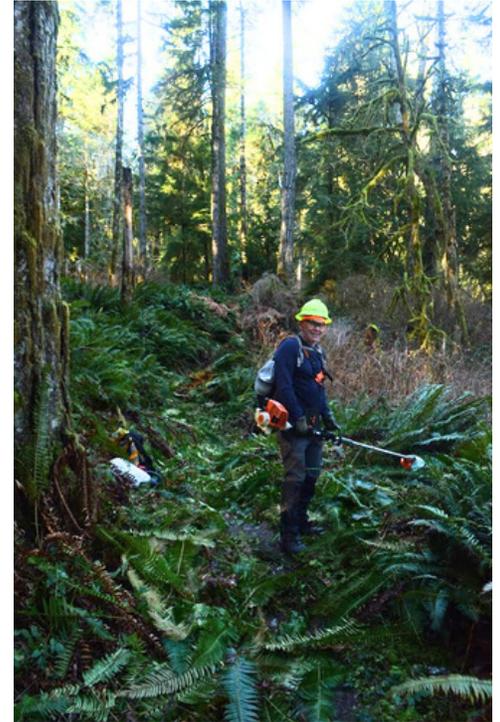
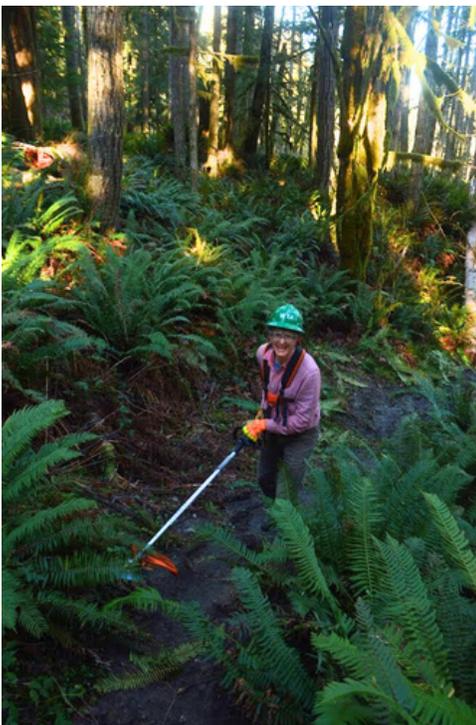
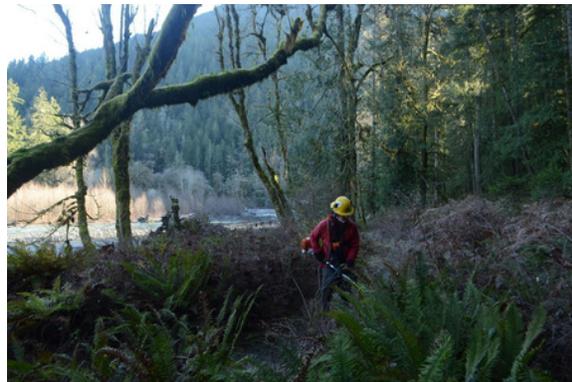
The tools we are using are called Kombi tools. They are a Stihl powerhead that can be used with different attachments. We use the attachment that can take a circular blade, which has carbide-tipped teeth. The blade is SO GOOD that we have to consciously remind ourselves to cut only smaller stuff because the power of the blade will outdo the strength of the plastic attachment on the shaft.

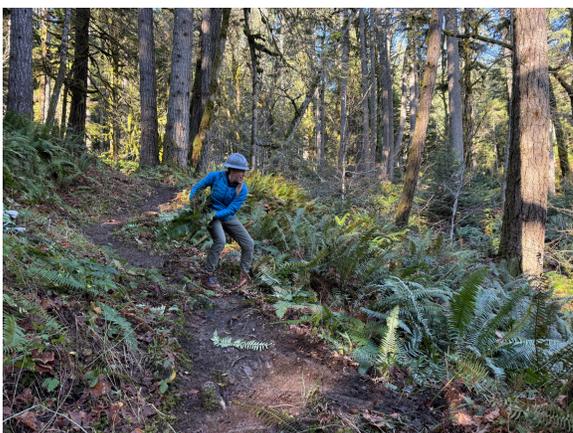
Michelle, left, tossing ferns as far off the trail as they would reasonably go. This is partly for aesthetics and partly so we don't create a berm of debris that blocks water from getting off the trail.

Rick, right, was primarily tasked with cutting back vine maples and encroaching branches all along the trail, but jumped in near the end to help with the massive clean up project.

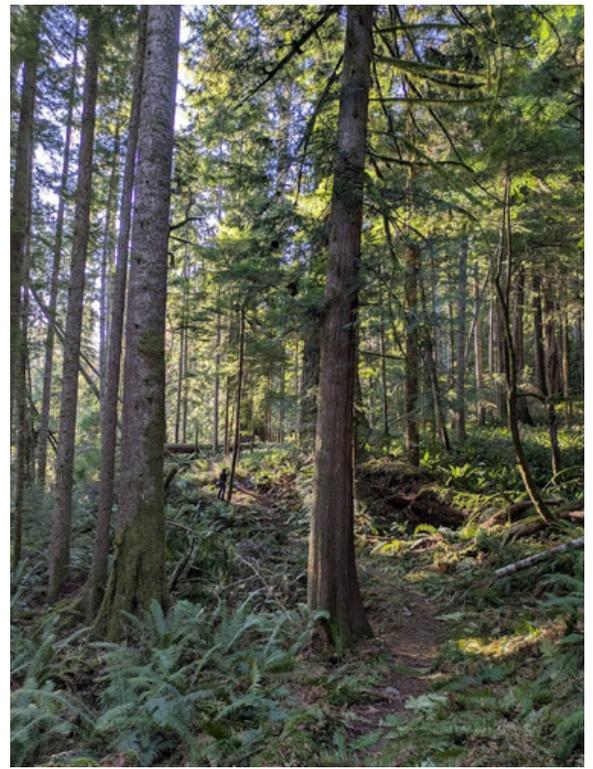
In this same area was Martin, Rebecca and Miguel working on drainage and tread problems on the hill going down to Altaire. This hill notoriously has water running down it which is eroding the trail terribly. We addressed drainage as much as we thought appropriate, and we'll go inspect it sometime soon after we get more rains. We can always put more drainage features in but it's best to only put in what is necessary. Many times you can catch the water from escaping at the top of a run and not need drainages all the way down.

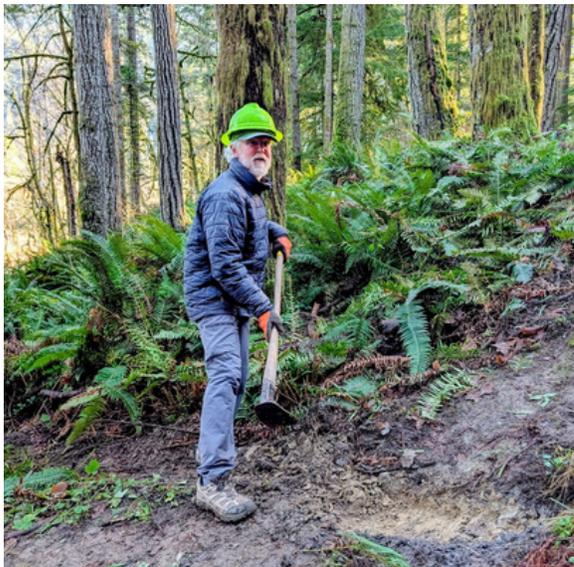
Miguel, left, was learning how to "think like a water drop" to give the water a place to flow off where it naturally would want to anyway.

Rebecca, right, was fixing tread where necessary (mostly where it needed widening or some flattening), working on drainage and teaching trail skills to the new folks on the team. Also helping with the brushing clean up.

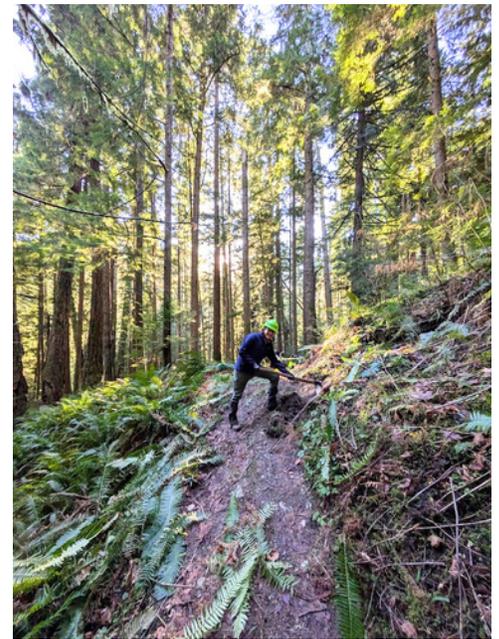
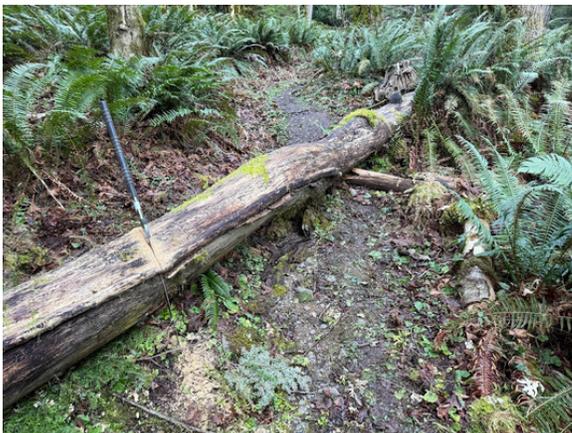
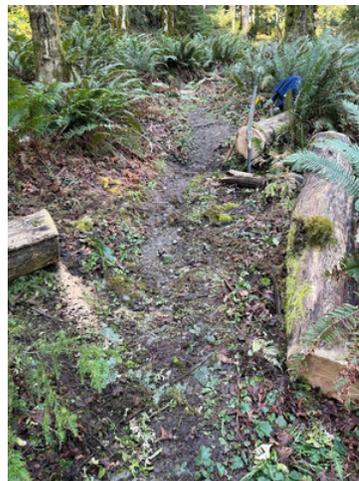
Martin, in addition to doing some remarkable drainage which is hard to get a good picture of, also had to cut out a log with his Katanaboy saw. This came down since we were last on the trail, because we had already cleared the trail of logs about a month ago.

Martin also spent some time to clean off and cut back this rootball that nature recently added to our collection of trailside views. It was partially blocking the puncheon.

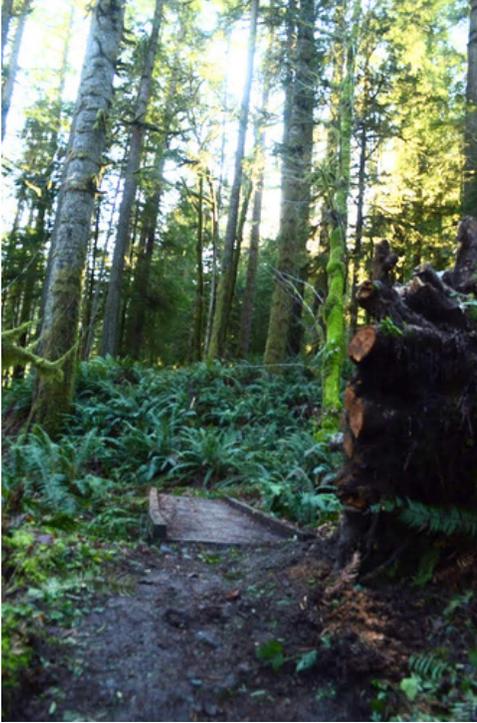
Some of the crew using the relatively new footlog across Hughes Creek. Thank you to the amazing ONP crew that put this in! So much safer.

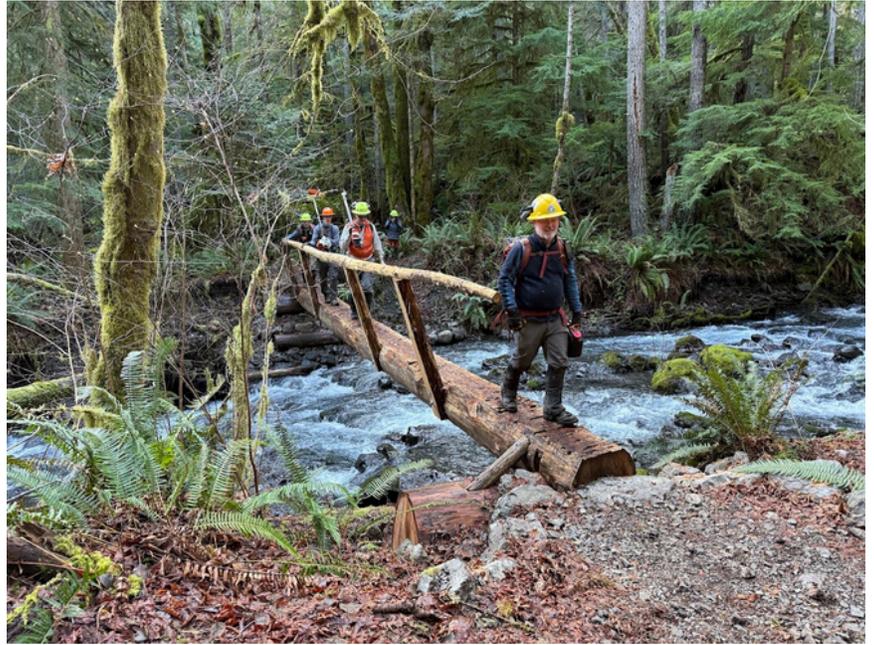
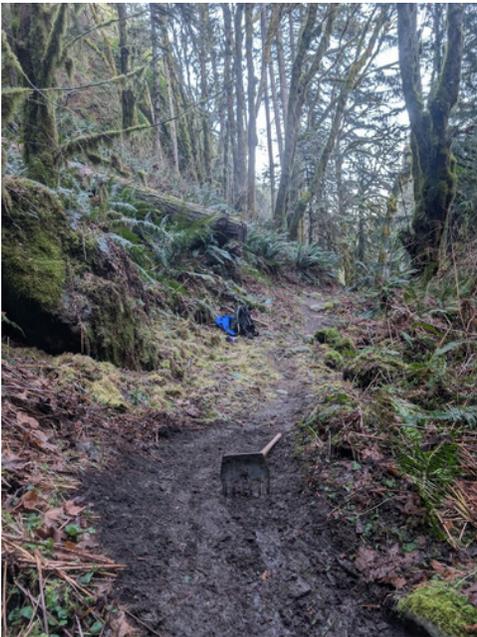
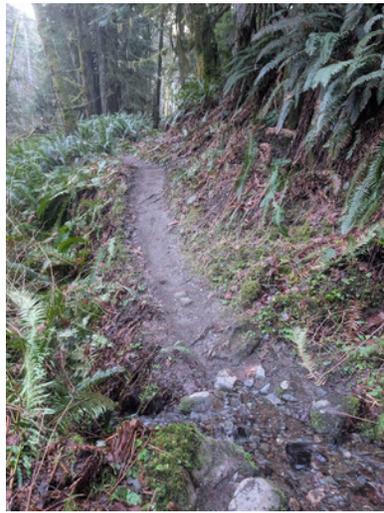
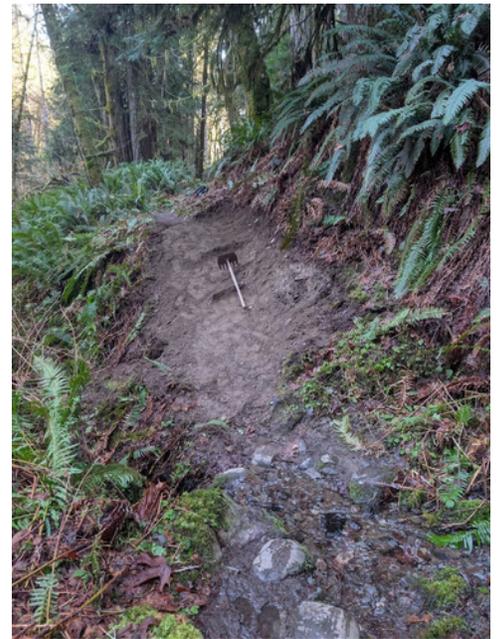
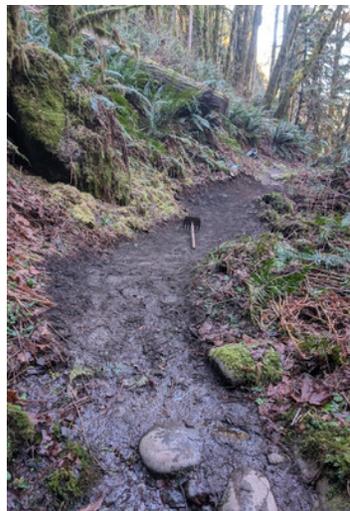
Some terrific before and after shots from tread master, Julie, all in a stream crossing area just south of Dead Horse Bridge (a little over a mile from the trailhead).

Left and middle bottom are looking north.

Middle top and right are looking south. This area had tread that was slowly getting more and more narrowed and off-balance. Julie spruced it all back up.

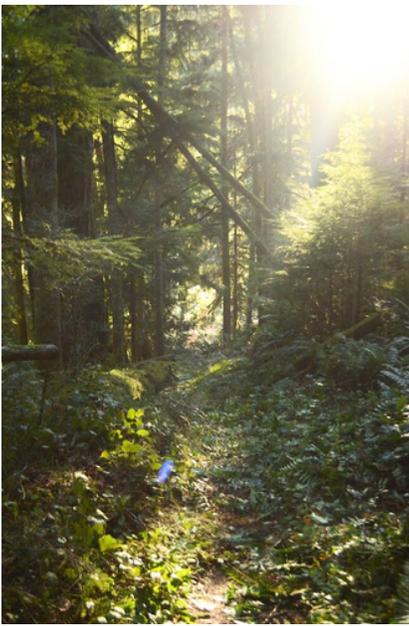
A before and after set, from the same viewpoint, showing the debris down on the trail and then it all nicely cleaned up.
