Gray Wolf Trail Crew - in partnership with - BCHW, Peninsula Chapter

Little River Trail, ONP

April 11, 2026

Report by Rebecca Wanagel

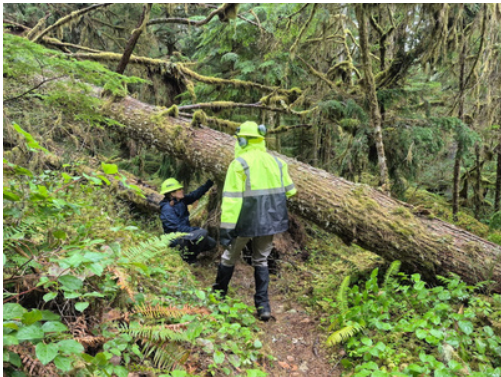
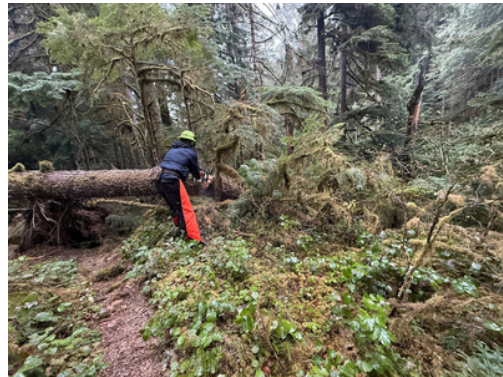
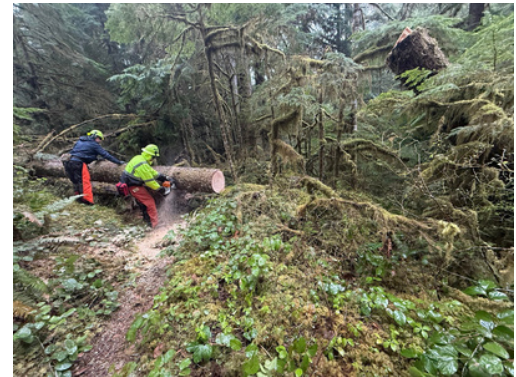
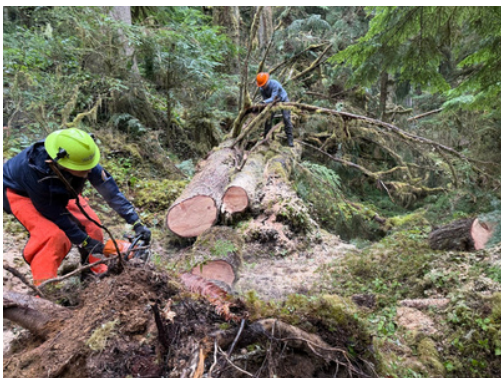
This was a set of two logs, both had fallen to the uphill side. The larger of the two had its rootball halfway down to the river. We knew this one was going to stand up after cutting and the bottom bind was severe. Paul got to do the release cut and it started snapping and pulling apart about when he put the saw to the wood. However, he handled it expertly and the log was released cleanly. Up it went!

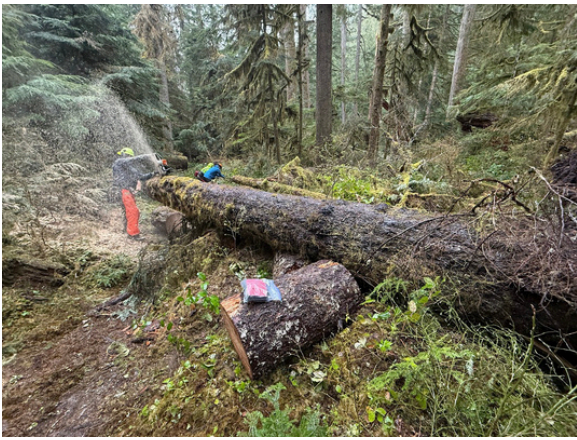
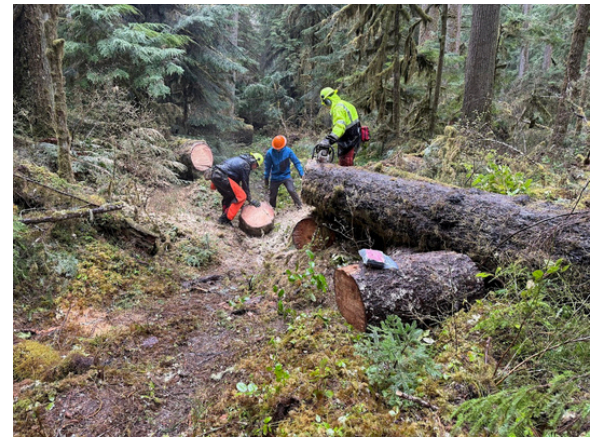
Some of the logs were non-complex like this one. However, logs at this height and size tend to be difficult for hikers to get over without getting soaking wet.

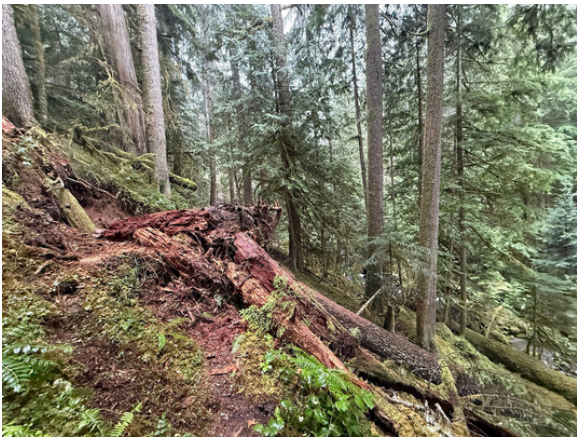
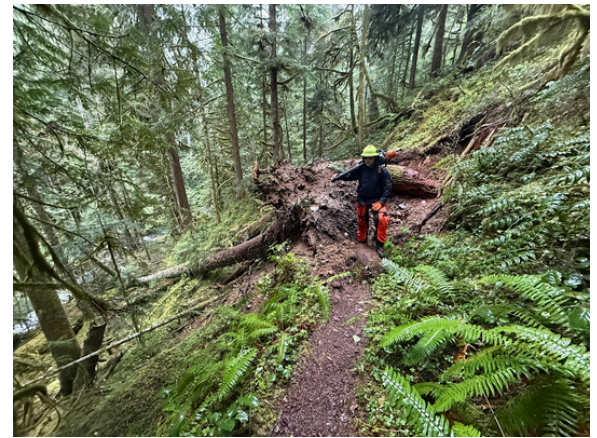
An overturned tree took out the trail for a short section. We quickly cut out one small rotten blocking log, but otherwise, this area needs a tread crew on a different day. Hikers are getting around this easily and have already beat in a path, so this project is not urgent.

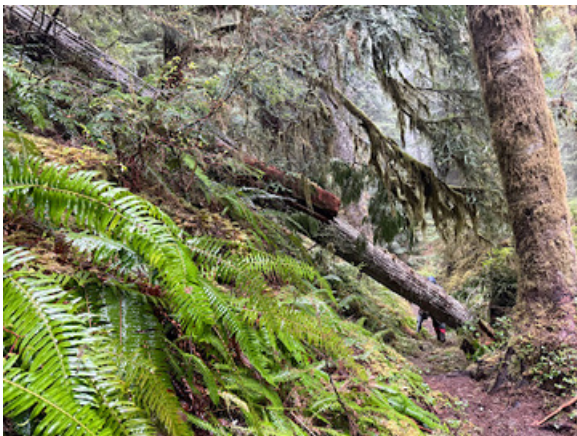
This is the cedar we decided as a team to leave for another day, which will be soon. The picture does not convey it well. The cedar is larger than it looks, very long, and completely detached from its rootball way up that very steep hillside. The chances of this thing sliding are 100%. That is not a problem for us, but does mean that we will have to cut it multiple times as it continues to slide down the hill (my joking term for that is a conveyor belt tree). It could take several hours and we had other big projects waiting up ahead. We decided to save this one for a better weather day when it can be the sole focus.

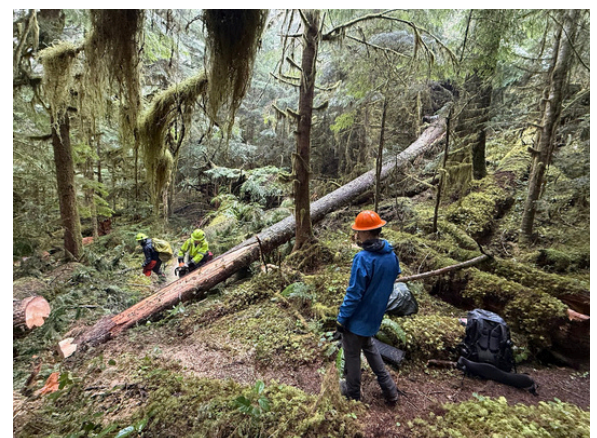
For as dramatic as this fir looks with its rootball way up there, and clearly snapped from the force of the fall, it was not difficult to cut. Bernt handled it with ease. And then we took lunch sheltered as best we could from the rain.

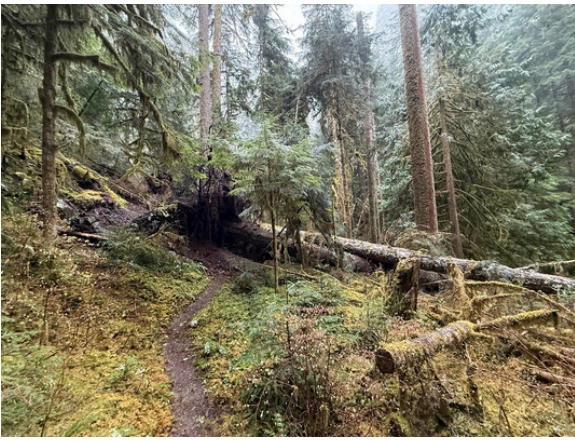
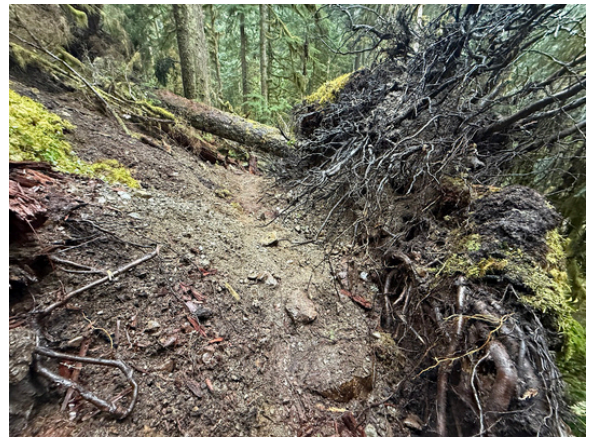
The second area where the trail was taken by a downed tree. You can see the trail goes right underneath the rootball. Hikers had clambered up around the back side, which you can see in the right picture. There being no way to retrieve the original trail line, we decided to cut out the top tree above the large rootball, and realign the trail to meet up with the original on the other side of this mess.

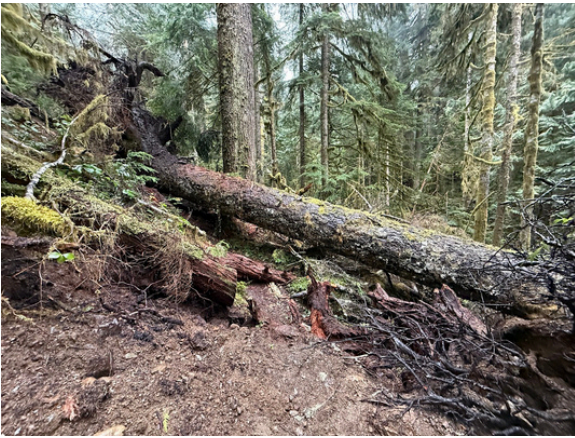
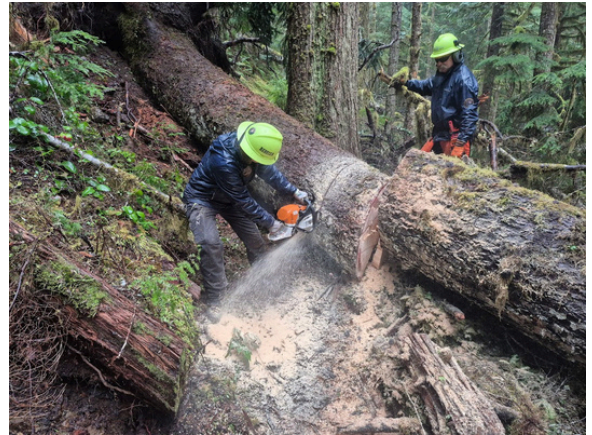
We chose the route to be above the standing tree because on the lower side the ground drops off sharply. The tree we're cutting is larger than the picture says it is - it was about 36" and the bark was full of dirt that had splashed onto it from its rootball. The dirt we had to clear away from underneath was full of rocks.

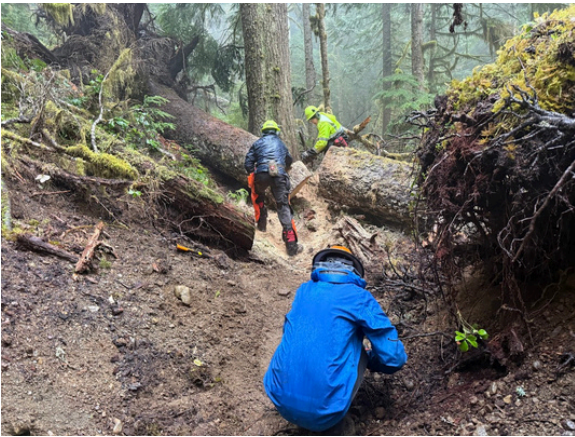
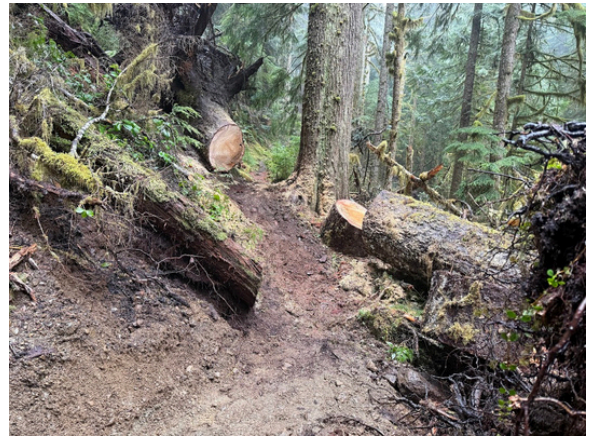
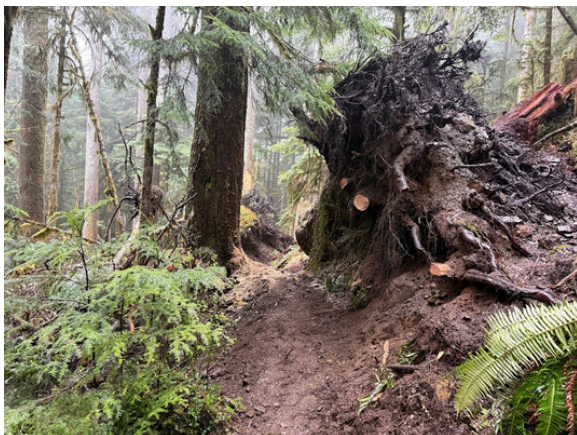
We cut away roots, smoothed out a tread and opened up a path. This is just fine for hikers. Is it to stock standards? No. You can see that the opening is not to typical stock standards although a horse there for recreation rather than tool packing could get through. For more on this see my note at the end of this report.
