Gray Wolf Trail Crew - in partnership with - BCHW, Peninsula Chapter

Lower Dungeness and Gold Creek, ONF

April 25, 2026

Report by Rebecca Wanagel

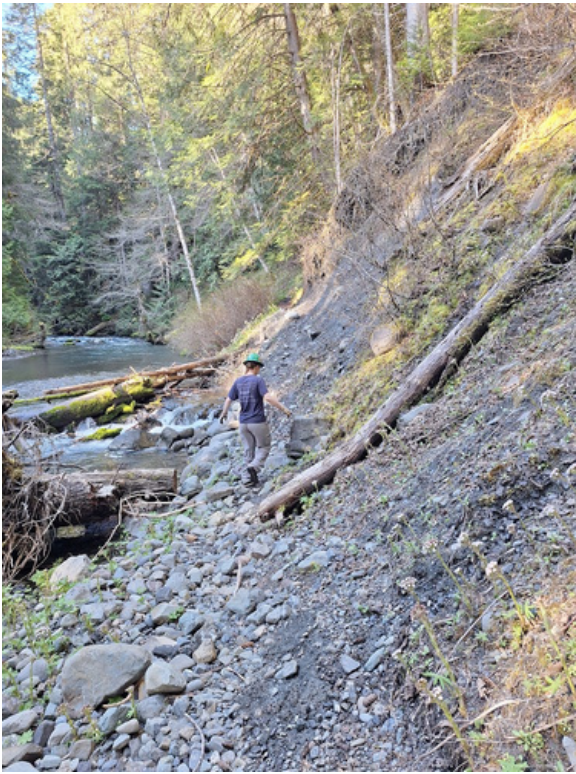
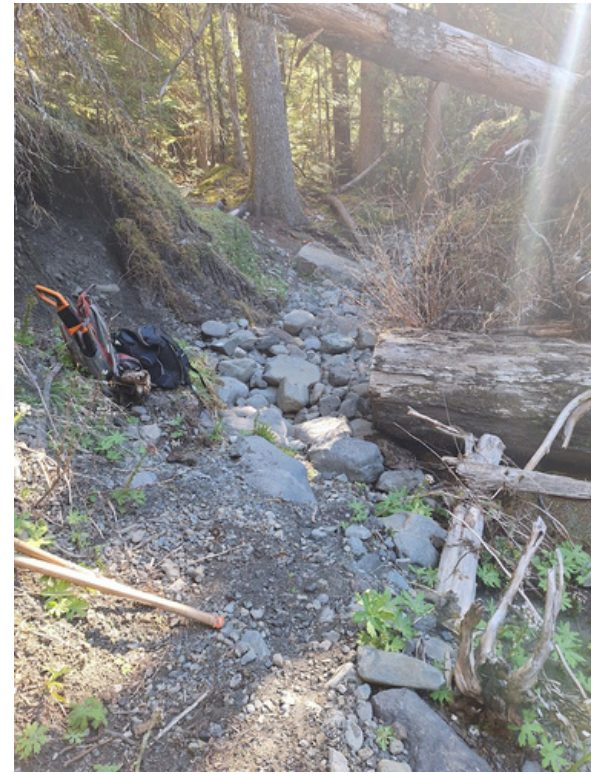
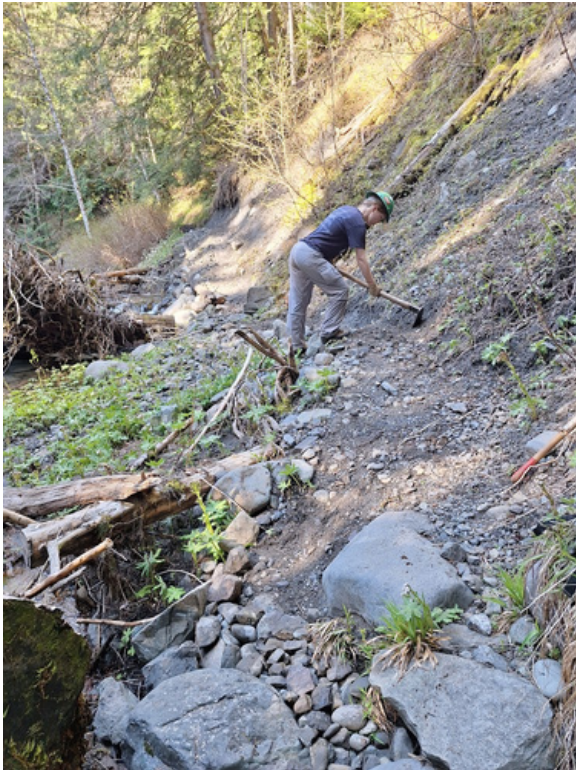
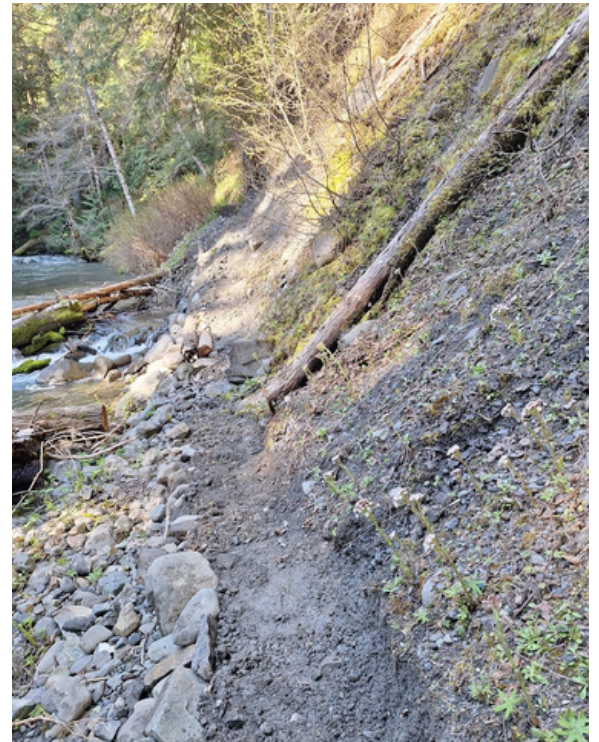
David and Hannah addressed the landslide area - an annual event.

This section has been problematic for eons. The plan is actually to bridge across the river and then another bridge back over to route the trail away from this. The Forest Service is looking into that and getting the appropriate -ologists to do their analysis in preparation for this plan. It is impossible to route up above this slide, so going over the river and back is the only solution. It's been done before. There is a place at 2 miles on Little River trail (ONP) where exactly that happened.

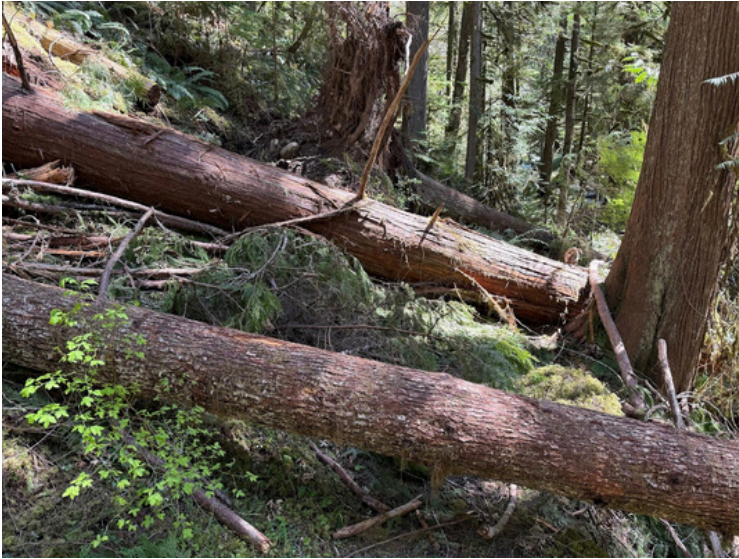
These were the trees reported on Gold Creek, about $\frac{3}{4}$ mile from the trailhead, before the footlog. They were difficult to get over, really blocking the trail.

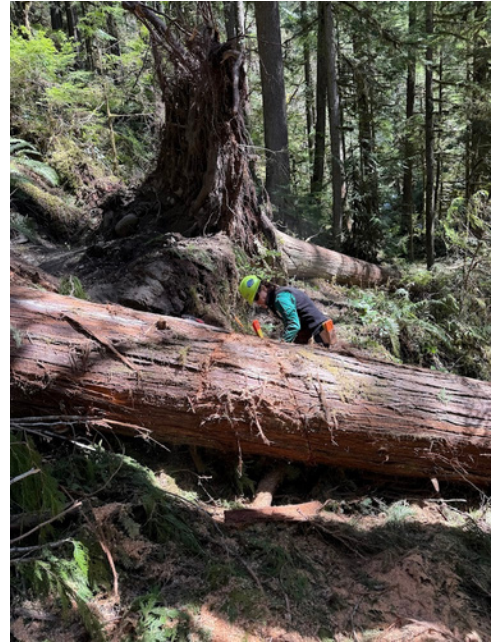
Honestly these were not challenging to cut, big and imposing as they look. But they did take some time.

You can see the angle I am using is pretty sharp. That is because we analyzed that the log to the picture left was going to drop, so we were giving it clearance space.

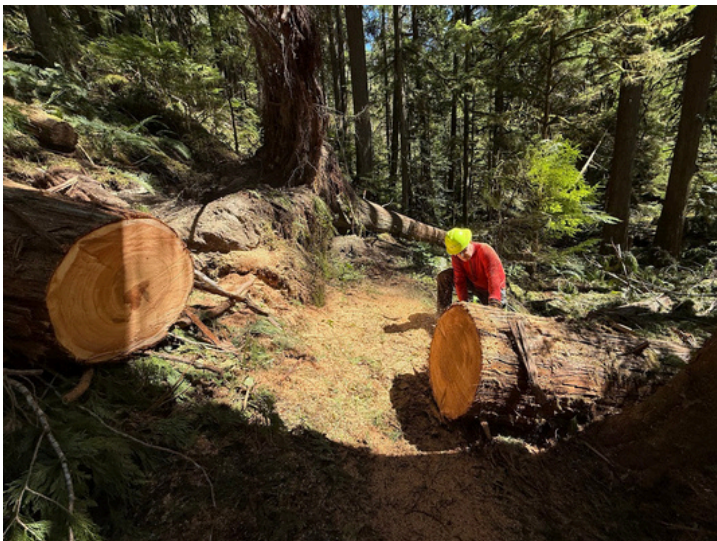
We cut everything to stock standards since it is a multi-use trail. Martin is taking out the last piece in this picture so the clearance is good and wide. This cedar was aromatic when we cut it! It was fresh, not rotten, fallen clearly due to wind, not rot.

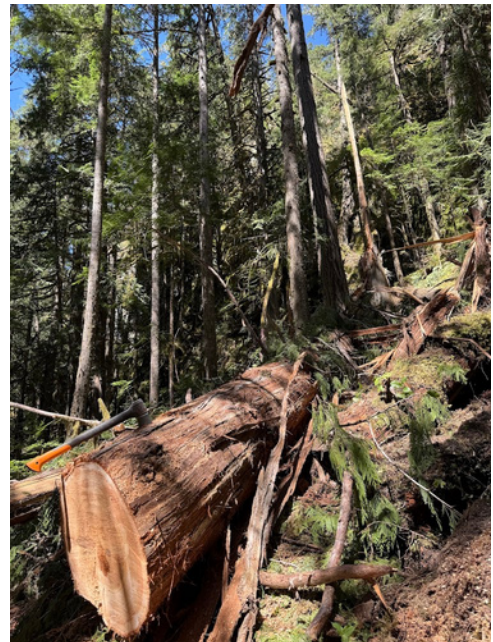
See that spire in the background? That is the piece left standing when this cedar was blown over by the wind.

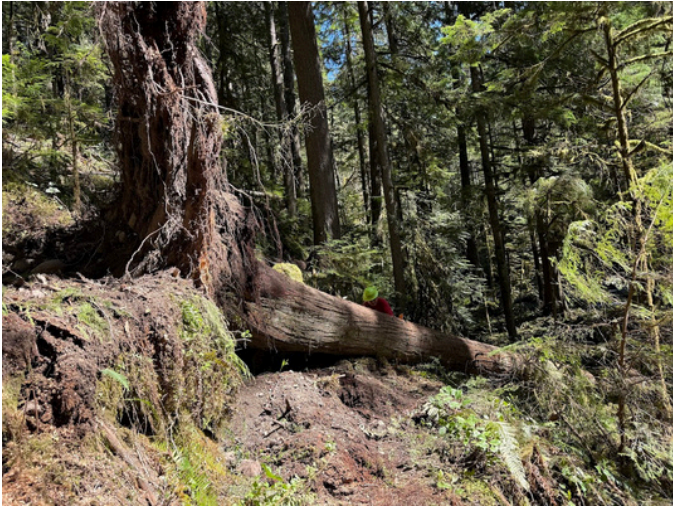
Another cedar. This one blew over intact, so its rootball uprooted. When a tree is blown over in the place where it was standing, we are always quite confident that the rootball will settle more, but it will not tip or roll because it has so many roots still in the ground. Martin is doing the release cut down below the trail to remove a whole bunch of weight, making it easier to cut up close to the rootball for the second cut.

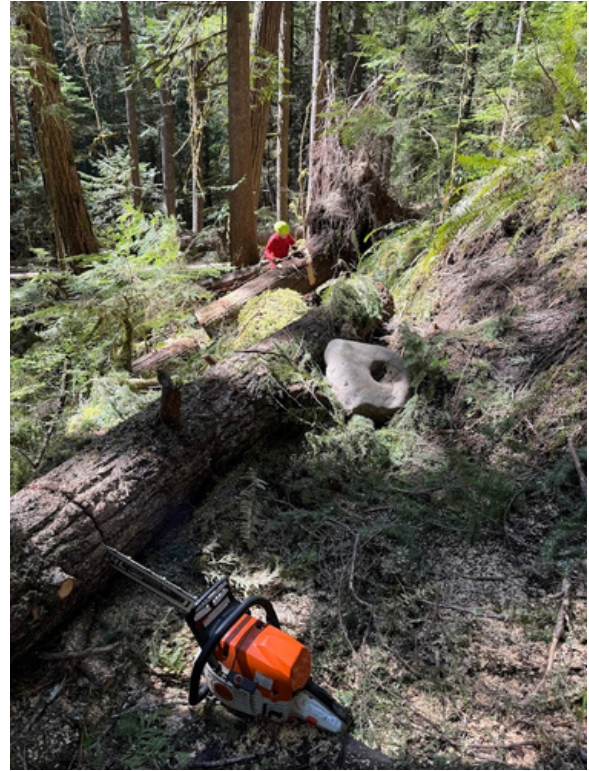
One thing I don't love about cuts near the rootball is there is always a lot of dirt on the bark. This has to be thoroughly cleaned or, sometimes more efficiently, the bark needs to be chopped off. Martin is working on that while I was clearing a few other tree chunks that came down in whatever wind event hit here. Lots of branches to clean up too.

Notice the rock? Isn't that strange? That rock is clearly water smoothed and carved. The roundness and the hole were caused by eddying water - I've seen that a lot in rivers. What was it doing above the trail so that it could fall down onto the trail?

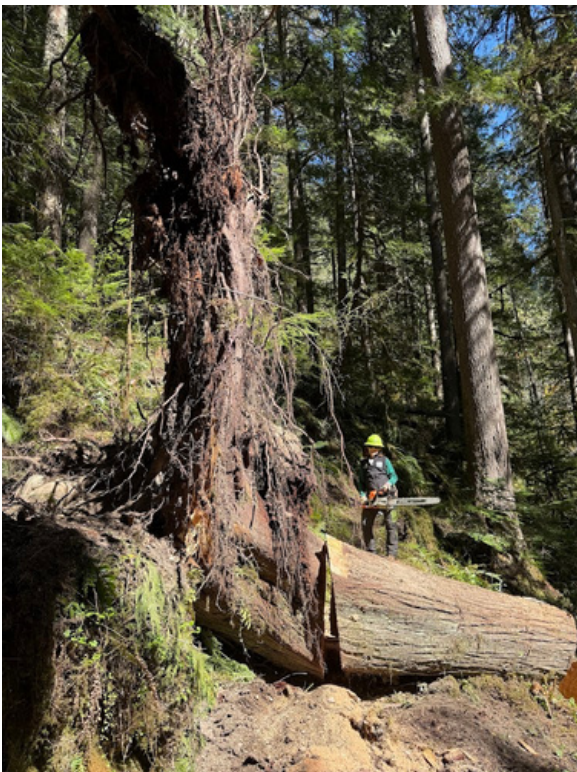
I did the final cut up near the rootball. It had already settled a lot so it didn't have much farther to go before it was sitting hard on the ground. No problems with the cut or rootball movement.

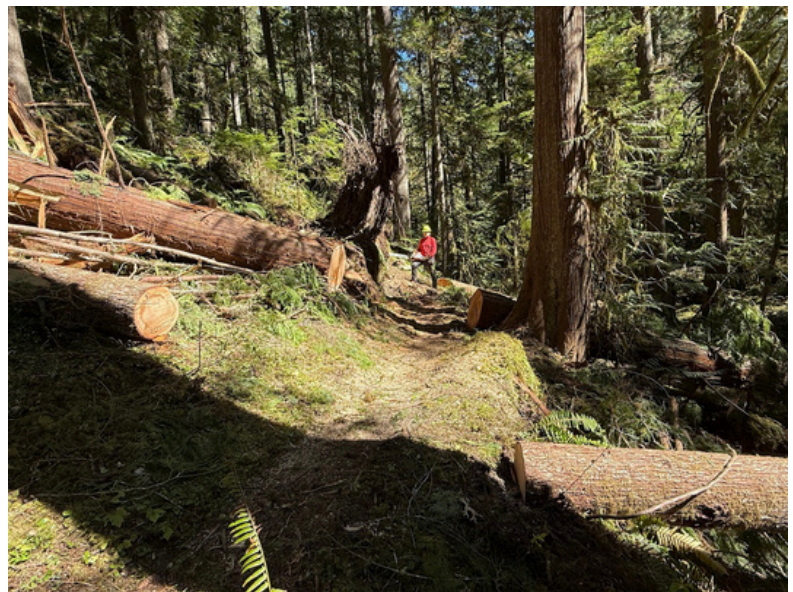
All cleared! It does need some treadwork near the rootball because it's tipping and crowding the trail a bit. However, I discovered that PNTA will be working on Gold Creek trail in July, so I'll go ahead and let them take care of the necessary tread work. We were not prepared with tools nor time to deal with treadwork at that moment.
