Gray Wolf Trail Crew in partnership with BCHW, Peninsula Chapter

Lake Quinault Recreation Trails (#854/855/860/888)
Olympic National Forest
15-17 April 2026

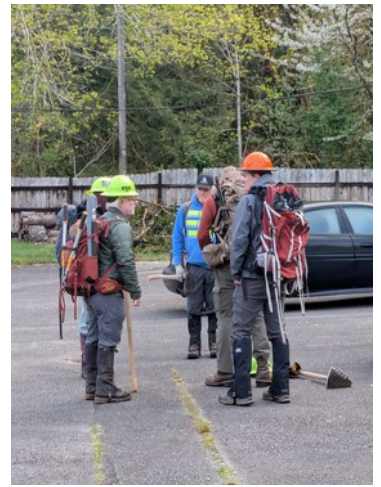
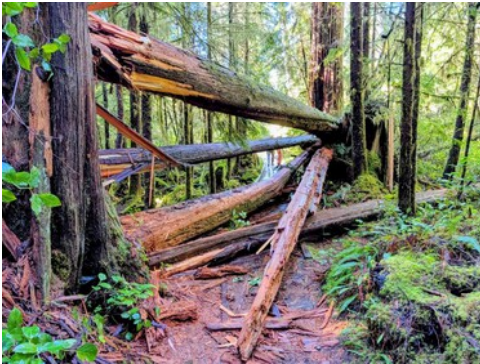
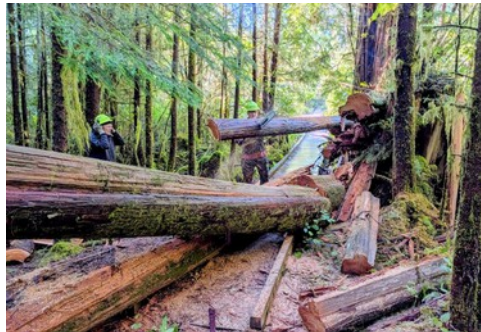
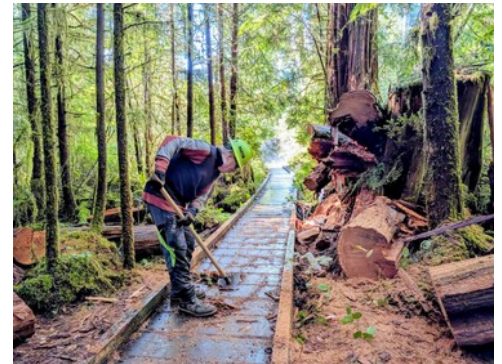
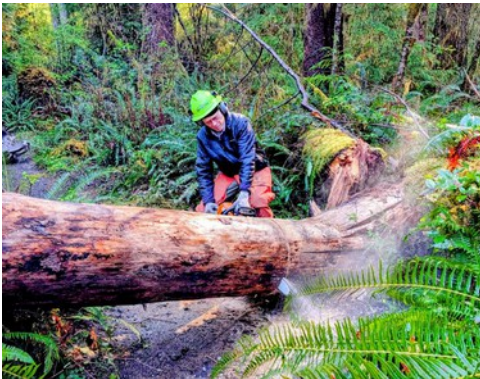
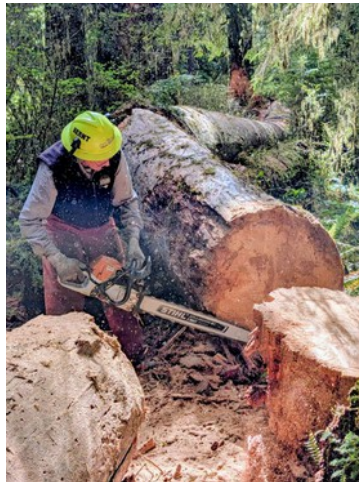
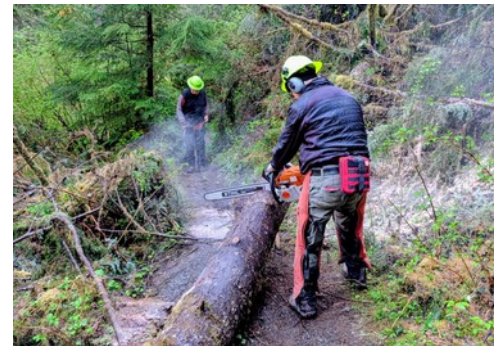
Tree removal this year was fairly straight-forward with neither any immensely large trees nor complicated situations to address. Still, covering the entire trail system while hauling saws, fuel, and other gear was not a walk in the park.

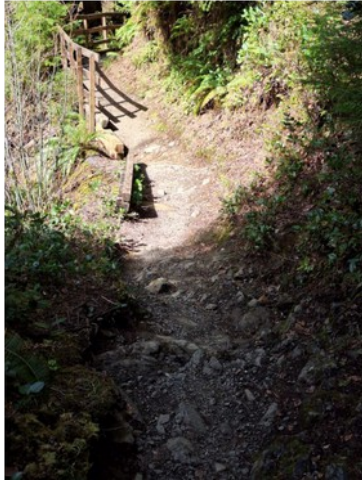
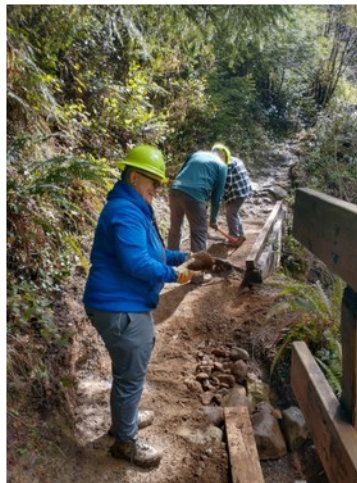
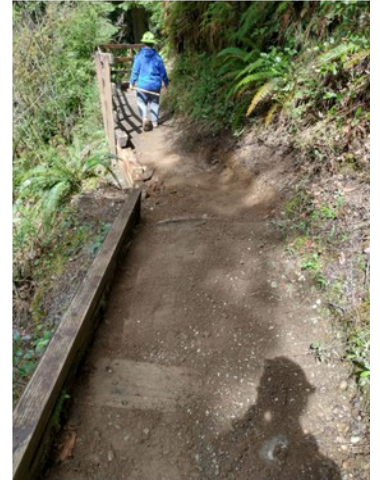
Steep washout area worsened by hikers cutting downhill to reach a off-trail view of a nearby waterfall.

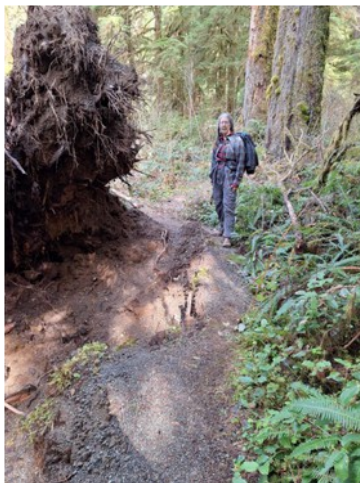
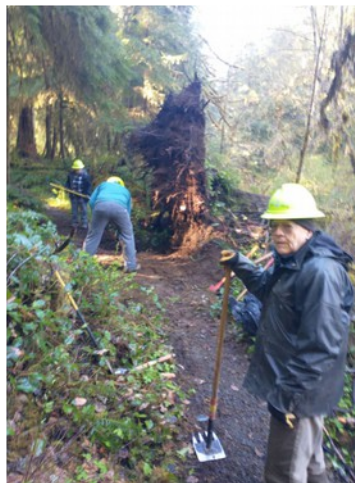
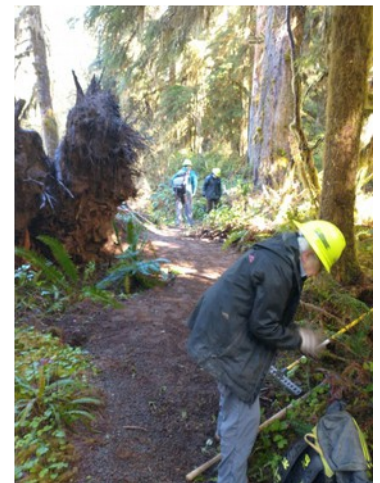
Root ball pullout that left a crater in the trail. Solved by a much dirt filling and slight re-alignment of the tread.

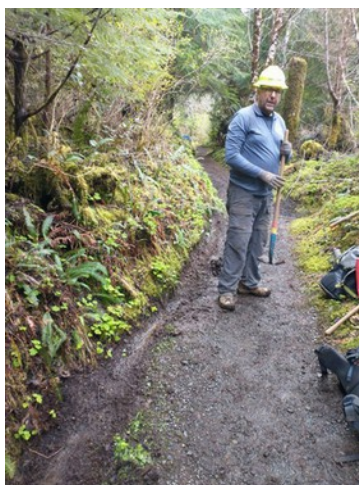
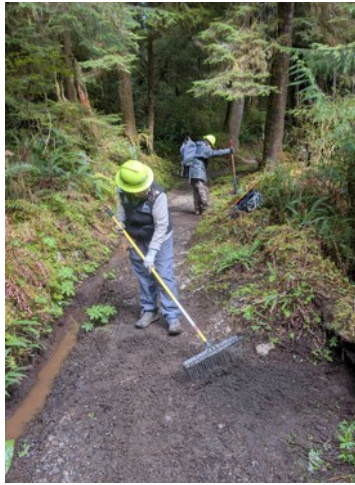
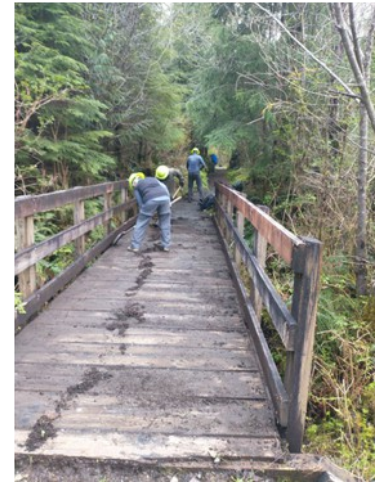
ADA trail and bridge where clogged drainage led to gravel covering bridge. Drainage restored and bridge cleaned.

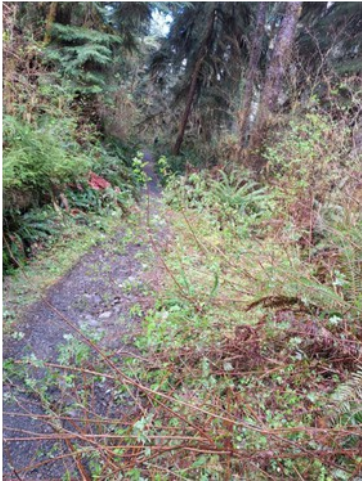
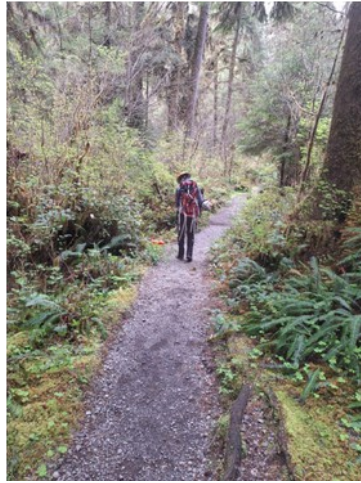
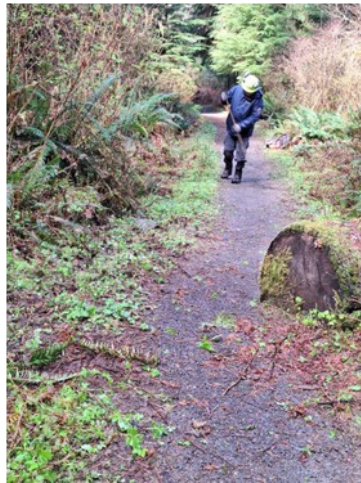
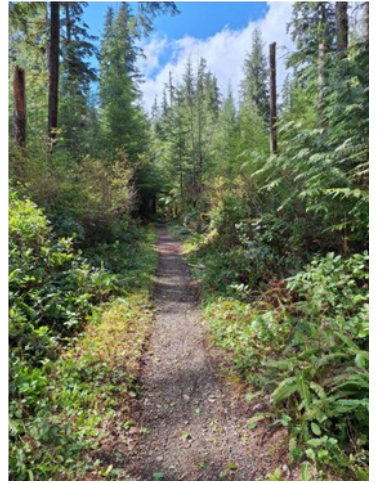
Salmonberry, salal, and other verdure thrive in the Quinault climate. The open, sunnier area of the trail provide a natural space for the plants to grow into. Some of the brush merely gets the local visitors wet, but there are sections where it really entangles the hikers and obscures the trail.

Each year there is the repeated task of re-opening the corridor. Spring pruning is not the best time for discouraging plant growth, but it's the only time we're out there. Forest staff and local volunteers continue brushing through the season.
