Monthly Trail Report for the Board and Membership
Peninsula Chapter and Gray Wolf Trail Crew
Report written by Rebecca Wanagel
December 2025

Lower Big Quilcene Trail, Olympic National Forest
08 November, 2025
Report by Rebecca Wanagel

Gray Wolf Trail Crew
- in partnership with -
BCHW, Peninsula Chapter
Heather Park Trail, Olympic National Park
14 and 16 November, 2025
Report by Rebecca Wanagel

Lower Big Quilcene Trail (#833), Olympic National Forest

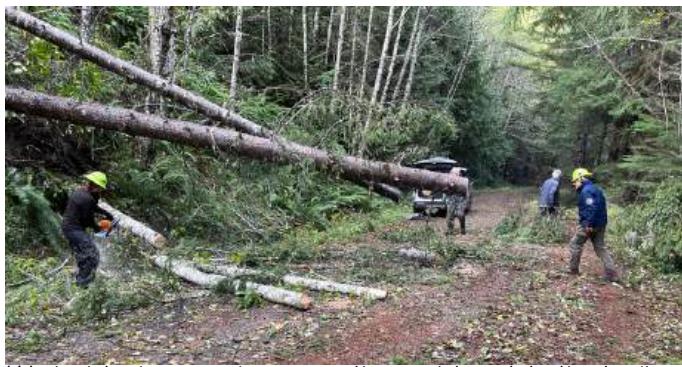
We had to do some clearing on the road to get to the trailhead.

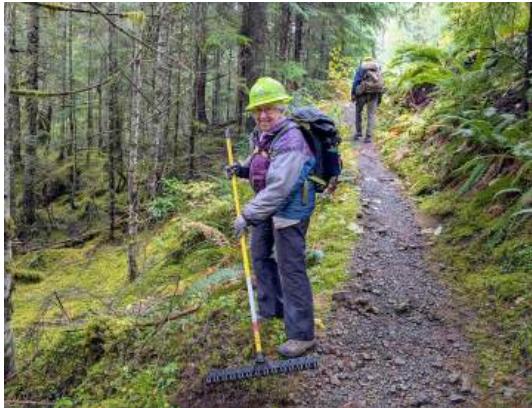
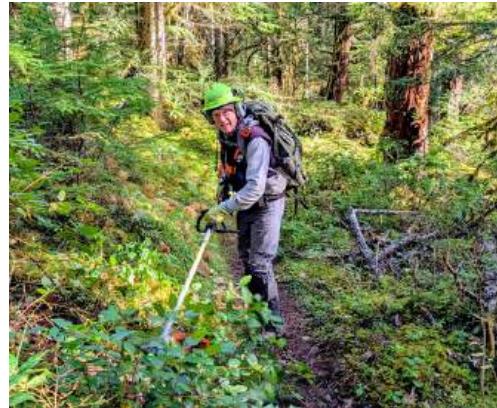
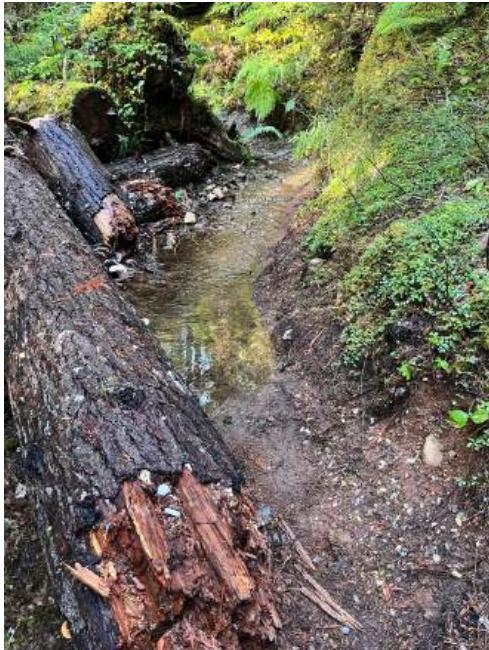
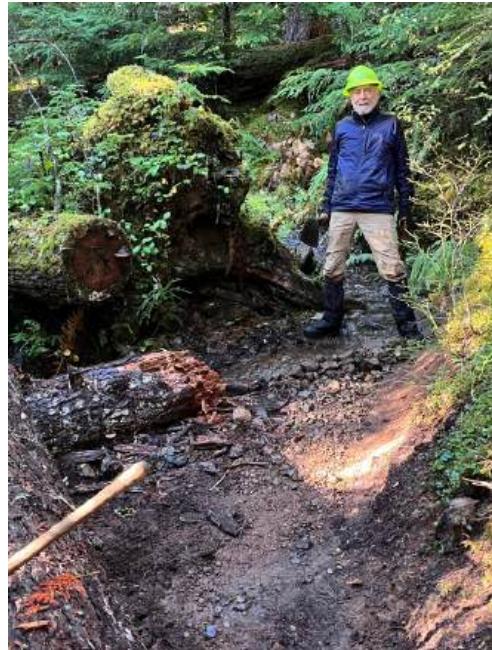
This 1-1/2 miles of trail is ready for winter!

Ridding the trail of deciduous leaves, brush debris and organic matter prevents mush and squish. Brushing keeps people from hugging the downhill edge, causing tread breakdown. Drainage of all sorts keeps the water from flowing unchecked down the trail. Water, while the stuff that makes our peninsula so lush and exquisite, is also the worst enemy of trails. Water does more trail damage than anything else short of fire. So we found, checked and cleaned culverts, widened or made drain dips, cleaned ditches, and got streams back into their channels.

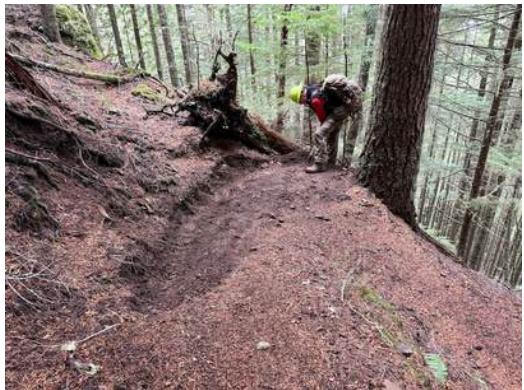
Left: this switchback was getting damaged by water seeping off the hillside. The water needed to be corralled and directed.

Right: You can see the erosion that is happening as a result of the water flowing unchecked down the trail. Heather Park has really nice tread - we are trying to preserve that!

However, that steepness, besides taking your breath away, has another downside: erosion due to water running down the trail. There are many drainage features put in earlier by trail workers, but they all needed to be cleared out because they currently were not working and the erosion was obvious. In addition, there were long stretches where the water was flowing unchecked, so we needed to add more drainages along the side of the trail, hopefully catching those problematic areas at the top of the flow.

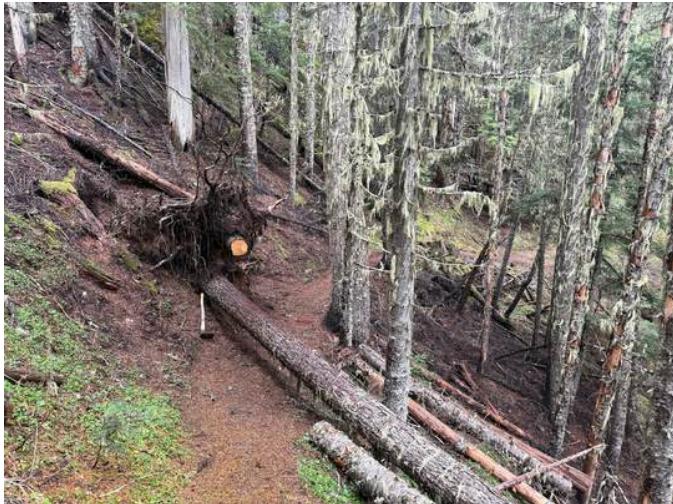
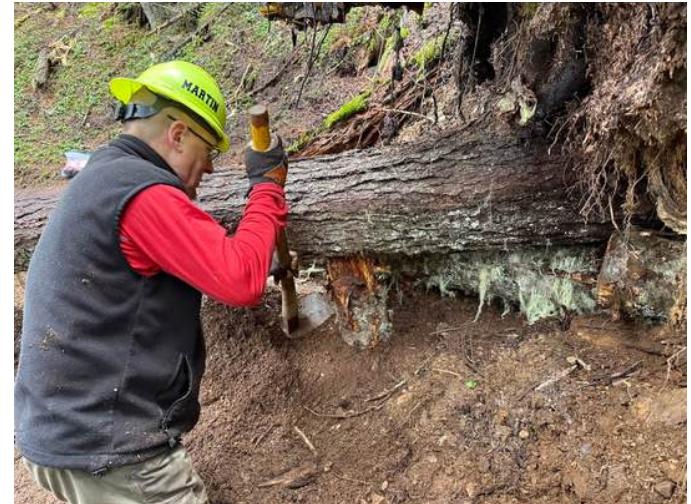
This tree was difficult to get over from the downhill side. It had been down long enough that the tread was destroyed. Martin is quite tall and yet you can see that the tree is at about shoulder height for him as he worked from the downhill side. That was because of the erosion of the tread in that spot.

What is he doing, you might ask? This rootball was still rooted in position enough that it wasn't going to roll, however, nothing was to stop it from tipping right into the trail corridor. We decided to use another nearby downed tree as a prop to hold it up. We jammed several pieces in there to make it impossible for the rootball to tip.

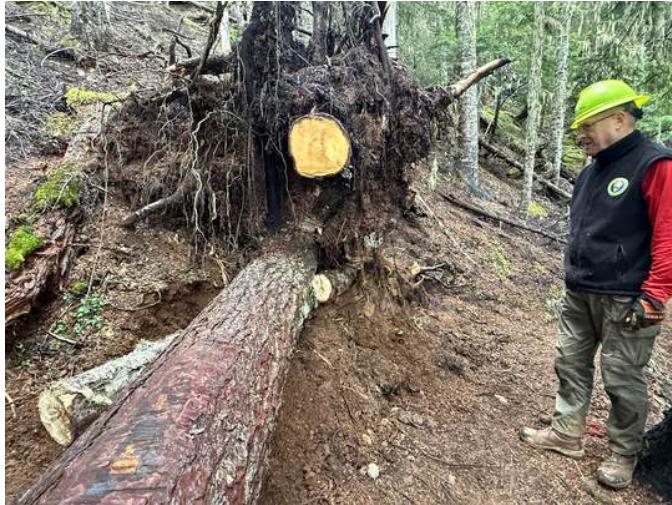
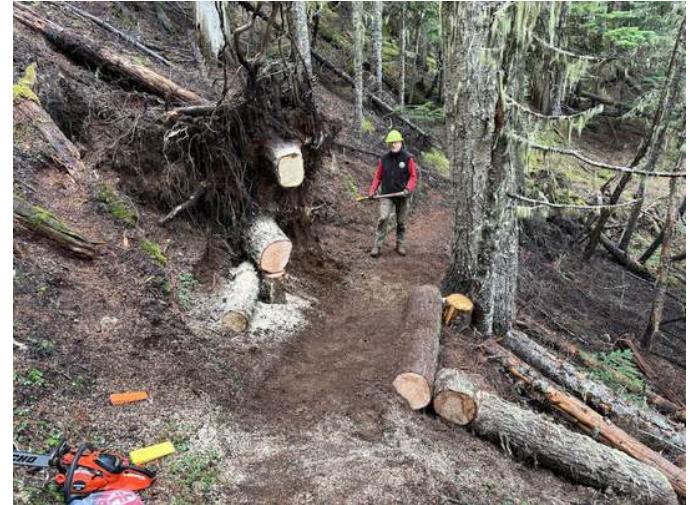
Left: the rootball is sufficiently blocked up, ready for the tree to be cut.

Right: After we cut the tree, we used a log from it, and others as blocks, to create a curb wall so we could repair the tread. This is the finished product.

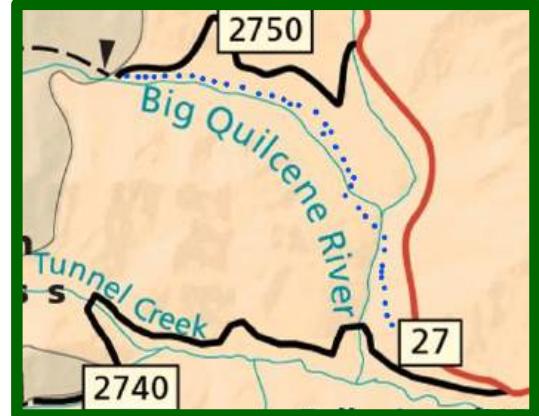
- Clear three fallen trees at the 4.2 mile point on this trail (blue dots).
- Address serious brush issues plus tread creep on a steep side slope section.
- Check performance of October's drainage work and address any newly discovered drainage issues.

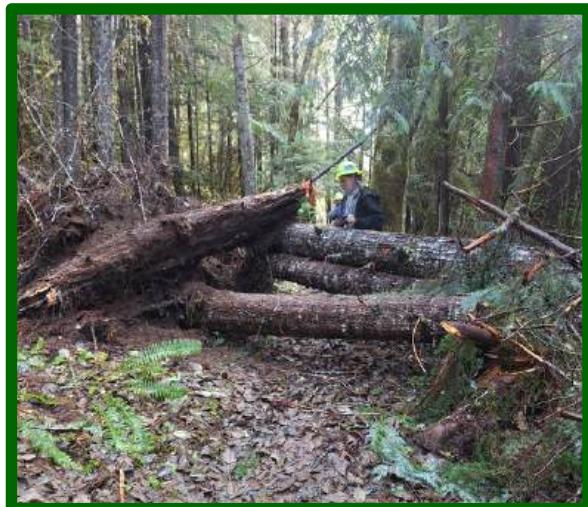
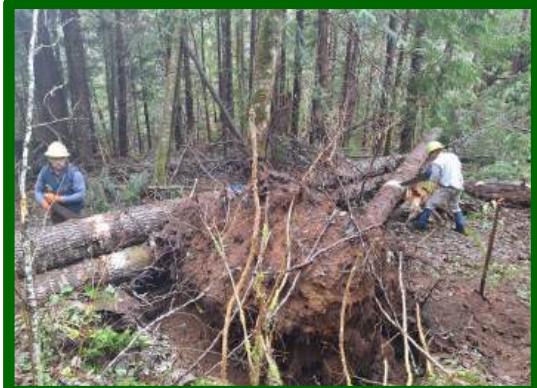
The trees were all tangled together with the end of one suspended far out and thus holding a lot of tension. The first order of business was to remove all the soil on the logs from hikers clambering over and then to cut the cantilevered end off to remove the bound-up energy. That done, the crew could often saw (crosscut) on multiple trees simultaneously.

After the first cuts, we made room for the final cuts by rolling the cut logs out of the way and levering one of the trees up to a 45 degree lean.

Fortunately, after these cuts, there was room on the side of the trail to drag all the cut logs.

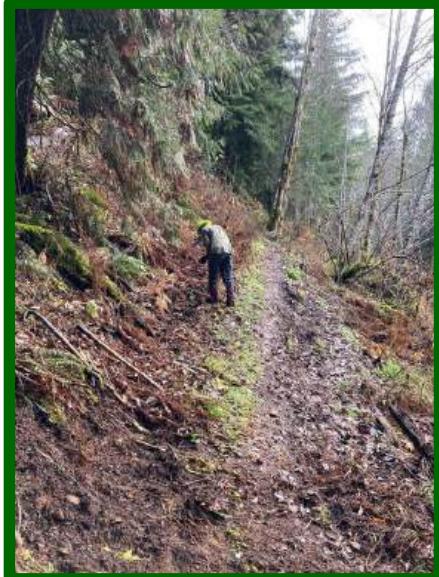
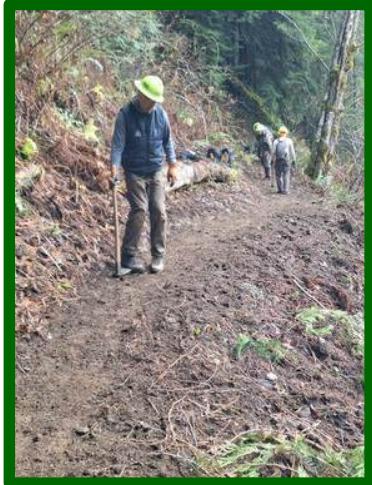
By this time, the rebenching crew had pulled, or dug out, the tree saplings and salmonberry crowding the uphill side of the trail. All that remained was to remove the organic matter covering the original tread (uphill of where trail users were going) and then to give

the tread the desired outslope angle. As a final touch, the crew walked back-and-forth to pack down the tread. While not as heavy a packing as from a 4-horse team,

this will help runoff to cross the tread and continue down-slope rather than washing away the tread or running down the trail.

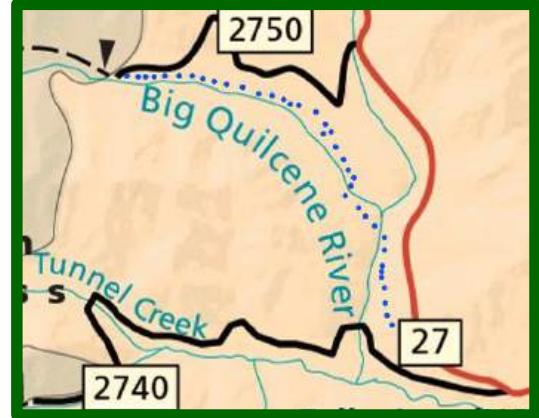
- Clear multiple fallen trees from the 4.5-5.5 mile point on this trail (blue dots).
- Address any drainage issues found.

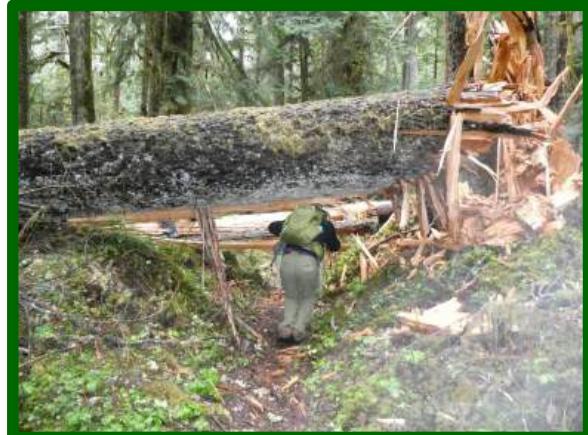
There were four primary clusters of fallen trees. Two of the clusters were of smaller (under 12") diameter trees and two of larger (20-30") diameter trees. A total of ten trees were removed from the trail corridor. Also, the ends of three trees that had fallen and been cut through years ago, were cut further back to meet stock corridor requirements. Finally, two blocked drain dips were cleaned removing standing water from the trail.

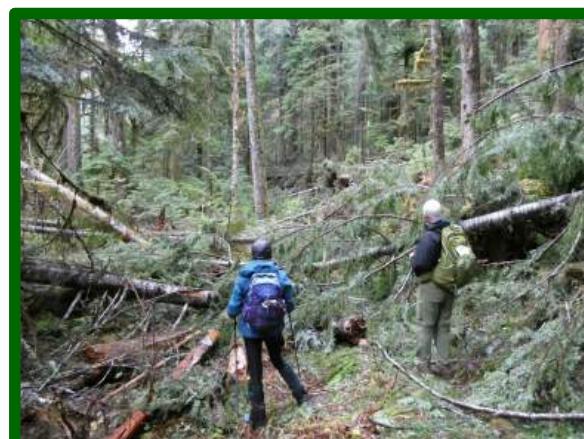
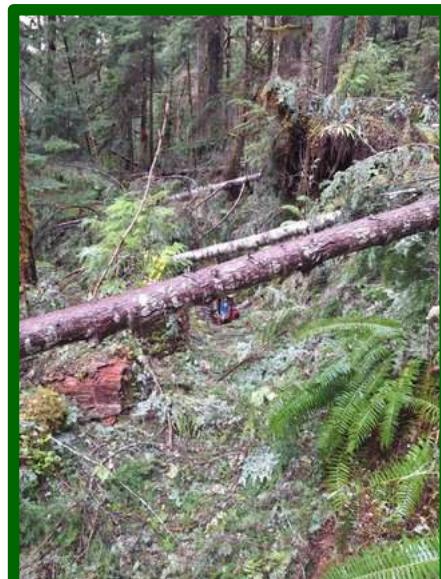
One of the other larger trees.

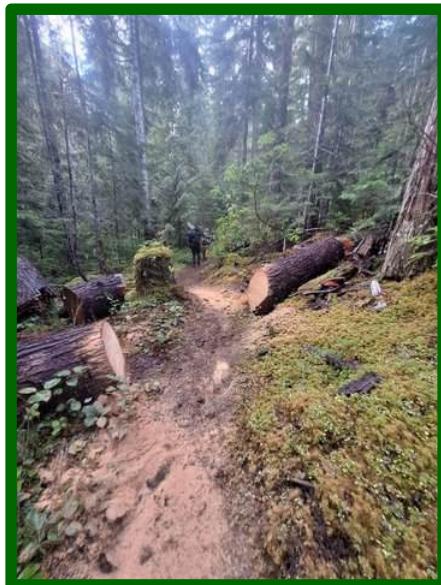
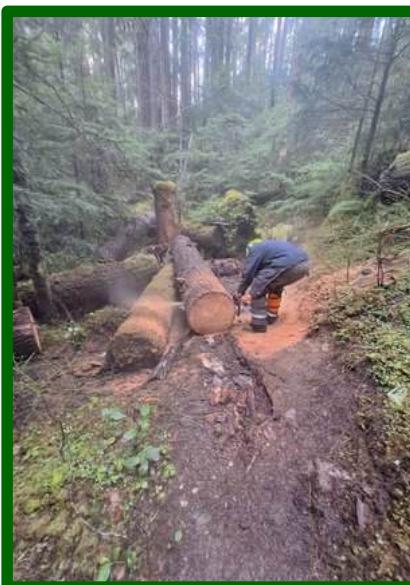
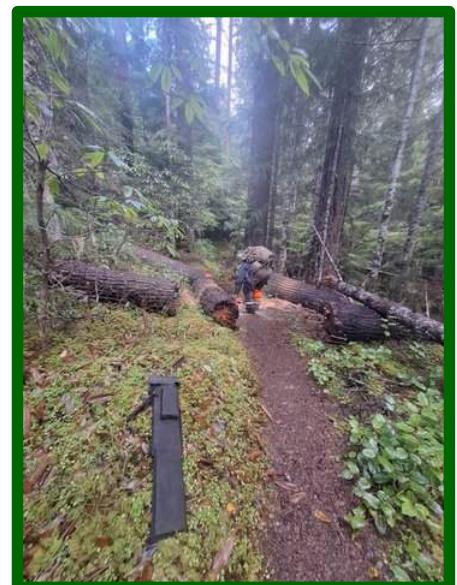
A little extra cleanup.

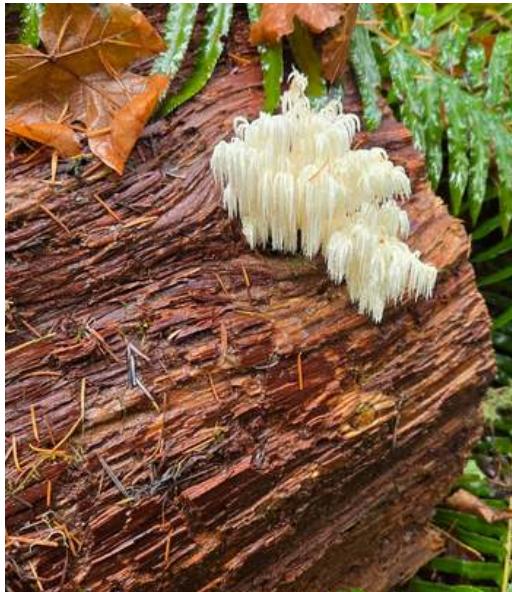
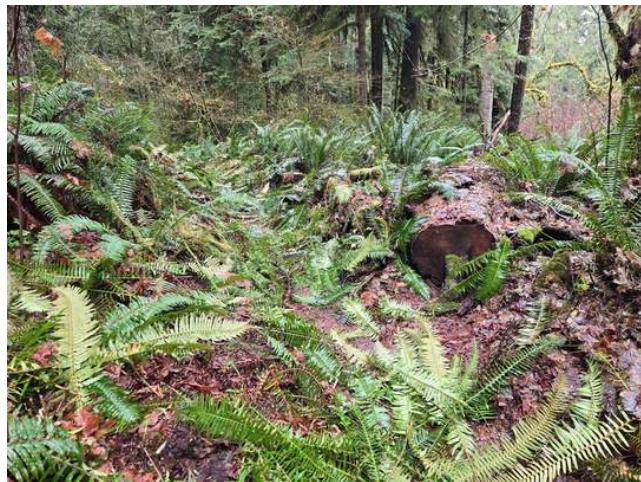
This crew was working so hard that we don't have the usual collection of pictures to document their amazing work! I will leave you with just two ... one showing the beauty that can be found along the West Elwha and the other a quick glimpse of a section of fern fronds and mushy leaves waiting to be cleared.
