**Monthly Trail Report for the Board and Membership**  
**Peninsula Chapter and Gray Wolf Trail Crew**  
**Report written by Rebecca Wanagel**  
**June 2026**

# Gray Wolf Trail Crew -in partnership with- BCHW, Peninsula Chapter

West Elwha, ONP

Build a new 230-foot trail to realign away from rotten, treacherous puncheon. This puncheon was sketchy for hikers when wet, and not appropriate for stock due to its condition.

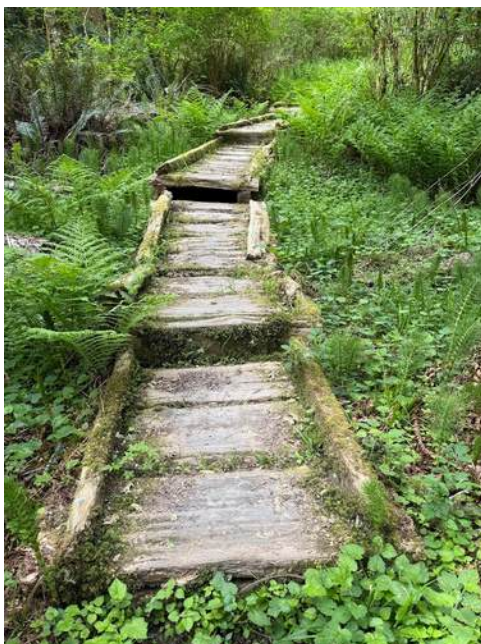
Picturesque but no longer practical.

It's easy to see why puncheon was used through here many years ago. The horsetail and other plants here give a clue as to how swampy it is.

We decided to make a route that benches into the hillside up above this wet area.

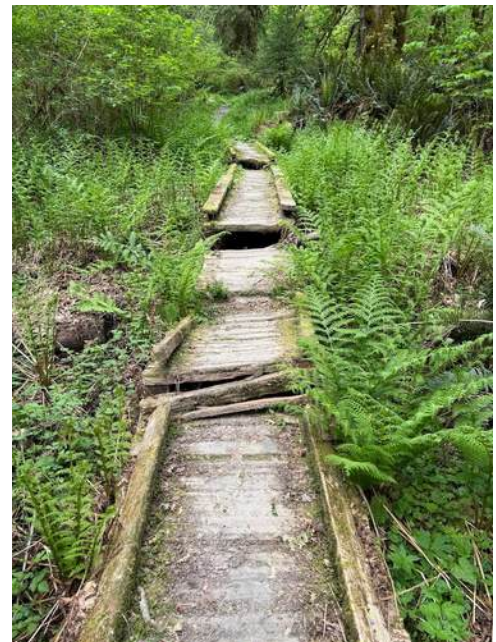
Martin and Rebecca flagged the route the day before our first crew, following the line that we had scouted previously with Nathan Forrest, Trails Supervisor. We were going for 30" tread and a corridor to stock standards. This allows stock passage but stays narrow enough that it still feels like a backcountry trail.

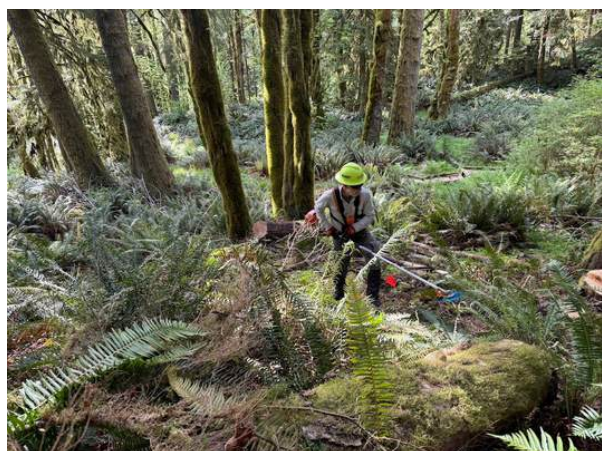
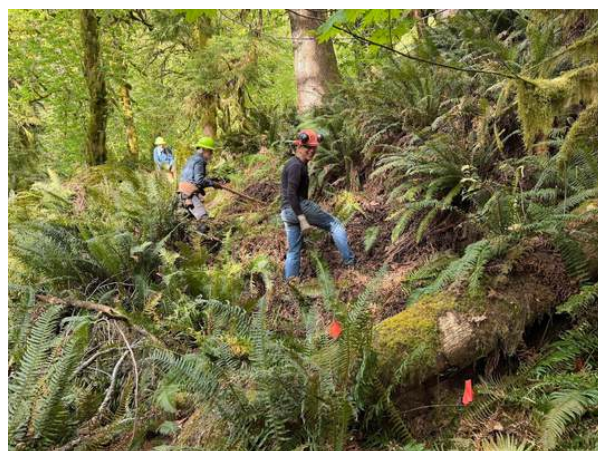
The first order of business was to brush out the corridor. Our main plant here is ferns and we needed to be able to see what we were doing. Many of them got dug out and replanted down below out of reach of the new trail. Tread started getting roughed in. Downed logs had to be bucked out.

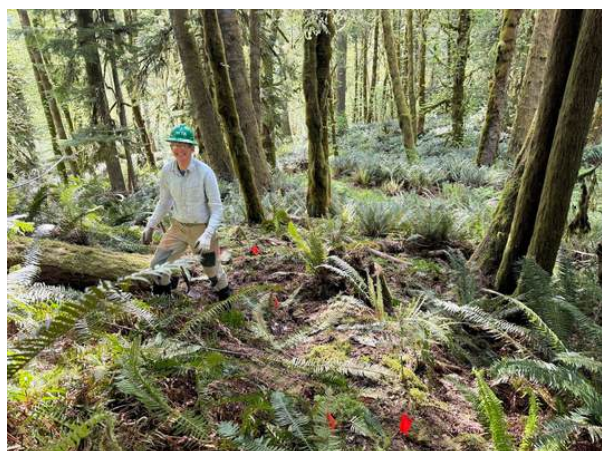
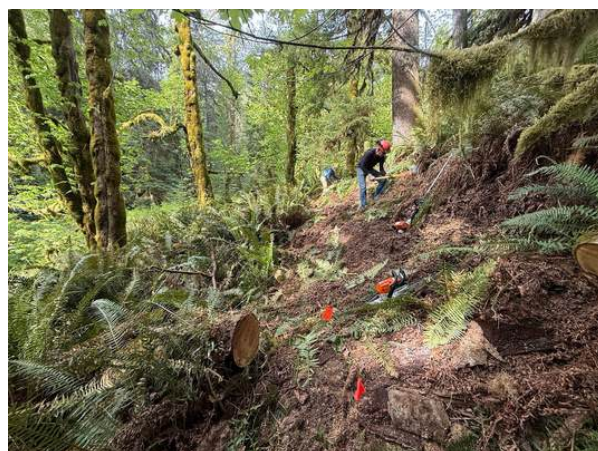
The tread started taking shape remarkably quickly. The team was spread out throughout the 230-foot flagged route. We purposely built this to flow around trees and objects and to be curvy and enticing, rather than a straight shot. It gives it a more natural feel, like the trail is resting on the terrain.

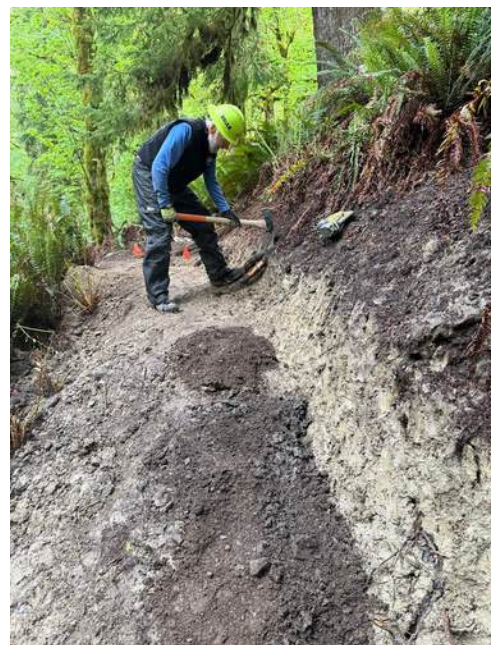
Roots need to go. You can also see here the beginning of our efforts to dump better soil on top of the clay that is this hillside.

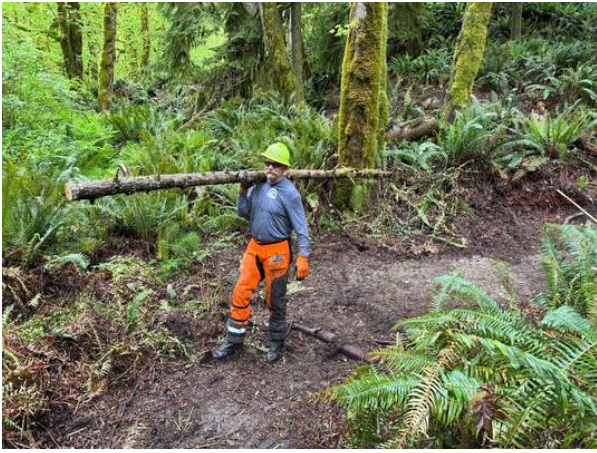
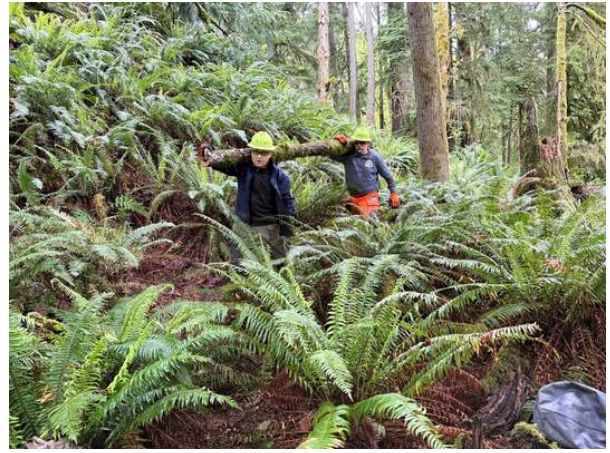
Scavenging for downed small logs that could be used as curb edges for the turnpike(s). I had planned on a turnpike at each end, but ended up finding out that only one is necessary for now. We will monitor the trail and put another one in up top if it proves to be needed.

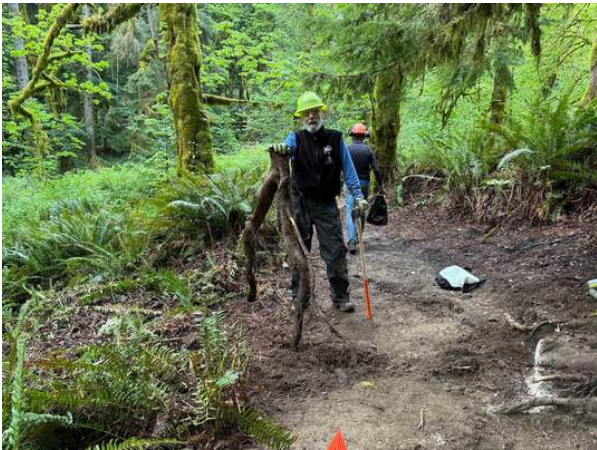
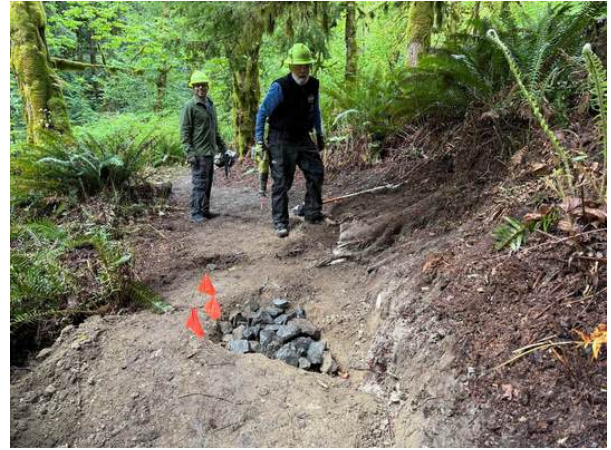
Some roots were more tenacious than others but none were as stubborn as Brian! One large hole had to be filled with rock carried in from elsewhere before dirt could be spread over the top.

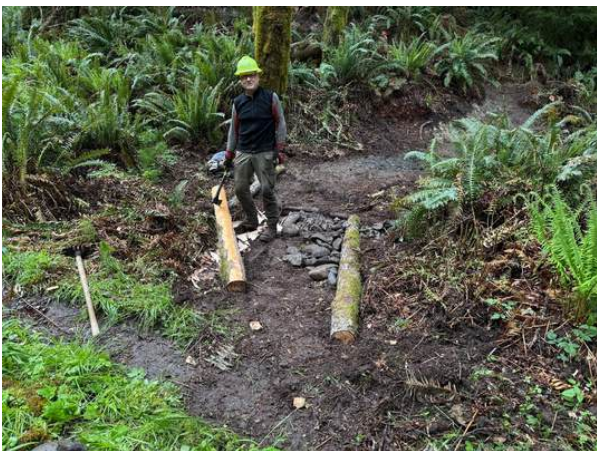
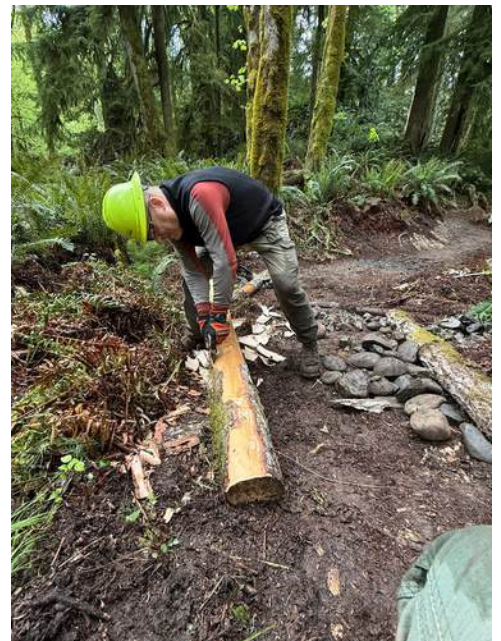
The turnpike down below taking good shape, including peeling the logs. The logs are fir, not cedar, but you have to work with what is in the area. Peeling them will make them last plenty long.

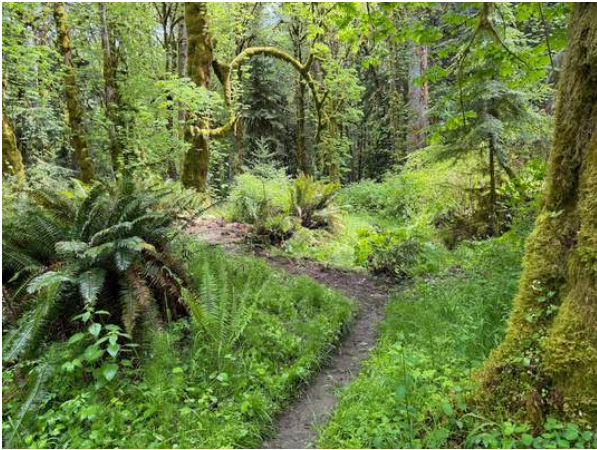
Here is the upper entrance with the puncheon no longer visible in the background to the right.

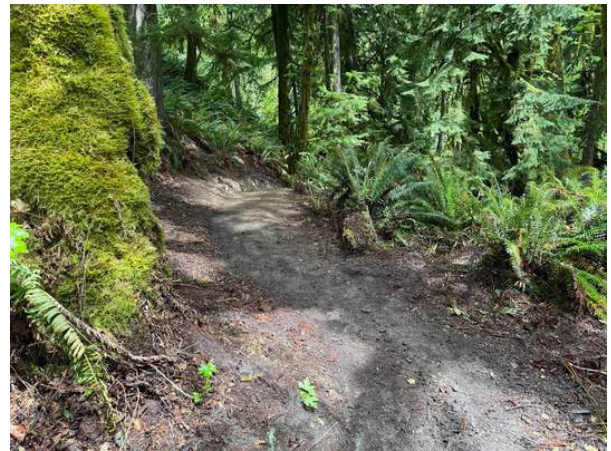
Part way down the trail. It's hard to tell here, but dozens of ferns were replanted and organic material tossed on the downhill edge, to give the trail a less recently-built look.

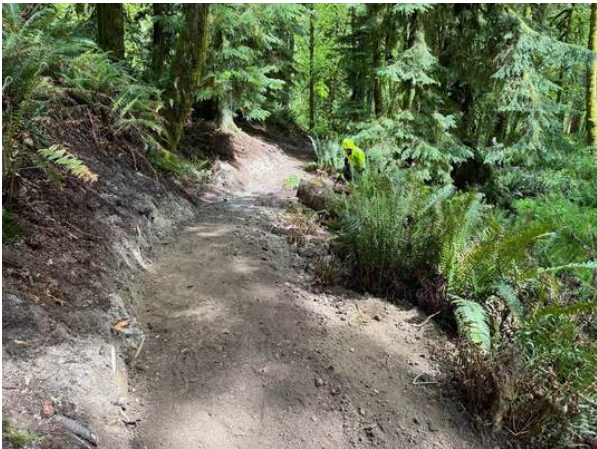
Heading down to the climbing turn.

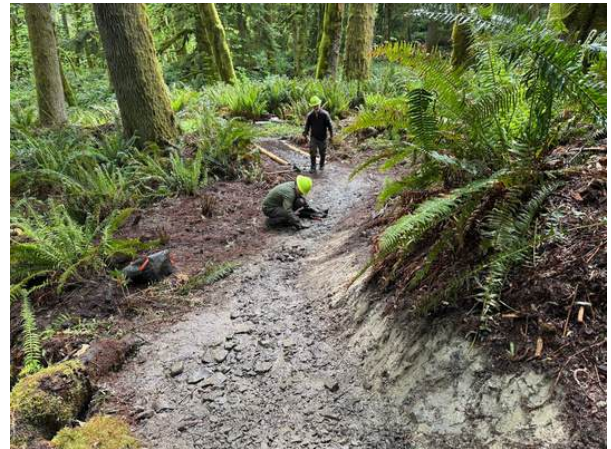
Going down around the climbing turn towards the bottom entrance. You can see material that was poured on top of the clay. Also, the climbing turn itself was constructed by tossing a huge pile of logs and small trees to give the turn a backdrop and soil supporter. Otherwise what we had was a huge, deep hole. (you can see it better in the lower left picture of the previous page).

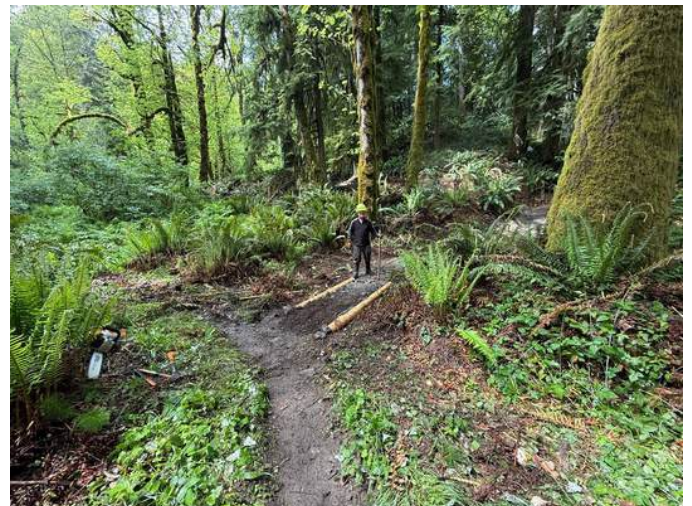
This shows the bottom entrance with the puncheon to the left no longer visible. We'll have to scrounge for additional material to fill and mound the turnpike more later, but definitely good enough for now. Our dry summer will help this all harden up and settle in. Many of the ferns I replanted will not make themselves obvious until next year when they put out new growth, but we made a concerted effort to make the tread look only 30" wide with ferns and organic debris along the downhill edge.

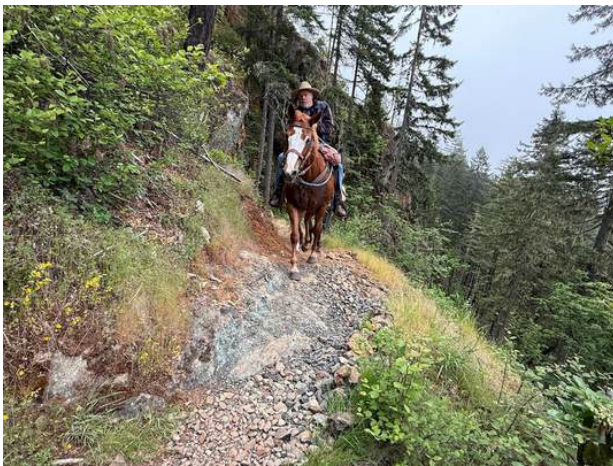
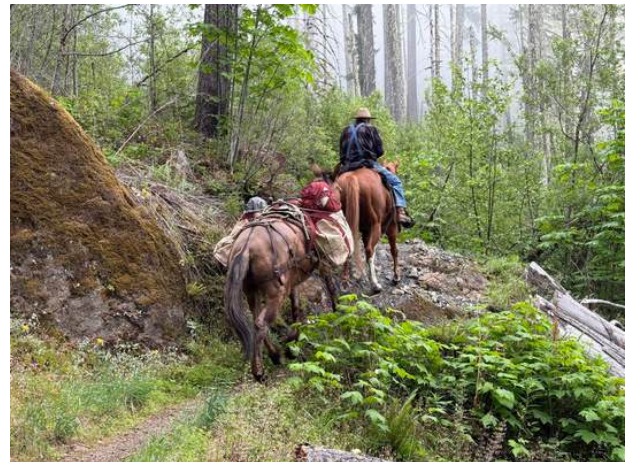
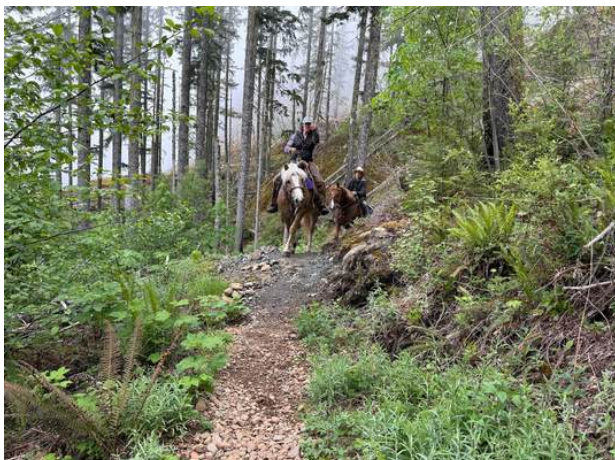
Top left: Harold riding Sugar with ease over a short spot just below "Snack Rock" that used to scare some riders.

Top right: Harold riding up onto what used to be the wet, slippery, smooth bedrock just above Snack Rock that was outsloped. Falls have happened here in the past. All I heard as Harold zoomed past was, "Oh Yeah ...".

Left: Rachael on Biskit going across the former slippery bedrock giving a big thumbs up.

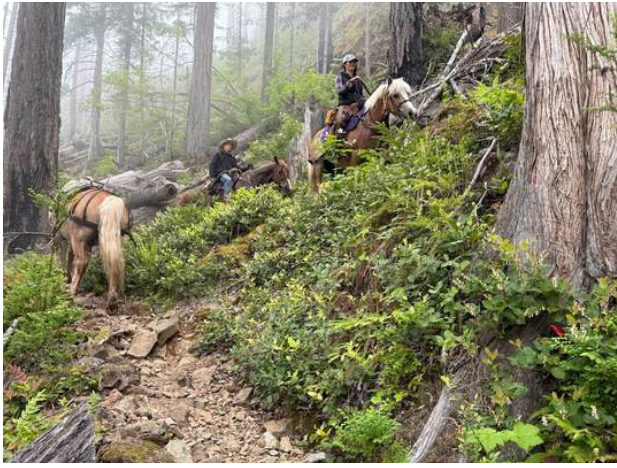
Going up around the second set of switchbacks between Snack Rock and Lunch Rock. The trail throughout here is very rocky. Nothing to be done about that - this is the site of a fire that burned away all the soil. The animals handle the rocks but Harold did say he might change their shoes for future trips on the Duckabush.

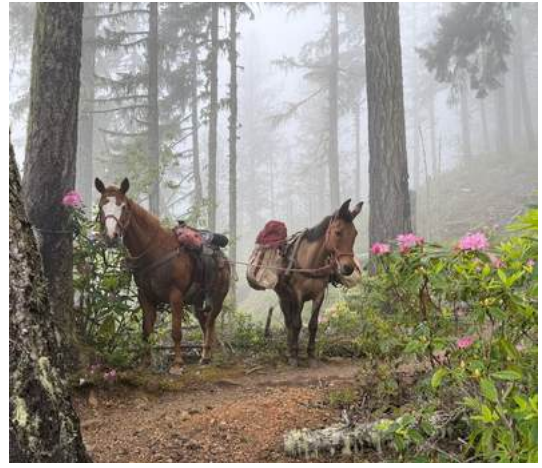
Sugar (left) and Archie, framed by the Rhodies. We had stopped at Lunch Rock to widen a log for better passage.

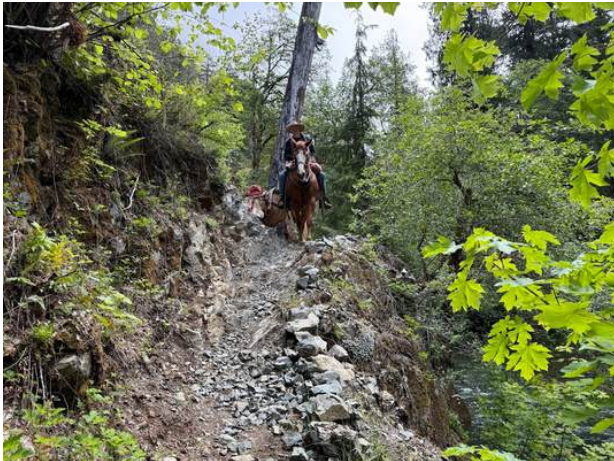
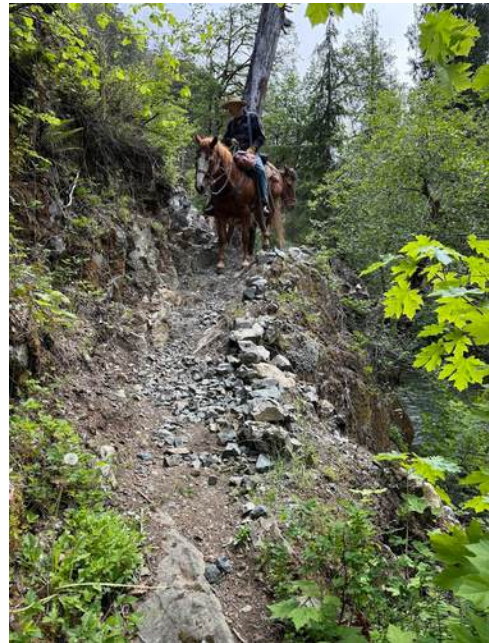
Clockwise from above: Harold on Sugar with Archie following, going around and down the most problematic corner of the trail. This was the spot that was making packers drop all our tools and gear at 5-Mile Camp rather than going on to 7-Mile Camp or beyond.

On this day all 6 animals and 3 packers had no trouble with this corner. Packs did not bump and footing was fine.

Recall from my earlier reports that packers would not go by here because it was so narrow and had such a big drop to the river. A bumped pack and toppled off horse / mule was way too high of a probability.

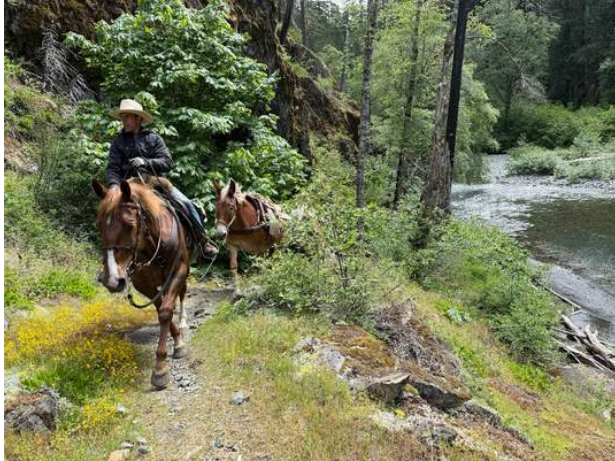
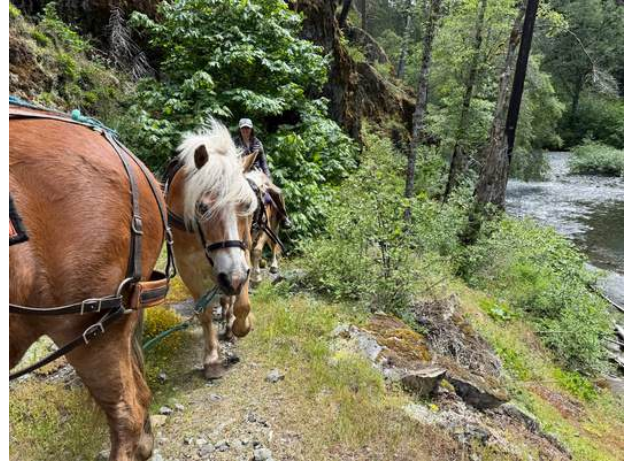
Almost directly after that curve and drop was another short rock hill that we had improved the footing on. No problems were reported here either. Matthew is on Dolly and the cutie with the long flowy bangs is Possi.

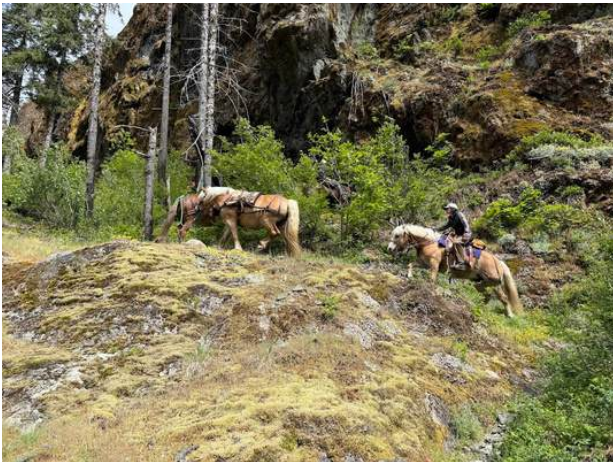
Here the crew is going around some tight S-curves and then along a rock-edged traverse up top. We had knocked the rock back for about 30 lineal feet on this traverse and it was reported that their packs did not bump the wall. You can see what a drop it would be to get bumped off here.
